Inspection Report for North Sturbridge Road Solar Facility NPDES ID No.: MAR10031G

Inspection Date: 04/8/2022

PHOTOGRAPHIC DOCUMENTATION North Sturbridge Road Solar Facility Charlton, Massachusetts Photographs Documented 04.8.2022

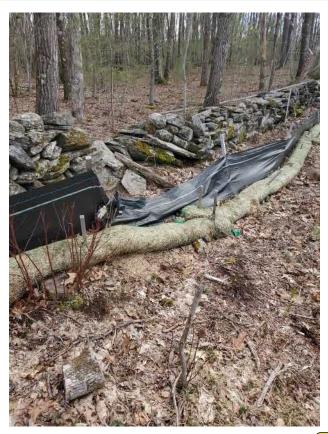
Photo 1

View of damaged silt fence in eastern portion of the Site —facing sou

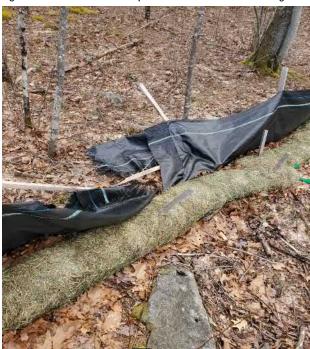
Photo 2

View of damaged silt fence in south portion of the Site —facing south
