Inspection Report for North Sturbridge Road Solar Facility NPDES ID No.: MAR10031G

NPDES ID No.: MAR10031G Inspection Date: 04/19/2022

PHOTOGRAPHIC DOCUMENTATION
North Sturbridge Road Solar Facility
Charlton, Massachusetts
Photographs Documented 04.19.2022

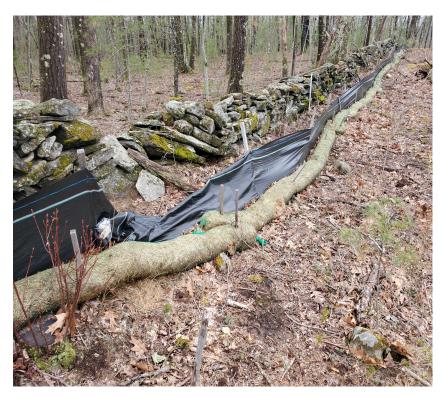
## Photo 1

Condition and Effectiveness of Erosion and Sediment (E&S) Controls (CGP Part 2.2)						
Type/Location of E&S Control	Maintenance Needed?*	Corrective Action Required?*	Date on Which Maintenance or Corrective Action First Identified?				
Silt Fence and Straw Wattles	Yes	No	4/19/2022	On 4/19/2022 BETA observed damage to the wattles in the northeast and eastern corners of the Site, damage was first observed on 3/15/2022. BETA also observed the silt fence to be partly torn in the southeastern corner of the Site, damage was first observed on 3/27/2022. General maintenance is needed for the entire silt fence. No evidence of discharge was observed.			
Stabilized Construction Entrance     (Site Entrance – Access Road)	No	No					
3. Stump and Soil Stockpile Area	No	No					
4. Dust Controls	N/A	N/A					
5. Jute Mesh (Steep Slopes)	N/A	N/A					
6. Temporary Seeding	No	No

View of damaged silt fence in eastern portion of the Site —facing southeast

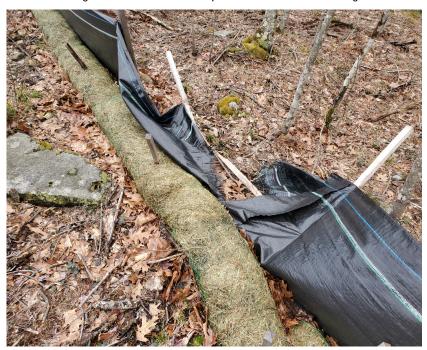
## Photo 2

View of damaged silt fence in south east portion of the Site —facing northeast

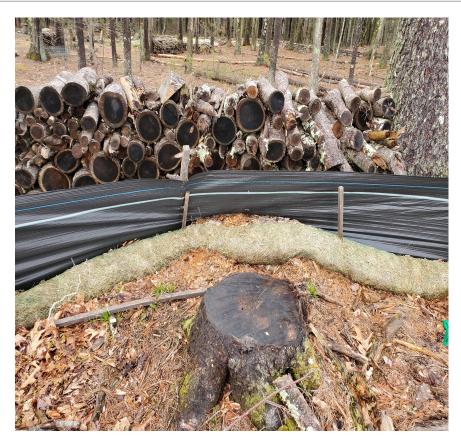
# Photo 3

View of damaged silt wattle in northern portion of the Site —facing north
