Inspection Report for North Sturbridge Road Solar Facility NPDES ID No.: MAR10031G

NPDES ID No.: MAR10031G Inspection Date: 04/19/2022

PHOTOGRAPHIC DOCUMENTATION North Sturbridge Road Solar Facility Charlton, Massachusetts Photographs Documented 04.19.2022

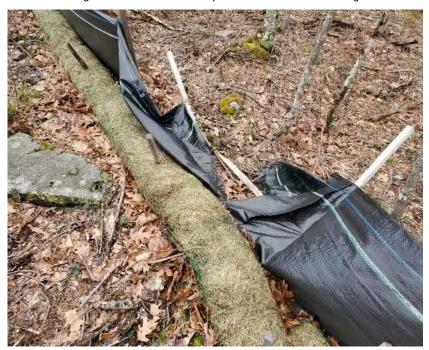
## Photo 2

View of damaged silt fence in southeast portion of the Site —facing northeast

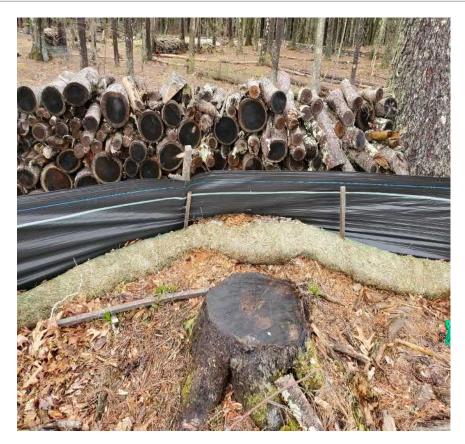
# Photo 3

View of damaged wattle in northern portion of the Site —facing north
