Inspection Report for North Sturbridge Road Solar Facility NPDES ID No.: MAR10031G Inspection Date: 04/19/2022

PHOTOGRAPHIC DOCUMENTATION North Sturbridge Road Solar Facility Charlton, Massachusetts Photographs Documented 04.19.2022

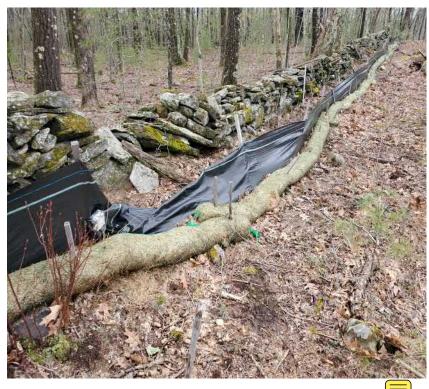
Photo 1

View of damaged silt fence in eastern portion of the Site —facing southeast

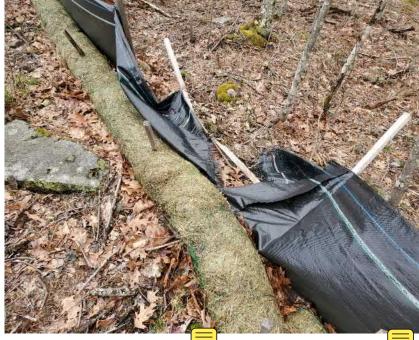
Photo 2

View of damaged silt fence in south east portion of the Site —facing north east

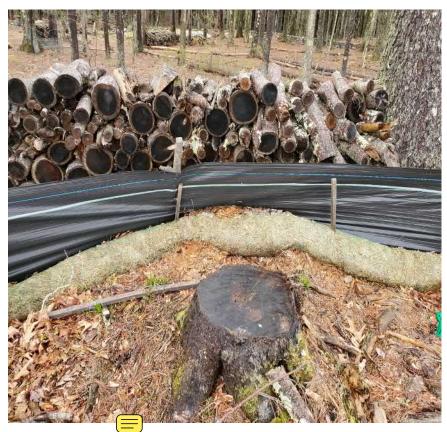
Photo 3

View of damaged silt wattle in northern portion of the Site —facing north
