Inspection Report for North Sturbridge Road Solar Facility NPDES ID No.: MAR10031G

NPDES ID No.: MAR10031G Inspection Date: 03/24/2022

PHOTOGRAPHIC DOCUMENTATION North Sturbridge Road Solar Facility Charlton, Massachusetts Photographs Documented 03.24.2022

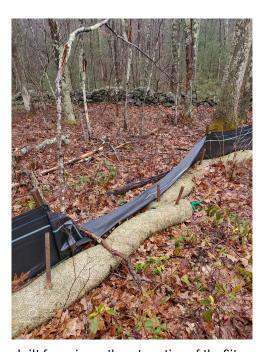
## Photo 2

3. Stump and Soil Stockpile Area	No	No		specification.		
4. Dust Controls	N/A	N/A	3/24/2022	On 3/24/2022 BETA observed severely damaged silt fence in the south east corner and norther portions of the Site. No evidence of discharge was observed.

View of damaged silt fence in south east portion of the Site —facing south east

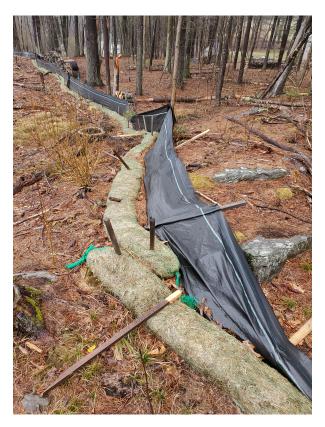
# Photo 3

View of damaged silt fence in northern portion of the Site—facing north west.

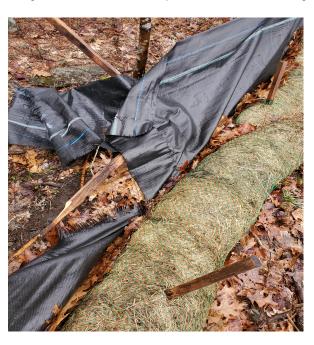
## Photo 4

View of damaged silt fence in south east portion of the Site —facing south east
