Inspection Report for North Sturbridge Road Solar Facility NPDES ID No.: MAR10031G

NPDES ID No.: MAR10031G Inspection Date: 04/19/2022

PHOTOGRAPHIC DOCUMENTATION
North Sturbridge Road Solar Facility
Charlton, Massachusetts
Photographs Documented 04.19.2022

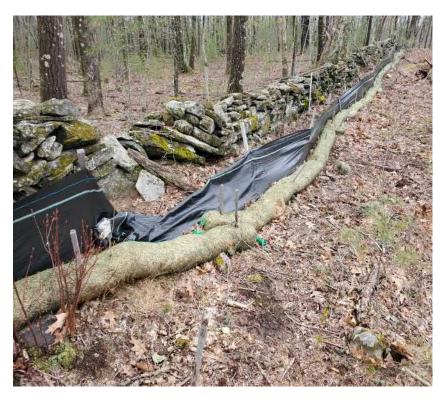
## Photo 1

View of damaged silt fence in eastern portion of the Site —facing south east

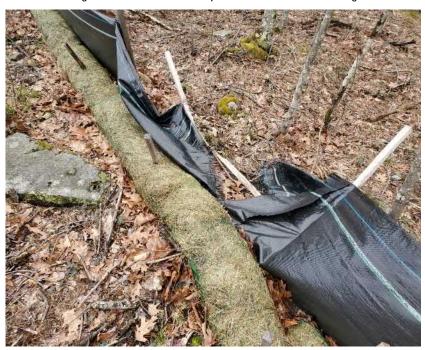
## Photo 2

3. Stump and Soil Stockpile Area	No	No		tenance.		
4. Dust Controls	N/A	N/A	3/24/2022	On 3/24/2022 BETA observed damaged silt fence in the southeast corner and northern portions of the Site. No evidence of discharge was observed.

View of damaged silt fence in south east portion of the Site —facing north east

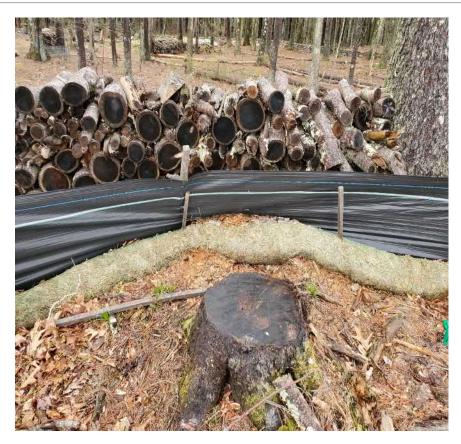
# Photo 3

View of damaged silt wattle in northern portion of the Site —facing north
