Inspection Report for North Sturbridge Road Solar Facility

NPDES ID No.: MAR10031G

Inspection Date: 04/27/2022

PHOTOGRAPHIC DOCUMENTATION
North Sturbridge Road Solar Facility
Charlton, Massachusetts
Photographs Documented 04.27.2022

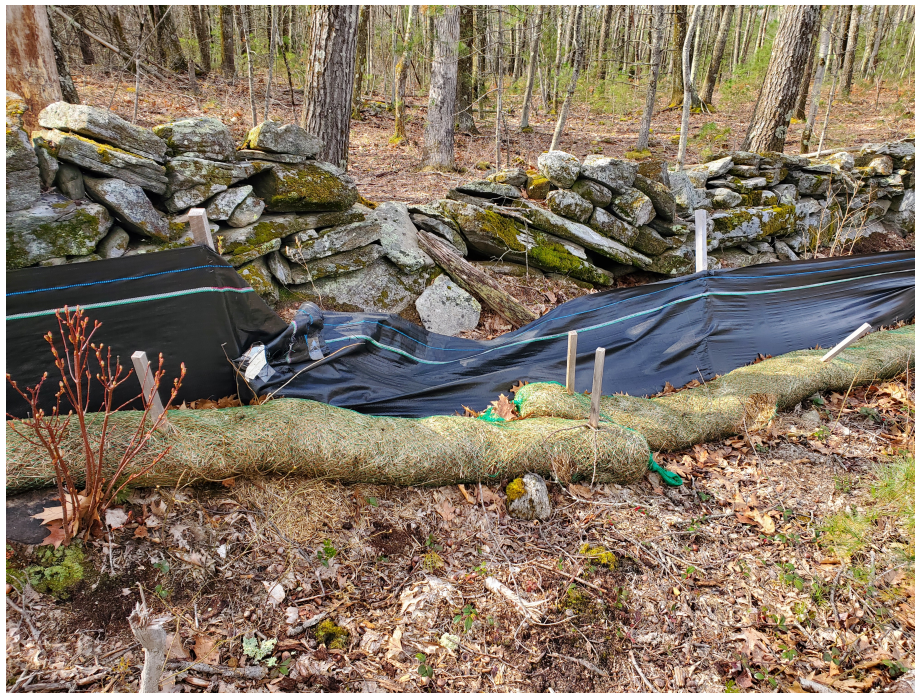
Photo 1

Type/Location of E&S Control	Maintenance Needed?*	Corrective Action Required?*	Date on Which Maintenance or Corrective Action First Identified?	
1. Silt Fence and Straw Wattles	Yes	No	4/27/2022	On 4/27/2022 BETA observed damage to the wattles in the northeast and eastern corners of the Site, damage was first observed on 3/15/2022. BETA also observed the silt fence to be partly torn in the southeastern corner of the Site, damage was first observed on 3/27/2022. General maintenance is needed for the entire silt fence. No evidence of discharge was observed.
2. Stabilized Construction Entrance (Site Entrance – Access Road)	No	No		
3. Stump and Soil Stockpile Area	No	No		
4. Dust Controls	N/A	N/A		
5. Jute Mesh (Steep Slopes)	N/A	N/A		
6. Temporary Seeding	No	No

View of damaged silt fence in eastern portion of the Site — facing southeast

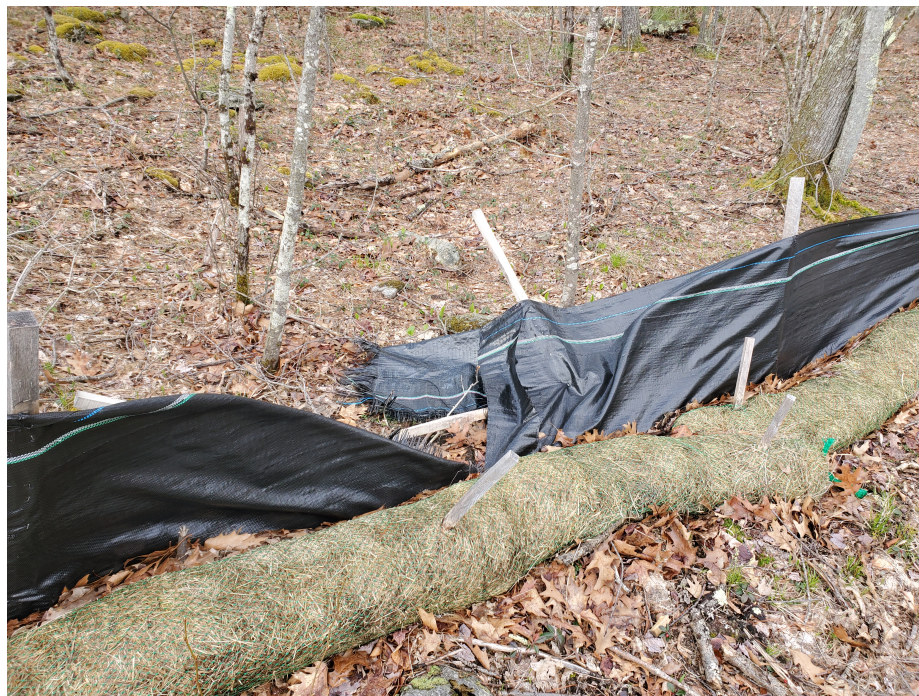
Photo 2

View of damaged silt fence in southeast portion of the Site — facing southeast

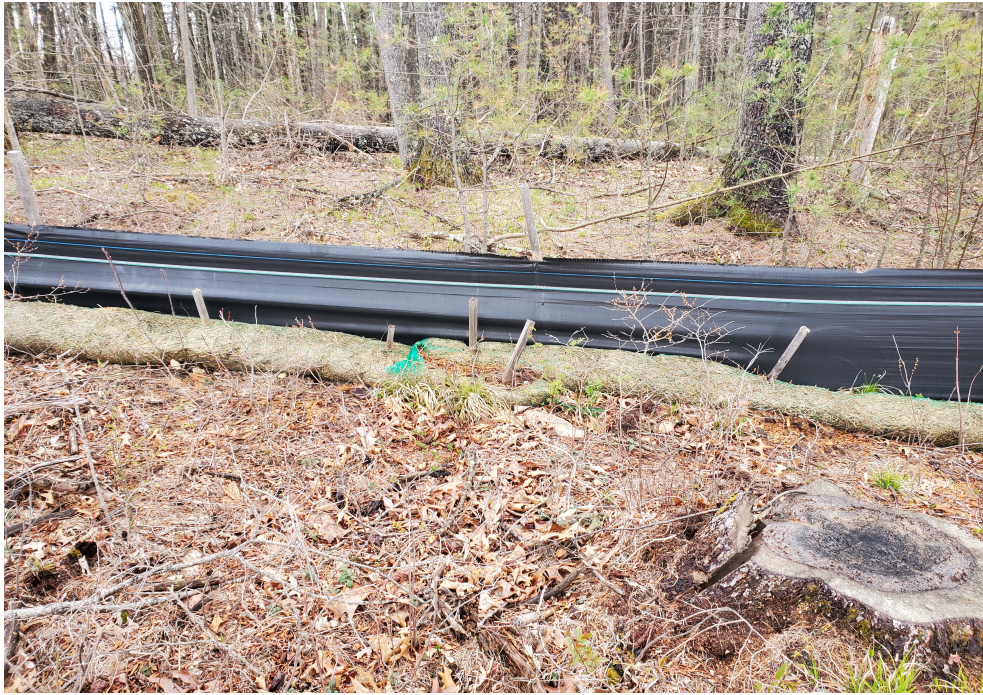
Photo 3

View of damaged silt wattle in northern portion of the Site — facing north

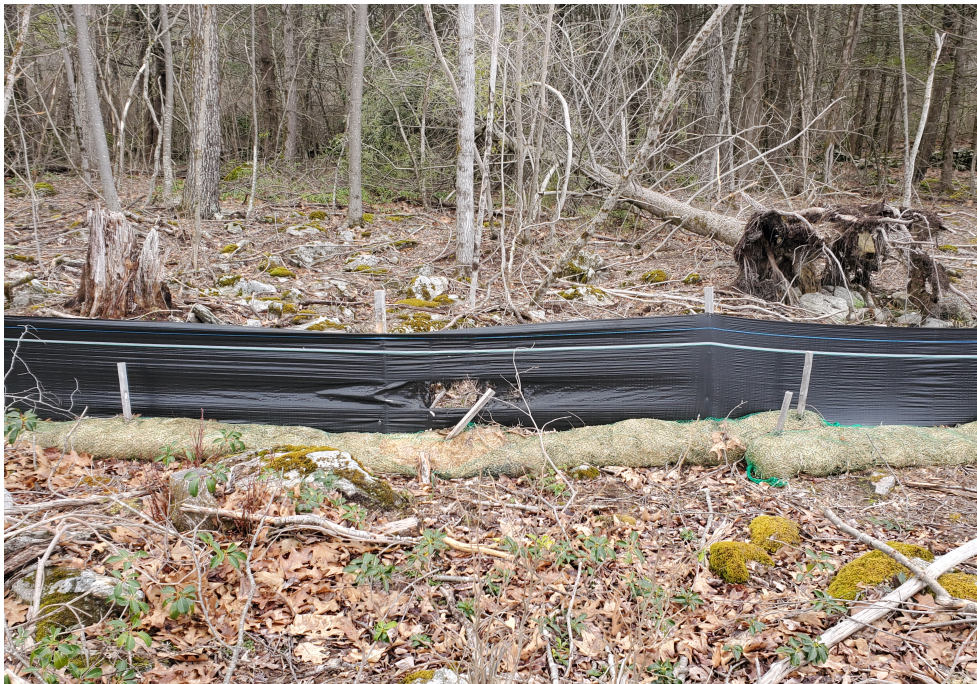
Photo 4

View of damaged silt wattle in northeastern portion of the Site — facing northeast

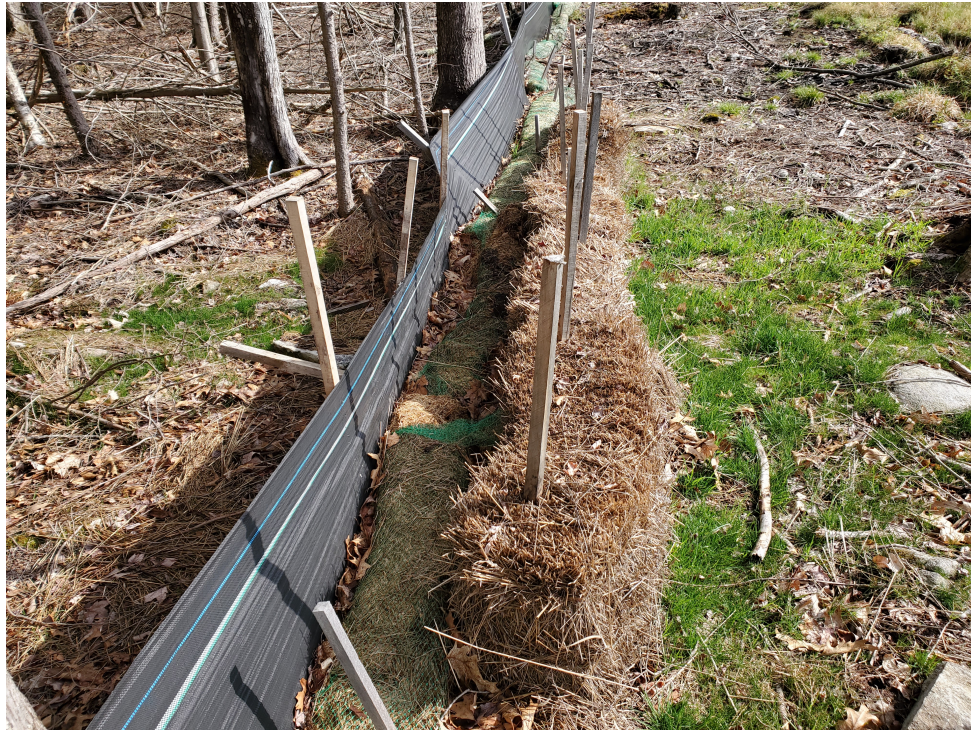
Photo 5

<p>4. Area beyond limits of work at Discharge 2</p>	<p>Hand application of seed</p>	<p><input type="checkbox"/> Yes Enter Date <input checked="" type="checkbox"/> No</p>	<p>On 4/8/2022 BETA observed the recently seeded grass to be thriving.</p>

View of seeded grass at Discharge 2 — facing north
