Inspection Report for North Sturbridge Road Solar Facility

NPDES ID No.: MAR10031G

Inspection Date: 04/27/2022

PHOTOGRAPHIC DOCUMENTATION
North Sturbridge Road Solar Facility
Charlton, Massachusetts
Photographs Documented 04.27.2022

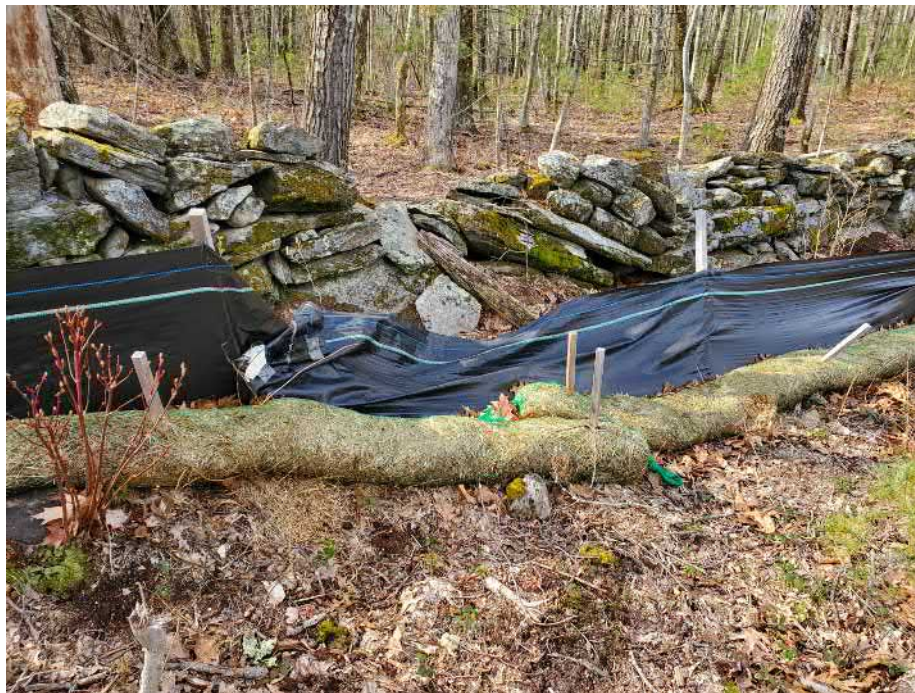
Photo 1

| Type/Location of E&S Control | Maintenance Needed?* | Corrective Action Required?* | Date on Which Maintenance or Corrective Action First Identified? | Notes |
|---|---|---|--|--|
| 1. Silt Fence and Straw Wattles | Yes | No | 3/15/2022 | On 4/27/2022 BETA observed damage to the wattles in the northeast and eastern corners of the Site, damage was first observed on 3/15/2022. BETA also observed the silt fence to be partly torn in the southeastern corner of the Site, damage was first observed on 3/27/2022. General maintenance is needed for the entire silt fence. No evidence of discharge was observed. |

View of damaged silt fence in eastern portion of the Site — facing southeast

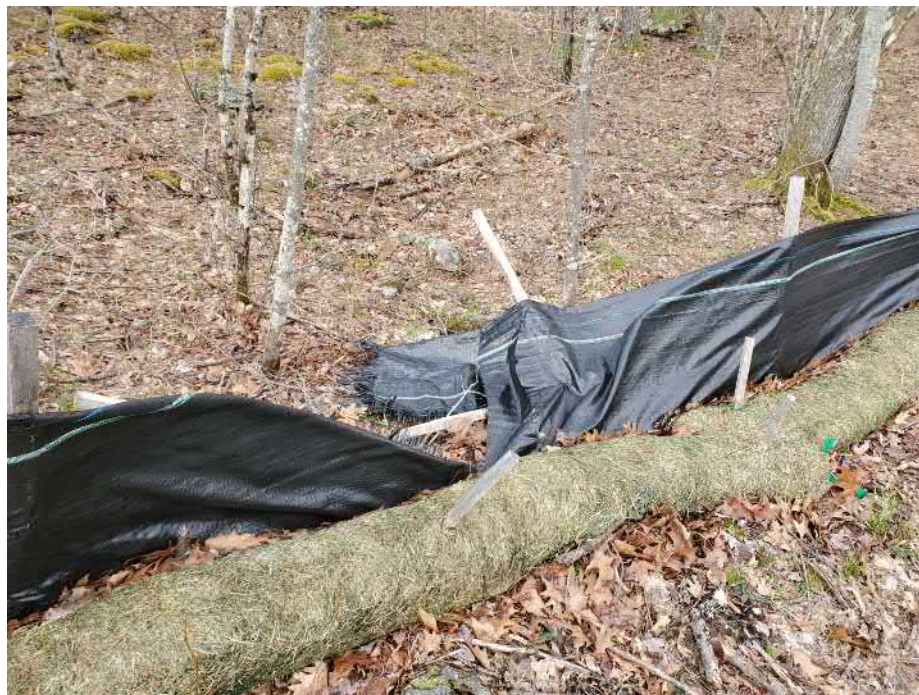
Photo 2

View of damaged silt fence in southeast portion of the Site — facing southeast

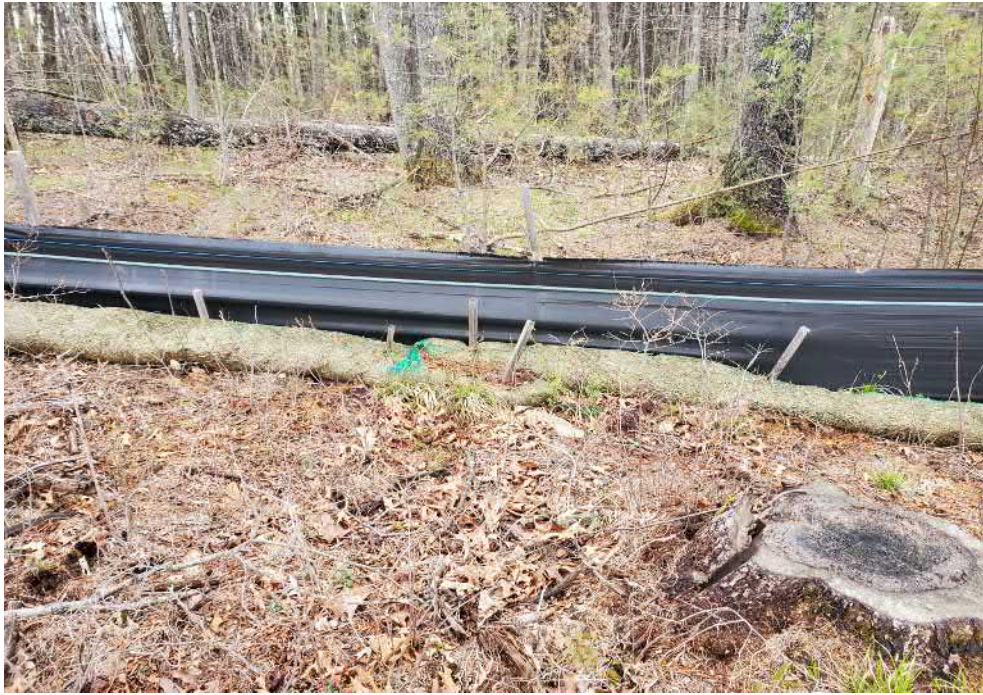
Photo 3

View of damaged silt wattle in northern portion of the Site — facing north

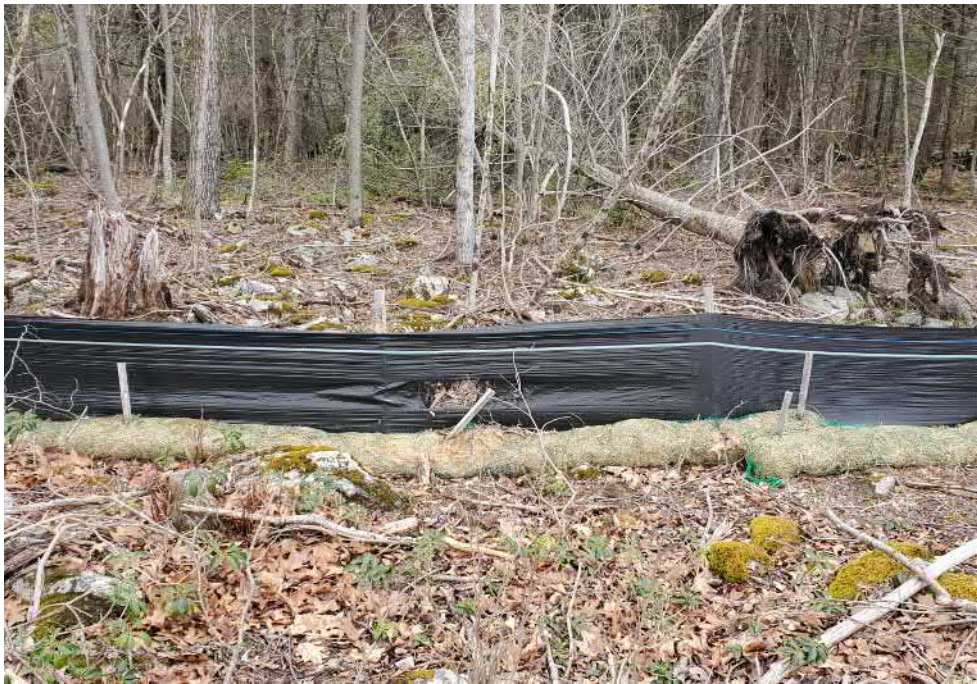
Photo 4

View of damaged silt wattle in northeastern portion of the Site — facing northeast

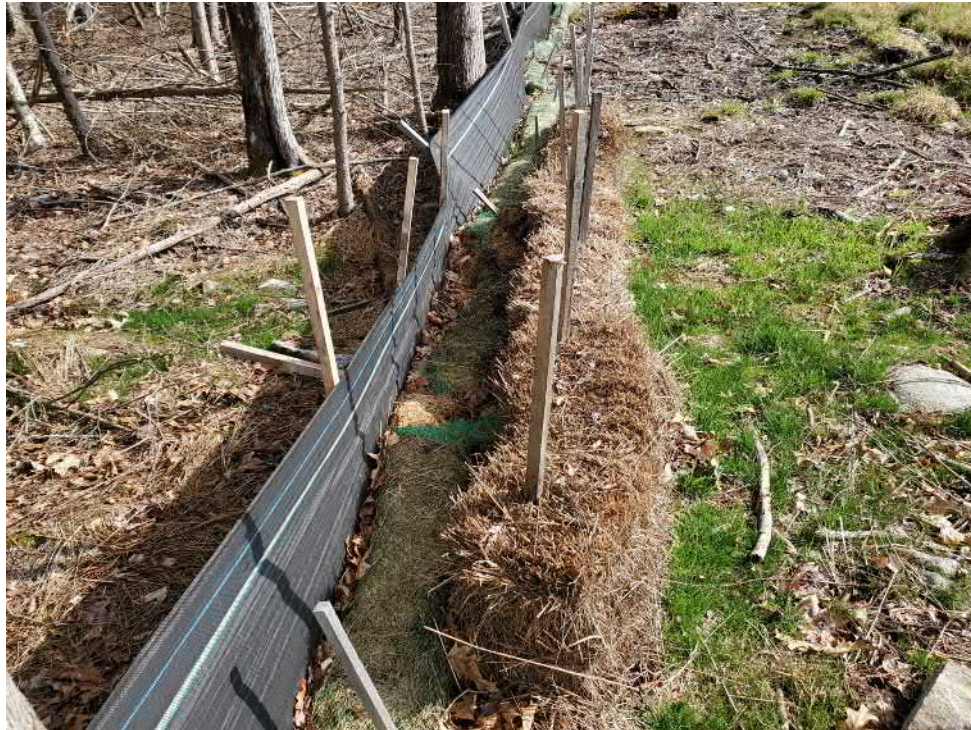
Photo 5

| <p>4. Area beyond limits of work at Discharge 2</p> | <p>Hand application of seed</p> | <p><input type="checkbox"/> Yes Enter Date <input checked="" type="checkbox"/> No</p> | <p>On 4/8/2022 BETA observed the recently seeded grass to be established.</p> |

View of established grass at Discharge 2 — facing north
