Inspection Report for North Sturbridge Road Solar Facility

NPDES ID No.: MAR10031G

Inspection Date: 04/27/2022

PHOTOGRAPHIC DOCUMENTATION
North Sturbridge Road Solar Facility
Charlton, Massachusetts
Photographs Documented 04.27.2022

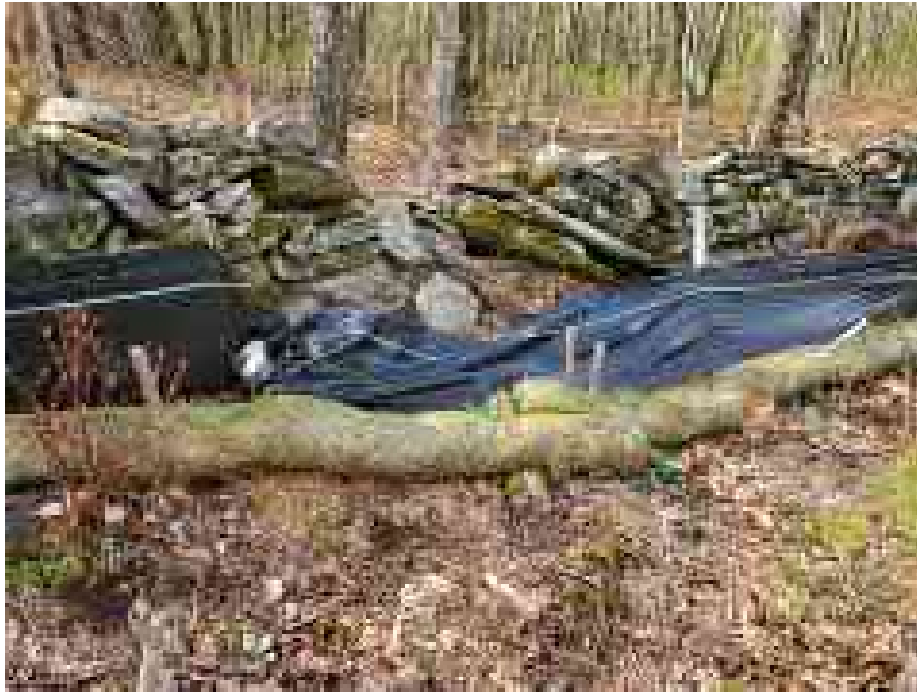
Photo 1

View of damaged silt fence in eastern portion of the Site — facing south east

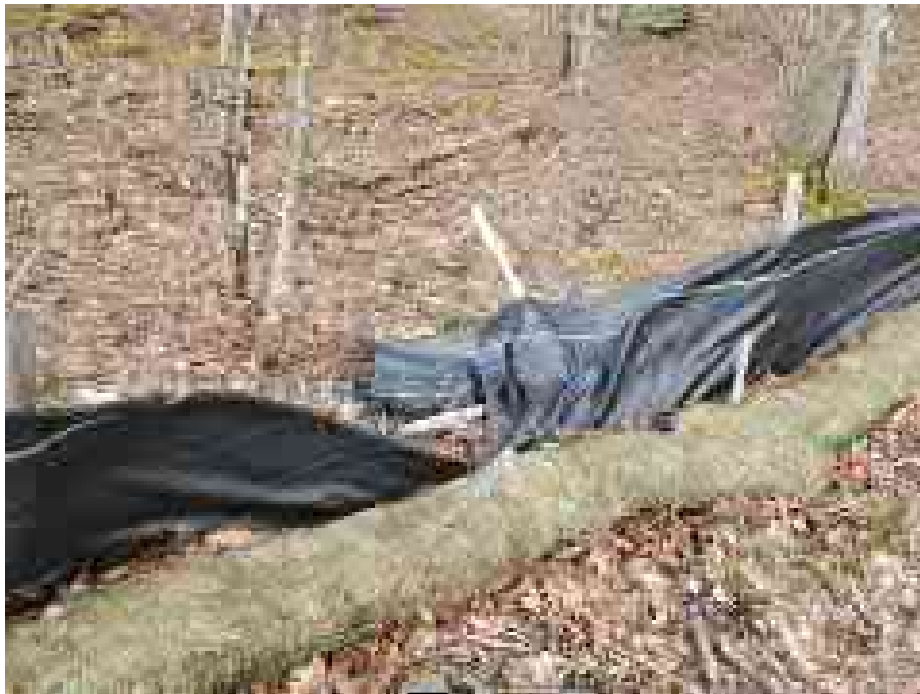
Photo 2

View of damaged silt fence in south east portion of the Site — facing south east

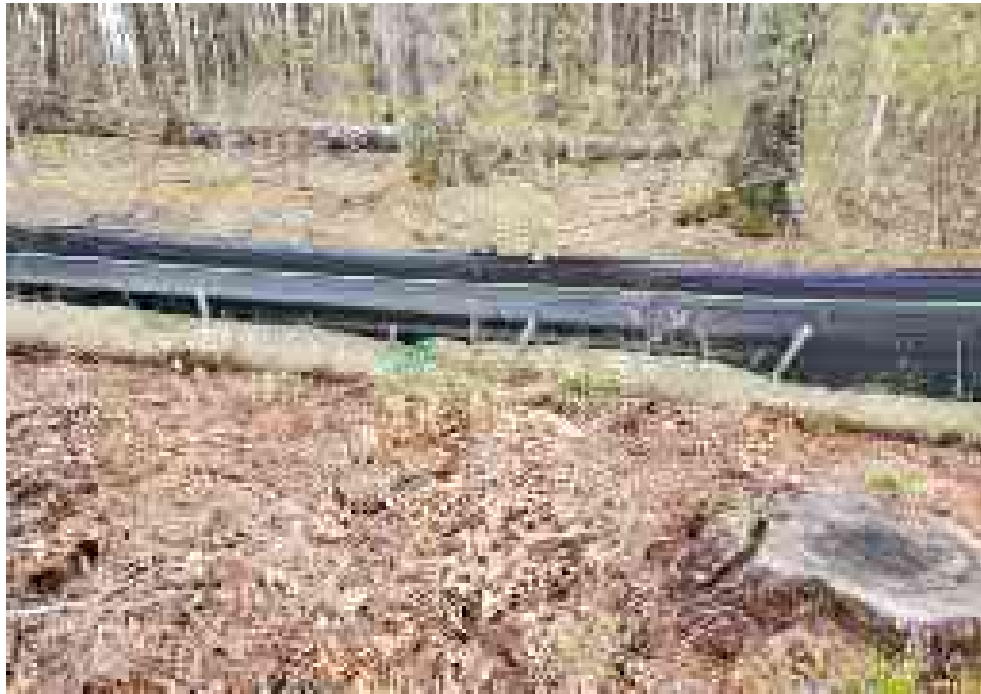
Photo 3

View of damaged silt wattle in northern portion of the Site — facing north

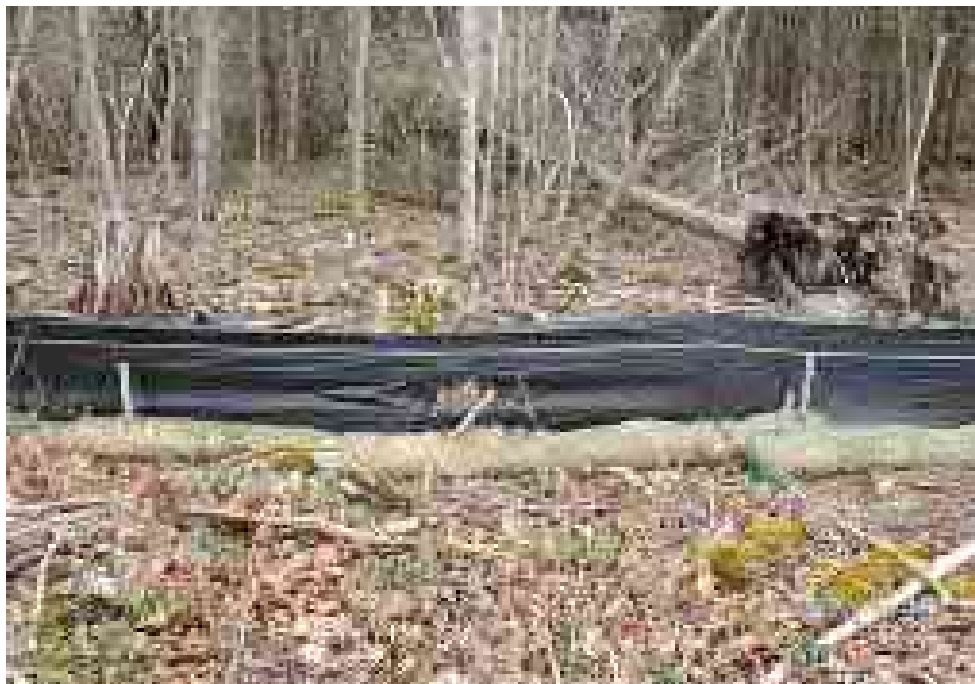
Photo 4

View of damaged silt wattle in northern portion of the Site — facing north east

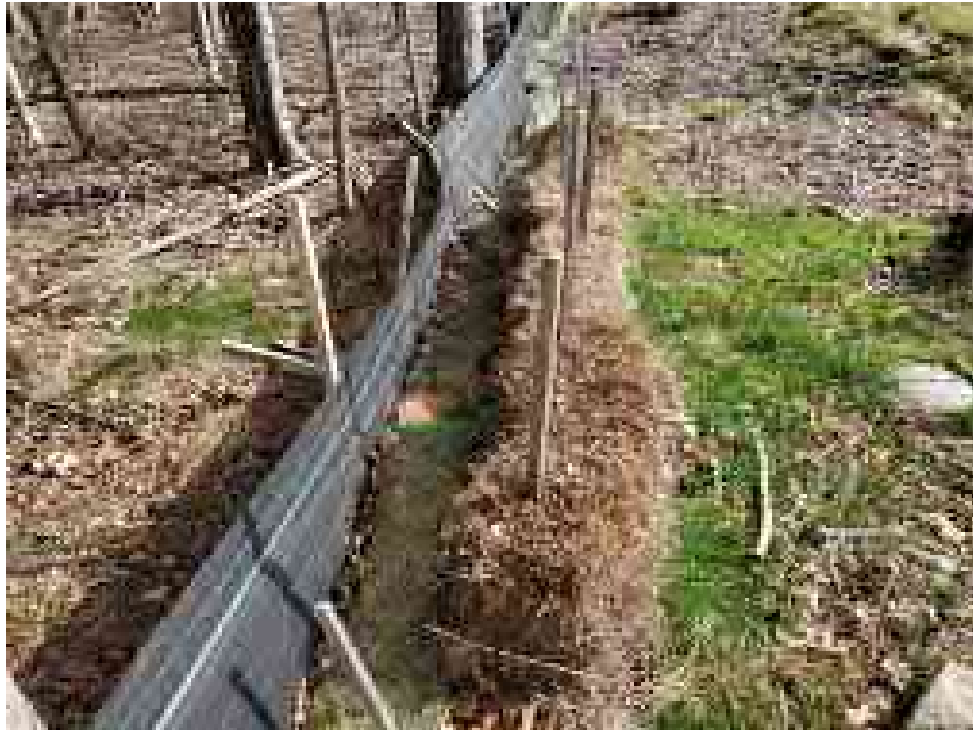
Photo 5

<p>4. Area beyond limits of work at Discharge 2</p>	<p>Hand application of seed</p>	<p><input type="checkbox"/> Yes Enter Date <input checked="" type="checkbox"/> No</p>	<p>On 4/27/2022 BETA observed the recently seeded grass to be thriving.</p>

View of seeded grass at Discharge 2 — facing north
