Inspection Report for North Sturbridge Road Solar Facility NPDES ID No.: MAR10031G

NPDES ID No.: MAR10031G Inspection Date: 03/24/2022

PHOTOGRAPHIC DOCUMENTATION
North Sturbridge Road Solar Facility
Charlton, Massachusetts
Photographs Documented 03.24.2022

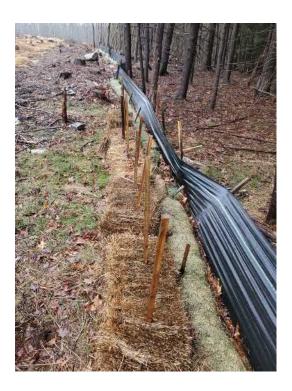
# Photo 1

View of area downgradient of Discharge 2—facing south west.

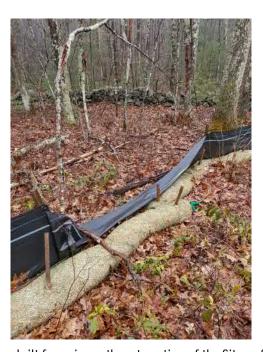
## Photo 2

3. Stump and Soil Stockpile Area	No	No		specification.
4. Dust Controls	N/A	N/A	3/24/2022	On 3/24/2022 BETA observed prey damaged silt fence in the south corner and norther tions of the Site. No evidence of discharge was observed.

View of damaged silt fence in south east portion of the Site —facing south east

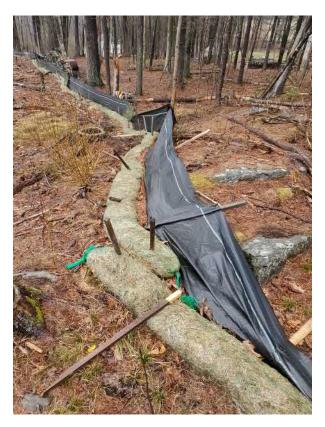
# Photo 3

View of damaged silt fence in northern portion of the Site—facing north west.

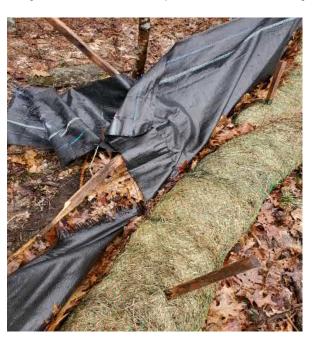
## Photo 4

View of damaged silt fence in south east portion of the Site —facing south east
