Inspection Report for North Sturbridge Road Solar Facility

NPDES ID No.: MAR10031G

Inspection Date: 04/27/2022

**FIGURE 1:  
SWPPP  
INSPECTION  
SKETCH  
04/27/2022**

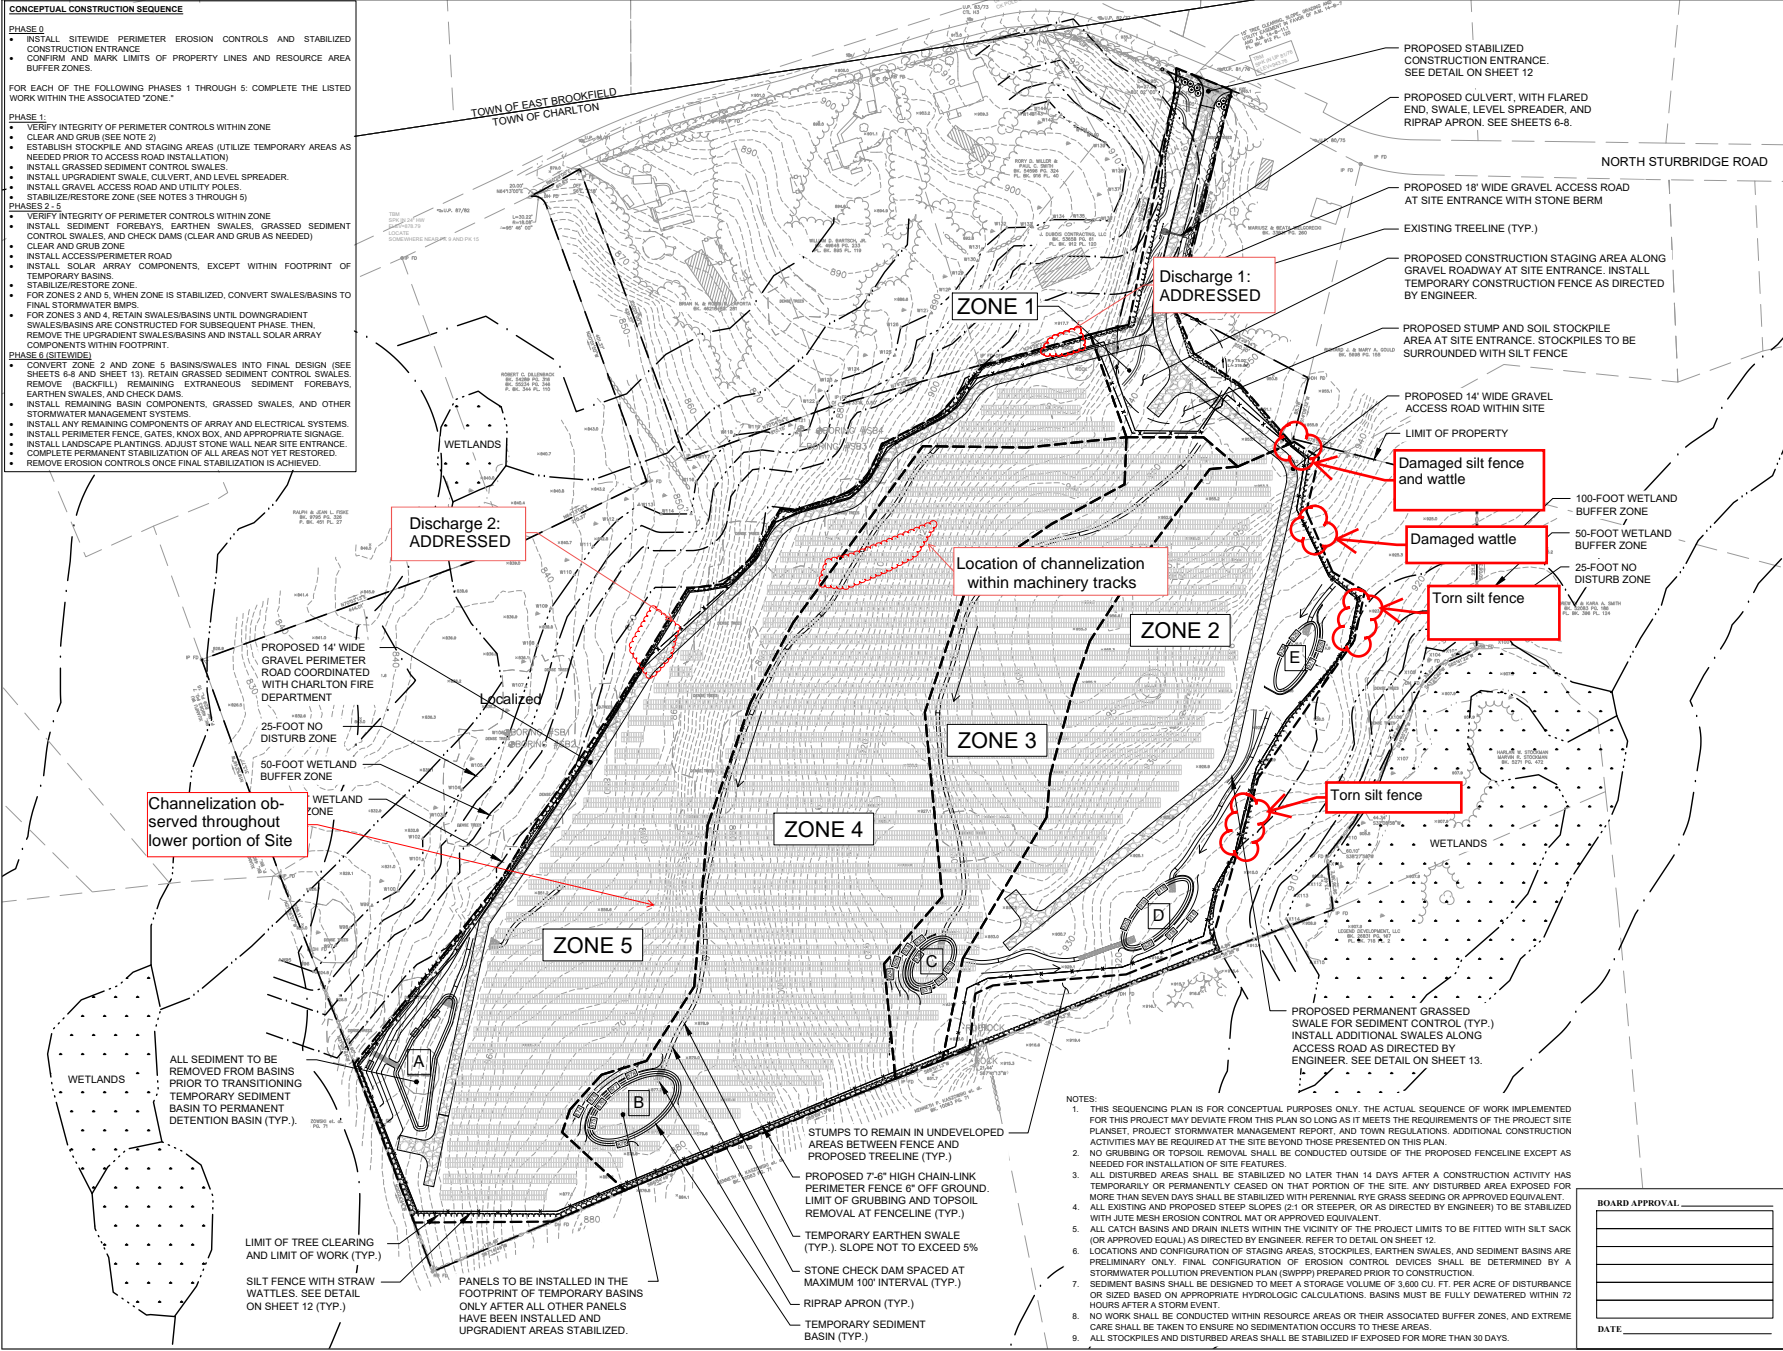
2. Informal access road along northern portion of the Site	Straw mulch or hydroseed	<input type="checkbox"/> Yes [Enter date] <input checked="" type="checkbox"/> No	Erosion channels are beginning to form within upgradient portions of the informal access road (Figure 1). The contractor indicated that stabilization by smoothing out soils and seeding or spreading mulch would occur on 7/30/2021. Stabilization of this area has not been initiated. After inspection of the area on 8/24/2021, it was determined that

Damaged silt fence and wattle

Damaged wattle

Torn silt fence

Location of channelization within machinery tracks

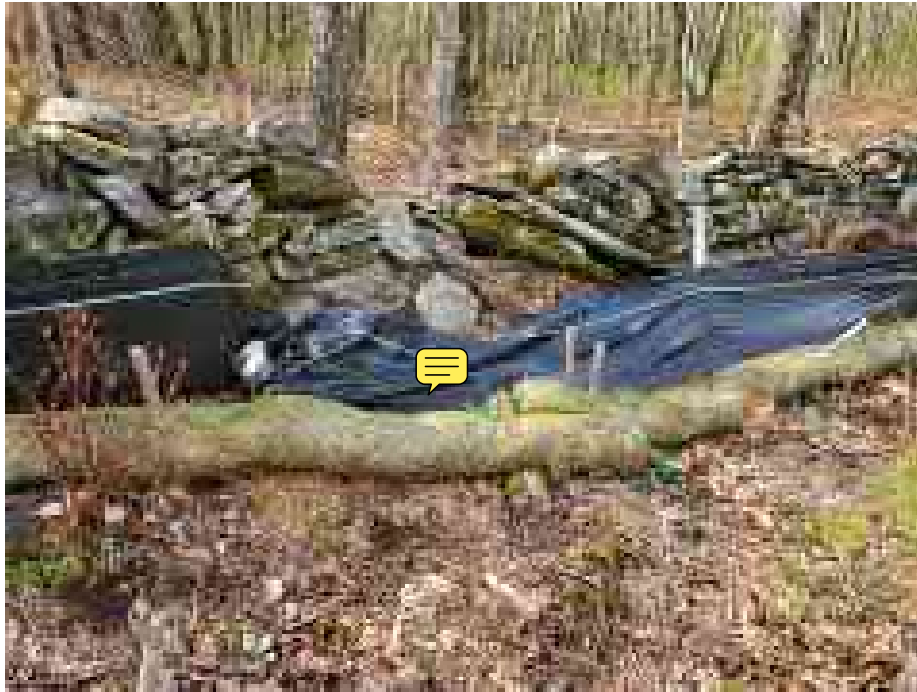
Photo 1

View of damaged silt fence in eastern portion of the Site — facing south, east

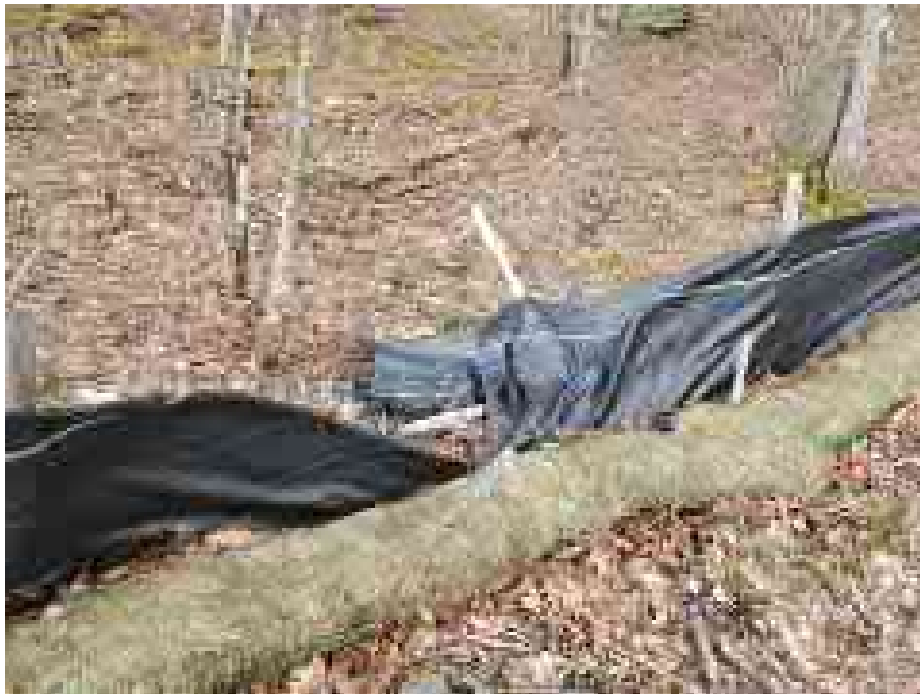
Photo 2

View of damaged silt fence in southern portion of the Site — facing south, east

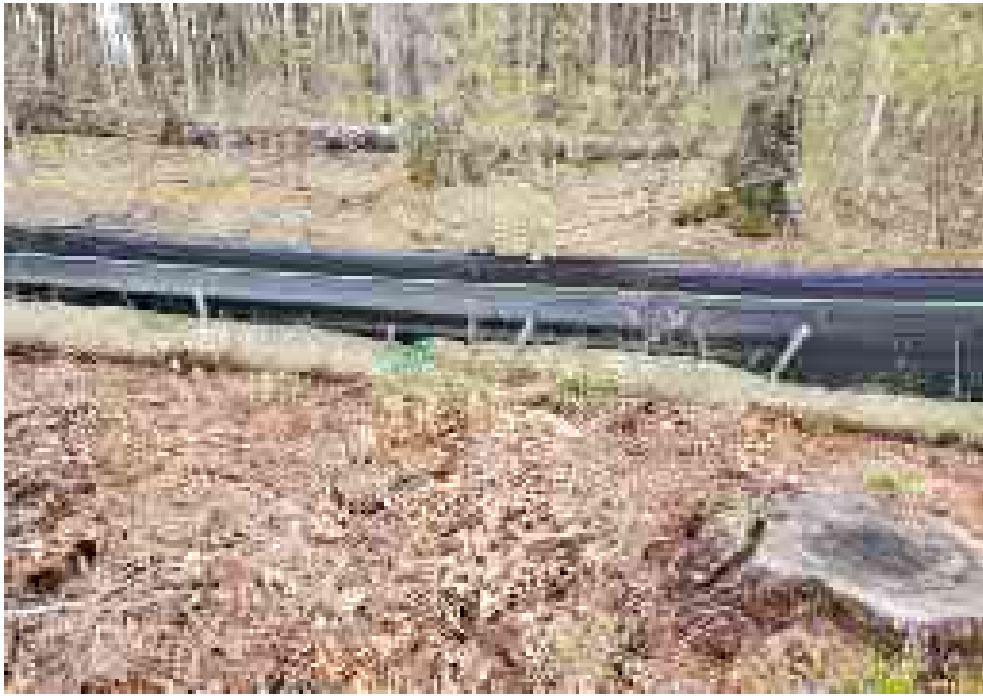
Photo 3

View of damaged silt wattle in northern portion of the Site — facing north

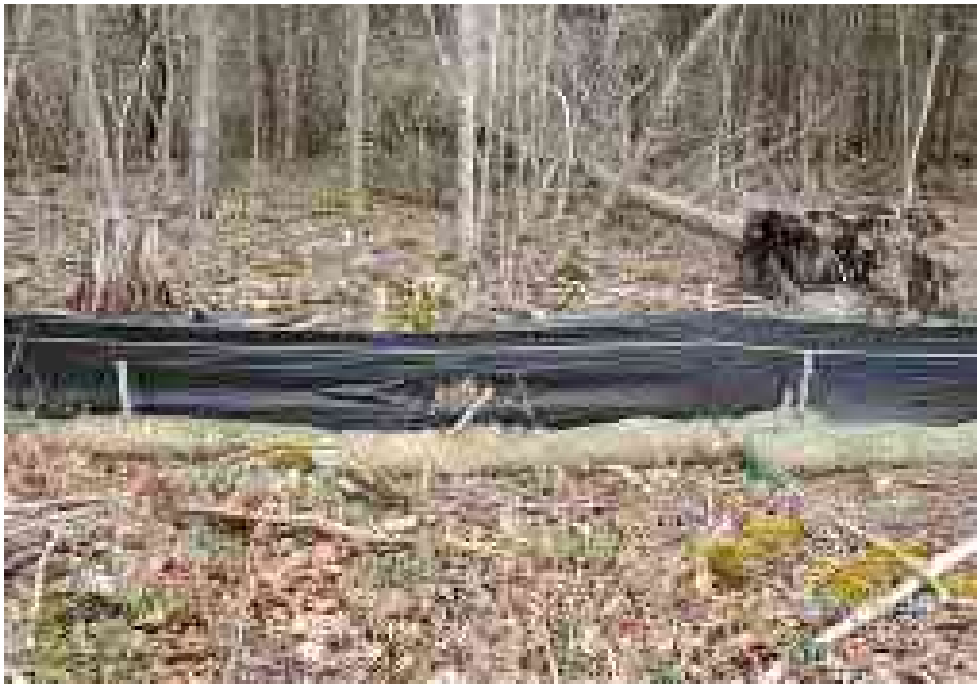
Photo 4

View of damaged silt wattle in northern portion of the Site — facing north
