Inspection Report for North Sturbridge Road Solar Facility

NPDES ID No.: MAR10031G

Inspection Date: 5/4/2022

PHOTOGRAPHIC DOCUMENTATION
North Sturbridge Road Solar Facility
Charlton, Massachusetts
Photographs Documented 5.4.2022

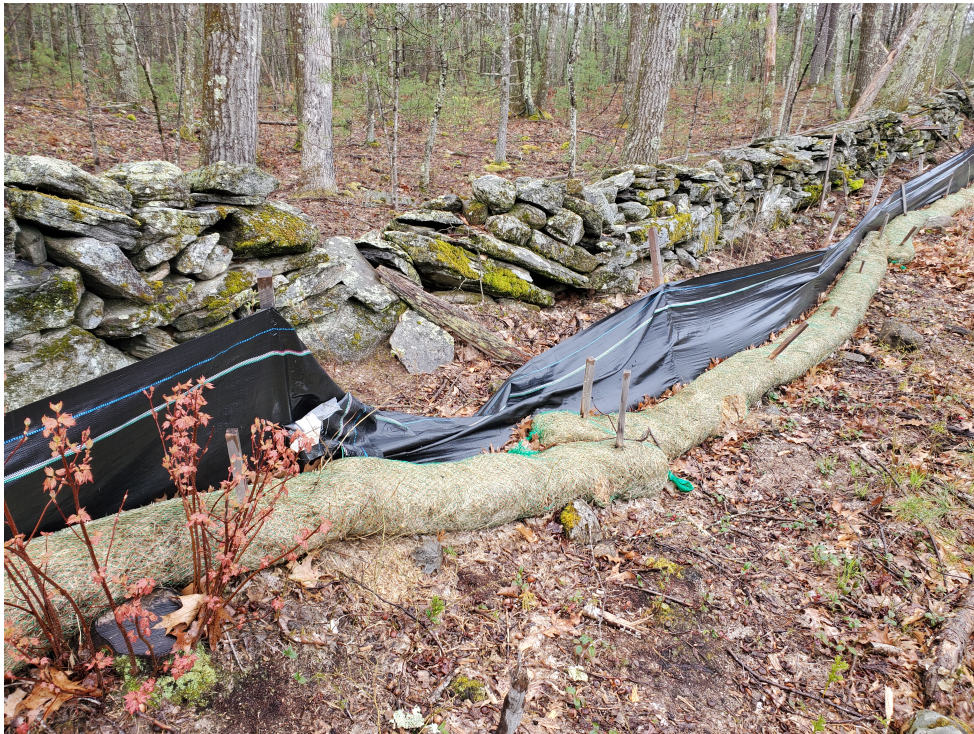
Photo 1

Type/Location of E&S Control	Maintenance Needed?*	Corrective Action Required?*	Date on Which Maintenance or Corrective Action First Identified?	
1. Silt Fence and Straw Wattles	Yes	No	5/4/2022	On 5/4/2022 BETA observed damage to the wattles in the northeast and eastern corners of the Site, damage was first observed on 3/15/2022. BETA also observed the silt fence to be partly torn in the southeastern corner of the Site, damage was first observed on 3/27/2022. General maintenance is needed for the entire silt fence. No evidence of discharge was observed.
2. Stabilized Construction Entrance (Site Entrance – Access Road)	No	No		
3. Stump and Soil Stockpile Area	No	No		
4. Dust Controls	N/A	N/A		
5. Jute Mesh (Steep Slopes)	N/A	N/A		
6. Temporary Seeding	No	No

View of damaged silt fence in eastern portion of the Site — facing southeast

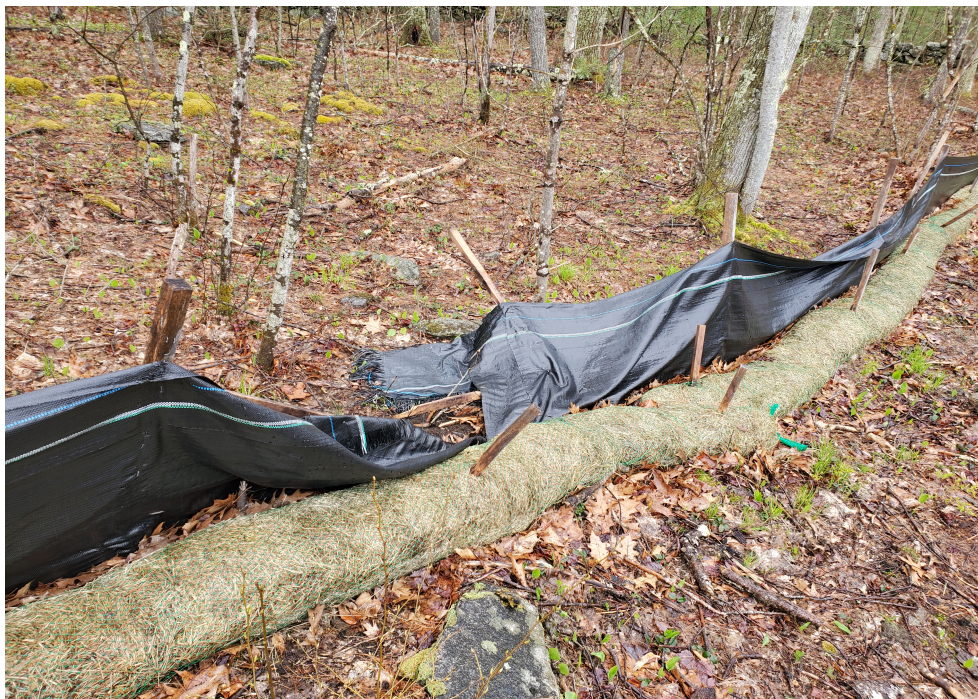
Photo 2

View of damaged silt fence in southeast portion of the Site — facing southeast

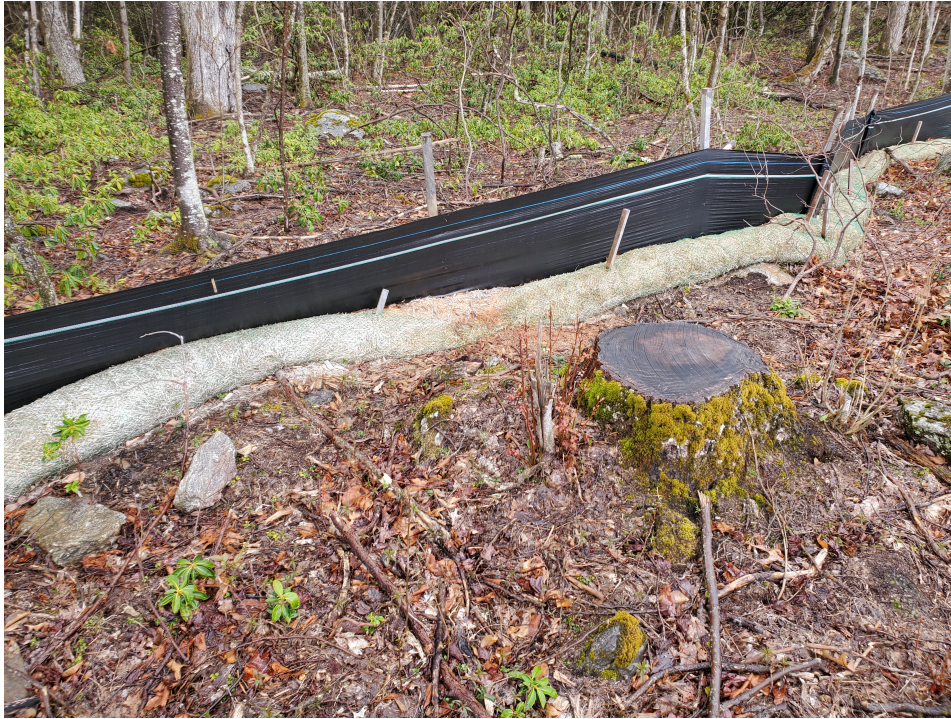
Photo 3

View of damaged silt wattle in northern portion of the Site — facing north

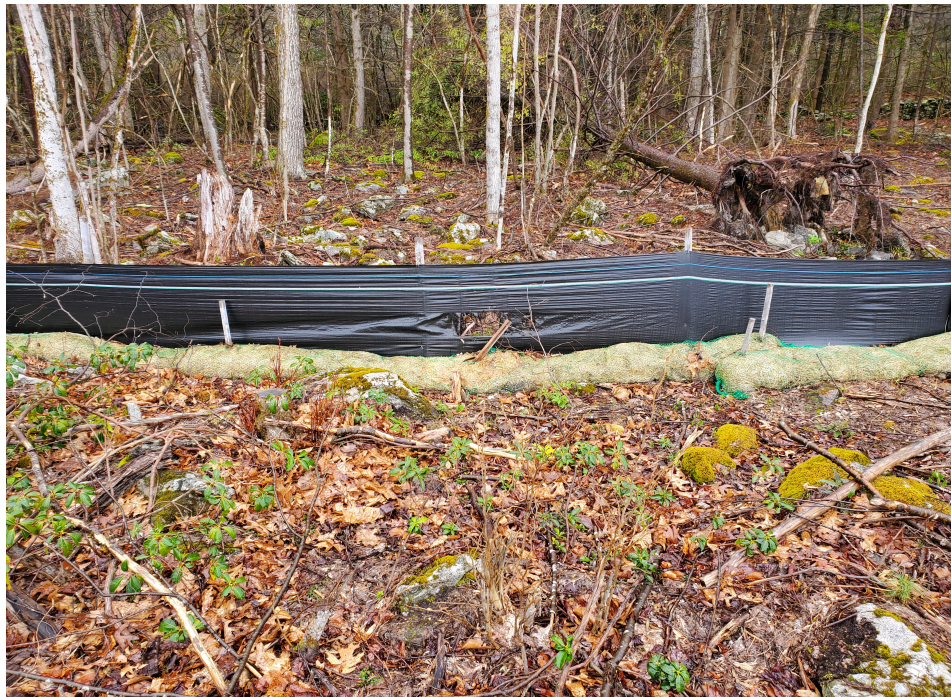
Photo 4

View of damaged silt wattle in northeastern portion of the Site — facing northeast

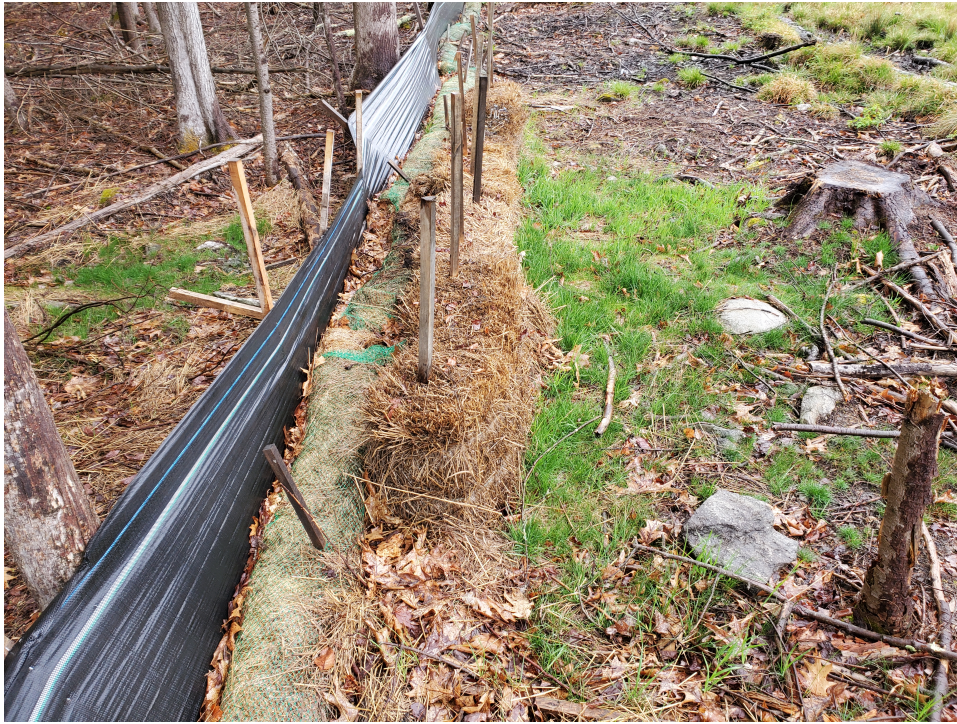
Photo 5

<p>4. Area beyond limits of work at Discharge 2</p>	<p>Hand application of seed</p>	<p><input type="checkbox"/> Yes Enter Date <input checked="" type="checkbox"/> No</p>	<p>On 4/8/2022 BETA observed the recently seeded grass to be thriving.</p>

View of seeded grass at Discharge 2 — facing north
