Inspection Report for North Sturbridge Road Solar Facility

NPDES ID No.: MAR10031G

Inspection Date: 5/4/2022

PHOTOGRAPHIC DOCUMENTATION  
North Sturbridge Road Solar Facility  
Charlton, Massachusetts  
Photographs Documented 5.4.2022

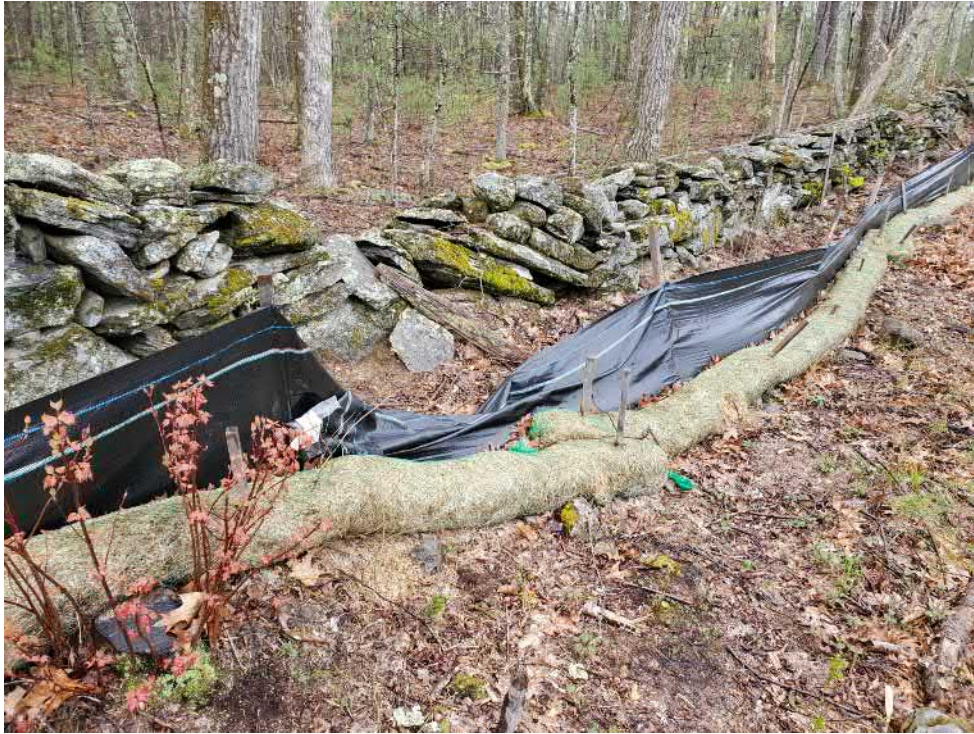
Photo 1

Type/Location of E&S Control	Maintenance Needed?*	Corrective Action Required?*	Date on Which Maintenance or Corrective Action First Identified?	Notes
1. Silt Fence and Straw Wattles	Yes	No	3/15/2022	On 5/4/2022 BETA observed damage to the wattles in the northeast and eastern corners of the Site, damage was first observed on 3/15/2022. BETA also observed the silt fence to be partly torn in the southeastern corner of the Site, damage was first observed on 3/27/2022. General maintenance is needed for the entire silt fence. No evidence of discharge was observed.
2. Stabilized Construction Entrance (Site Entrance – Access Road)	No	No		
3. Stump and Soil Stockpile Area	No	No		
4. Dust Controls	N/A	N/A		
5. Jute Mesh (Steep Slopes)	N/A	N/A		
6. Temporary Seeding	No	No

View of damaged silt fence in eastern portion of the Site — facing southeast

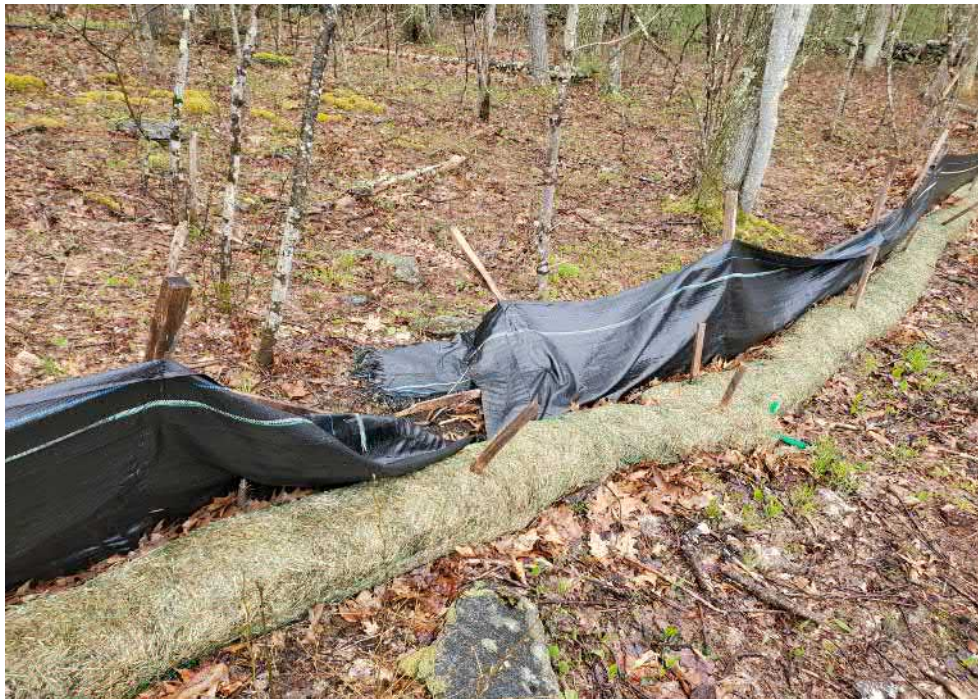
Photo 2

View of damaged silt fence in southeast portion of the Site — facing southeast

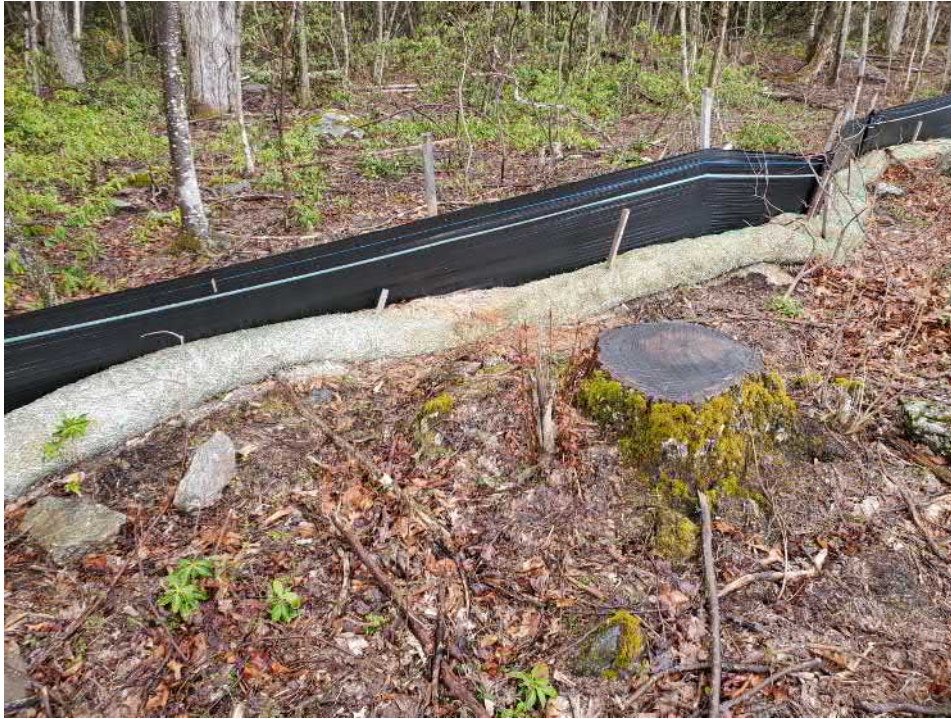
Photo 3

View of damaged silt wattle in northern portion of the Site — facing north
