#### Inspection Report for North Sturbridge Road Solar Facility NPDES ID No.: MAR10031G Inspection Date: 5/4/2022

PHOTOGRAPHIC DOCUMENTATION North Sturbridge Road Solar Facility Charlton, Massachusetts Photographs Documented 5.4.2022

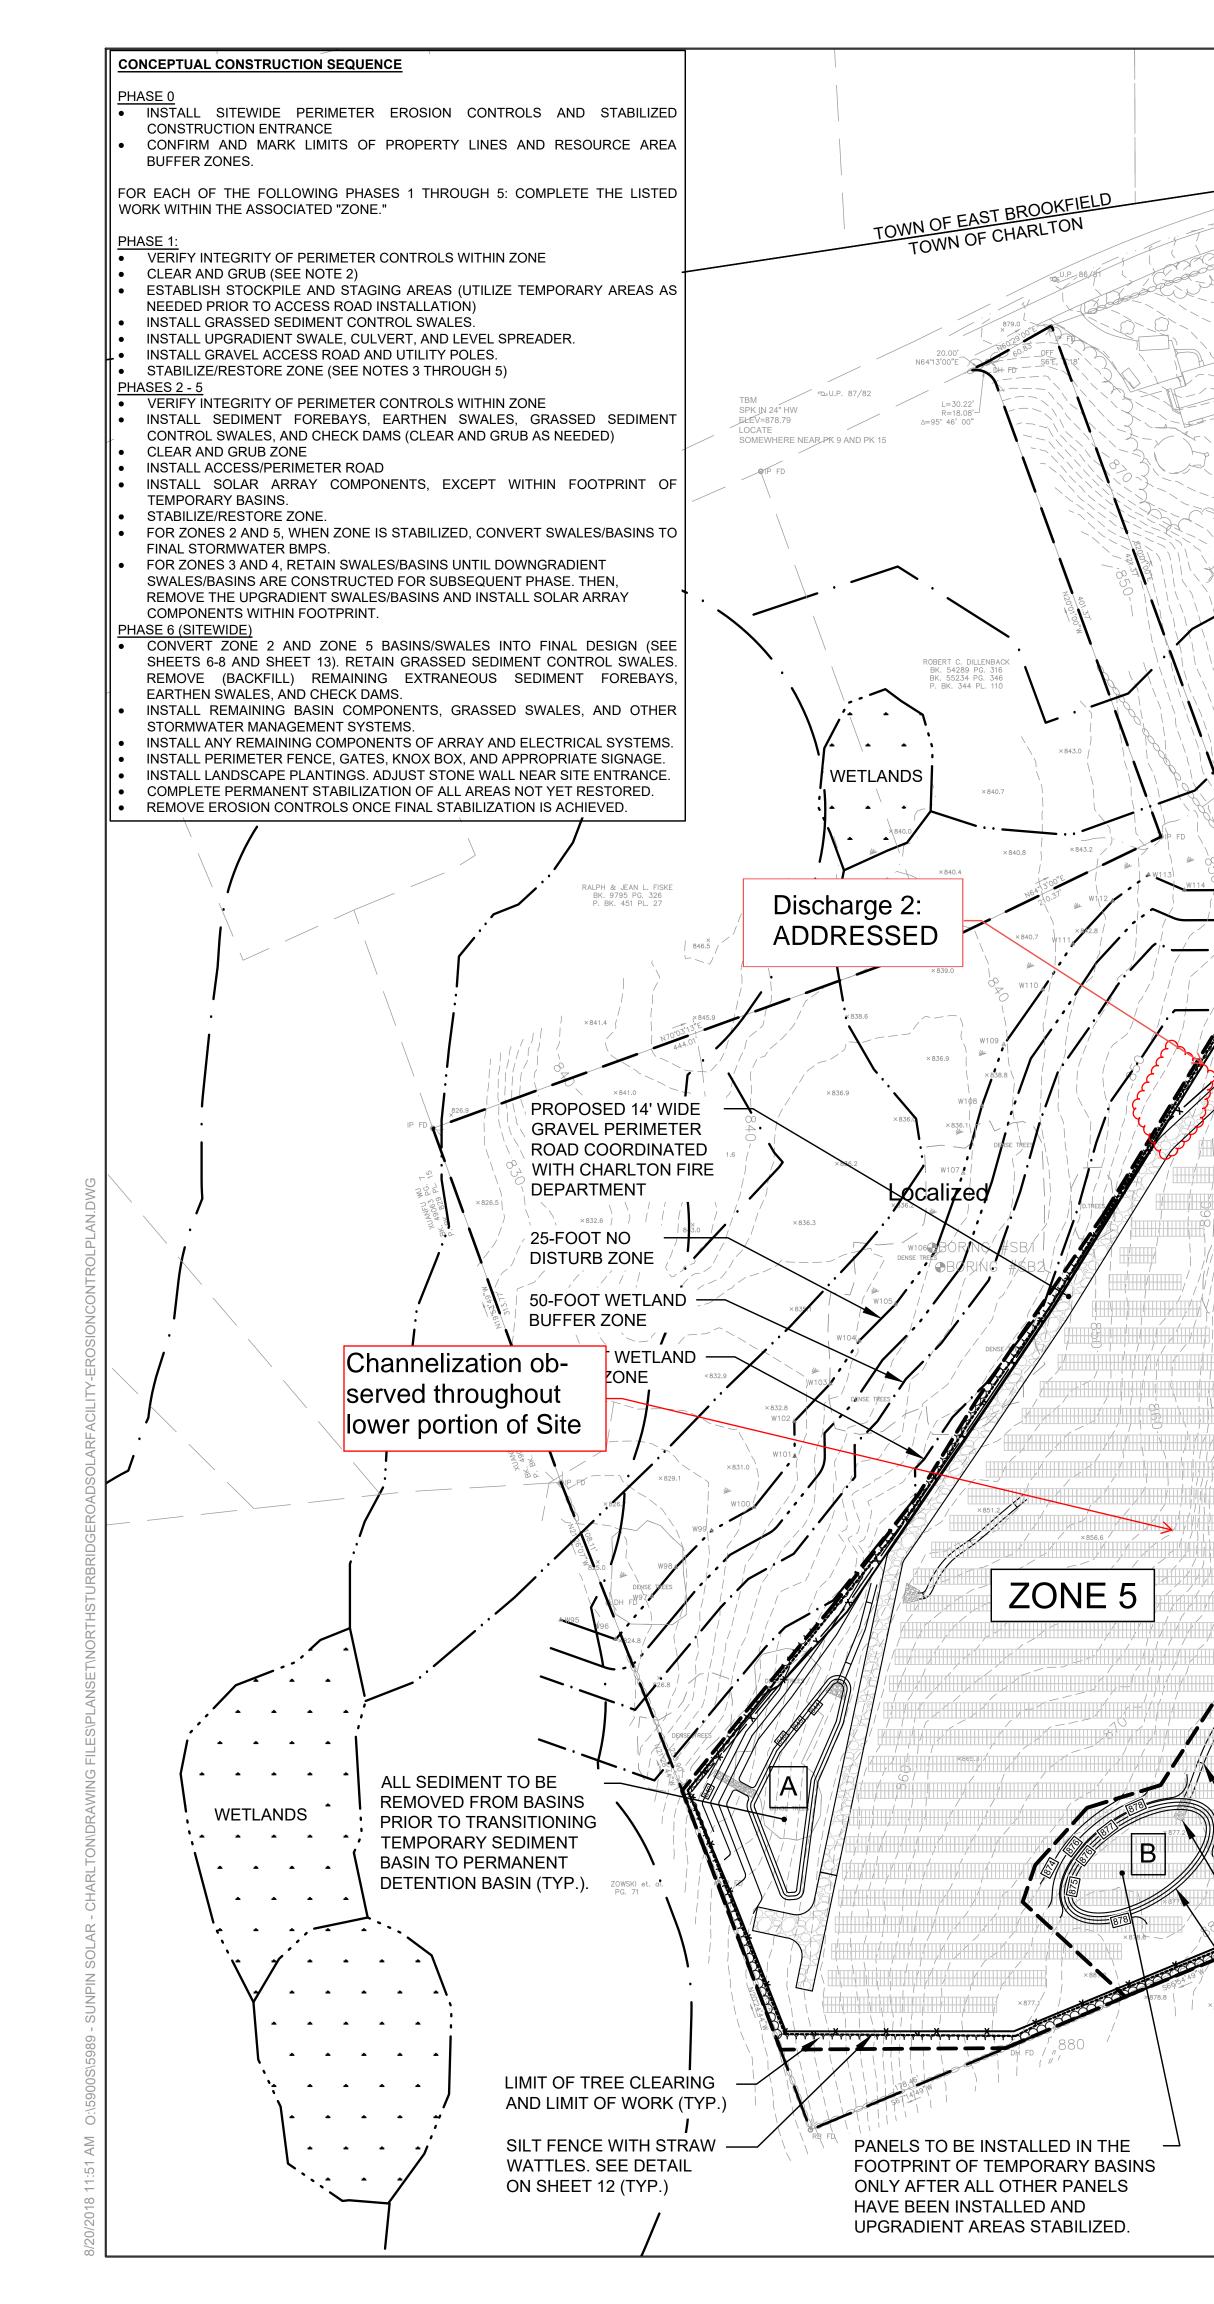
## Discharge 1: ADDRESSED

# Location of channelization within machinery tracks

Torn silt fence

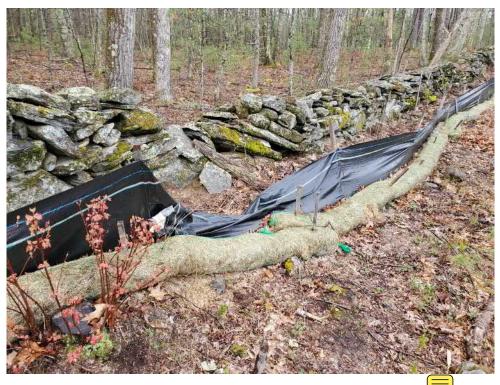
### Photo 1

View of damaged silt fence in eastern portion of the Site — facing south

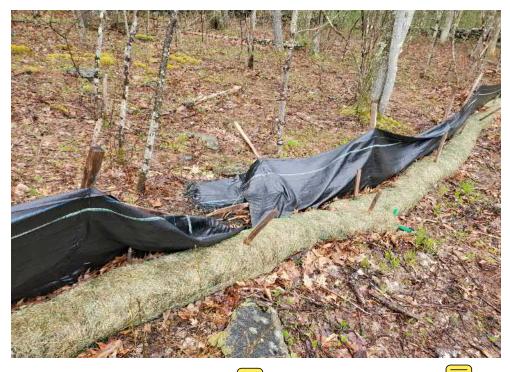
Photo 2

View of damaged silt fence in south portion of the Site — facing south

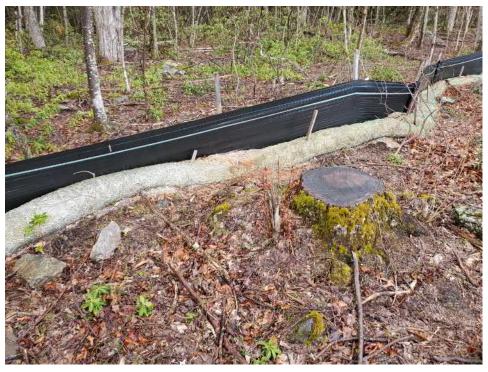
### Photo 3

View of damaged silt wattle in northern portion of the Site — facing north

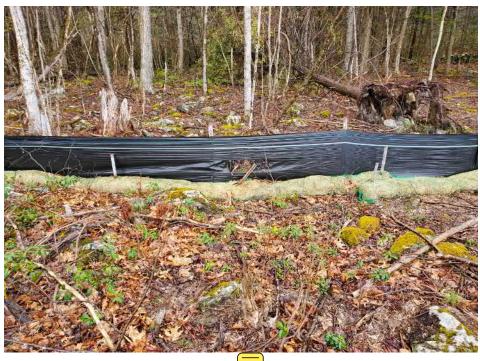
Photo 4

View of damaged silt wattle in north exercise rn portion of the Site — facing nort

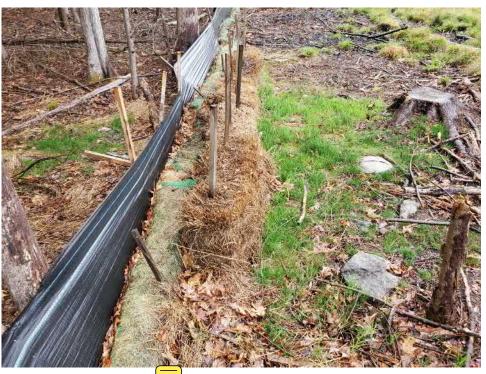
## Photo 5

View of seeding rass at Discharge 2 — facing north
