Inspection Report for North Sturbridge Road Solar Facility NPDES ID No.: MAR10031G

Inspection Date: 04/8/2022

PHOTOGRAPHIC DOCUMENTATION
North Sturbridge Road Solar Facility
Charlton, Massachusetts
Photographs Documented 04.8.2022

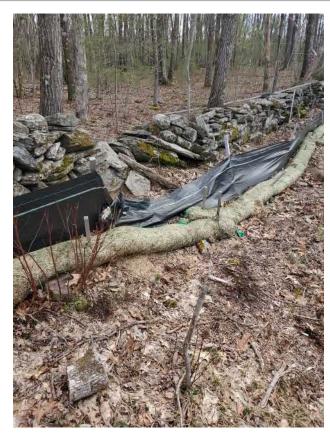
Photo 1

View of damaged silt fence in eastern portion of the Site —facing south east

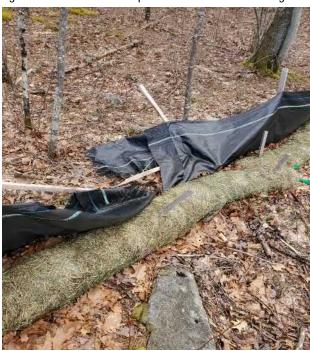
Photo 2

View of damaged silt fence in south east portion of the Site —facing south east
