Inspection Report for North Sturbridge Road Solar Facility

NPDES ID No.: MAR10031G

Inspection Date: 04/19/2022

PHOTOGRAPHIC DOCUMENTATION
North Sturbridge Road Solar Facility
Charlton, Massachusetts
Photographs Documented 04.19.2022

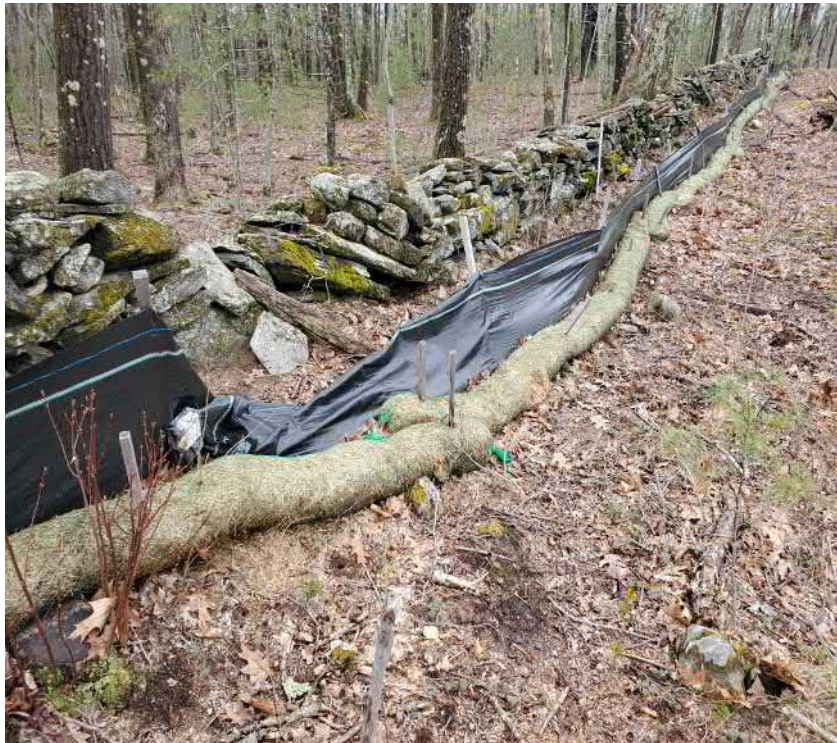
Photo 1

View of damaged silt fence in eastern portion of the Site —facing south east

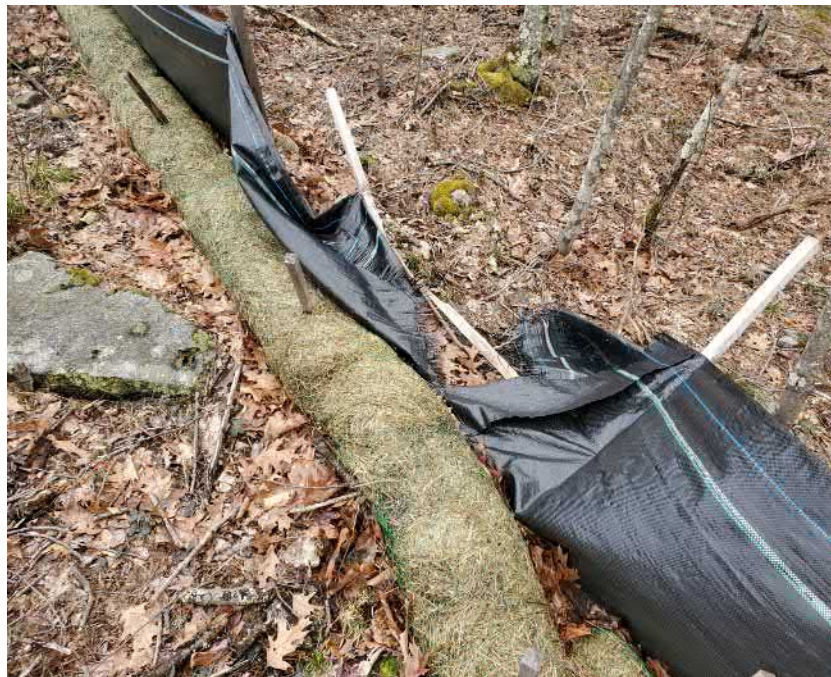
Photo 2

View of damaged silt fence in south east portion of the Site —facing north east

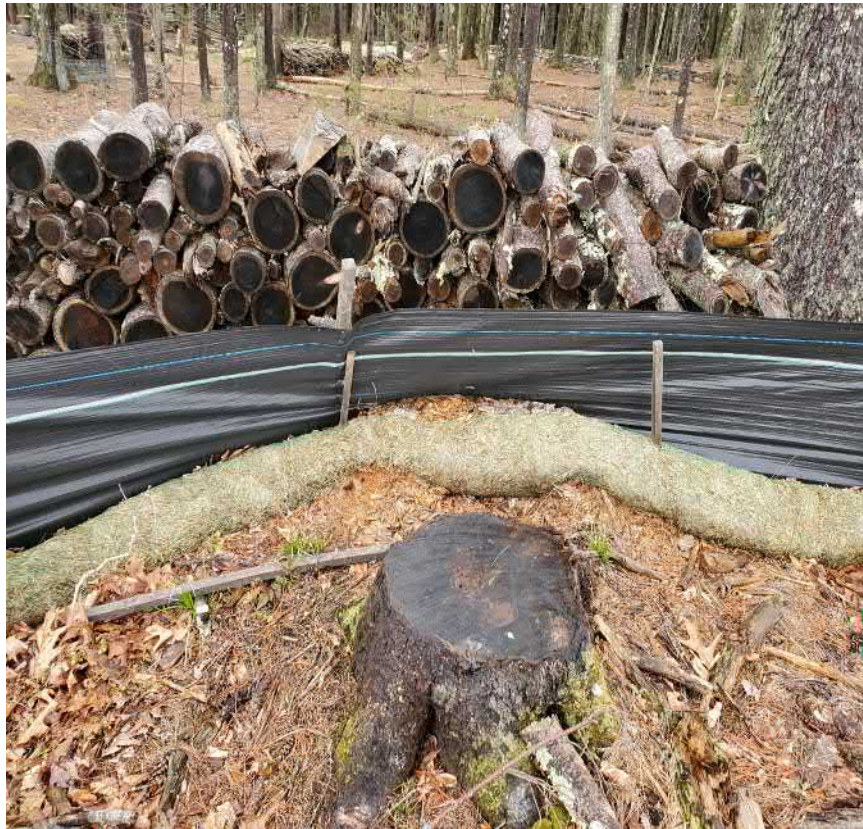
Photo 3

View of damaged silt wattle in northern portion of the Site —facing north
