Inspection Report for North Sturbridge Road Solar Facility

NPDES ID No.: MAR10031G

Inspection Date: 04/27/2022

**FIGURE 1:  
SWPPP  
INSPECTION  
SKETCH  
04/27/2022**

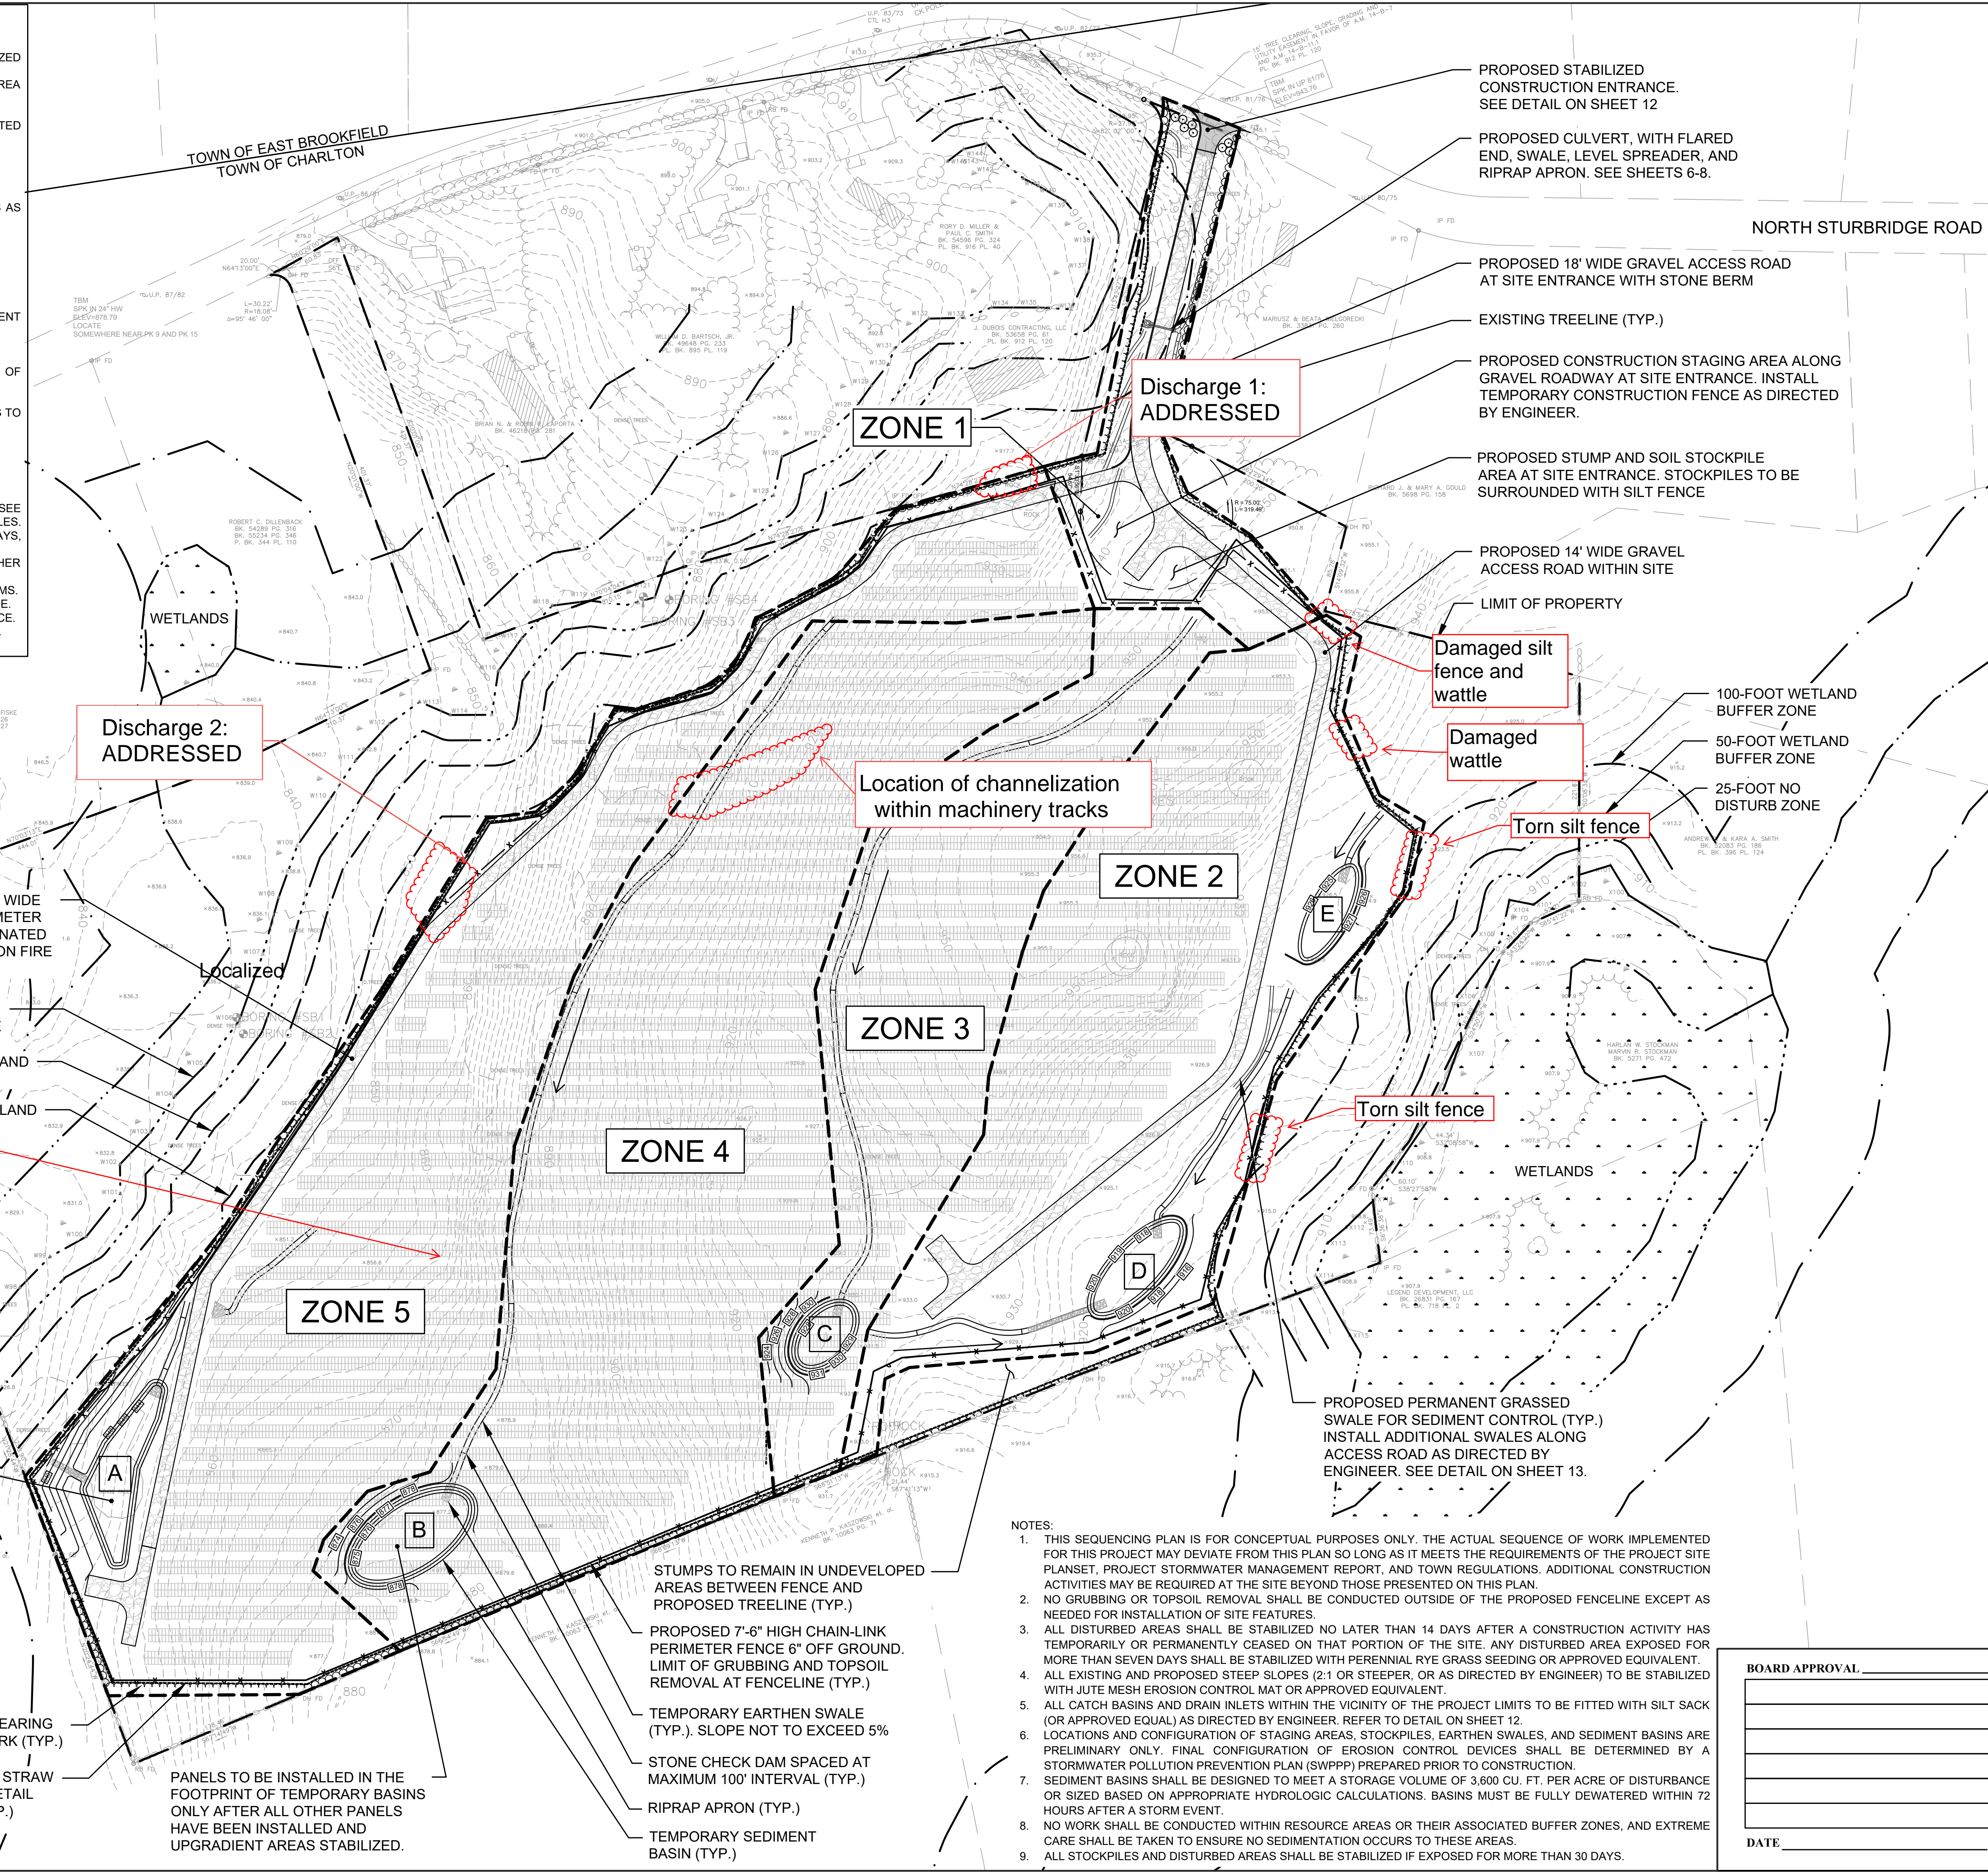
2. Informal access road along northern portion of the Site	Straw mulch or hydroseed	<input type="checkbox"/> Yes [Enter date] <input checked="" type="checkbox"/> No	Erosion channels are beginning to form within upgradient portions of the informal access road (Figure 1). The contractor indicated that stabilization by smoothing out soils and seeding or spreading mulch would occur on 7/30/2021. Stabilization of this area has not been initiated. After inspection of the area on 8/24/2021, it was determined that

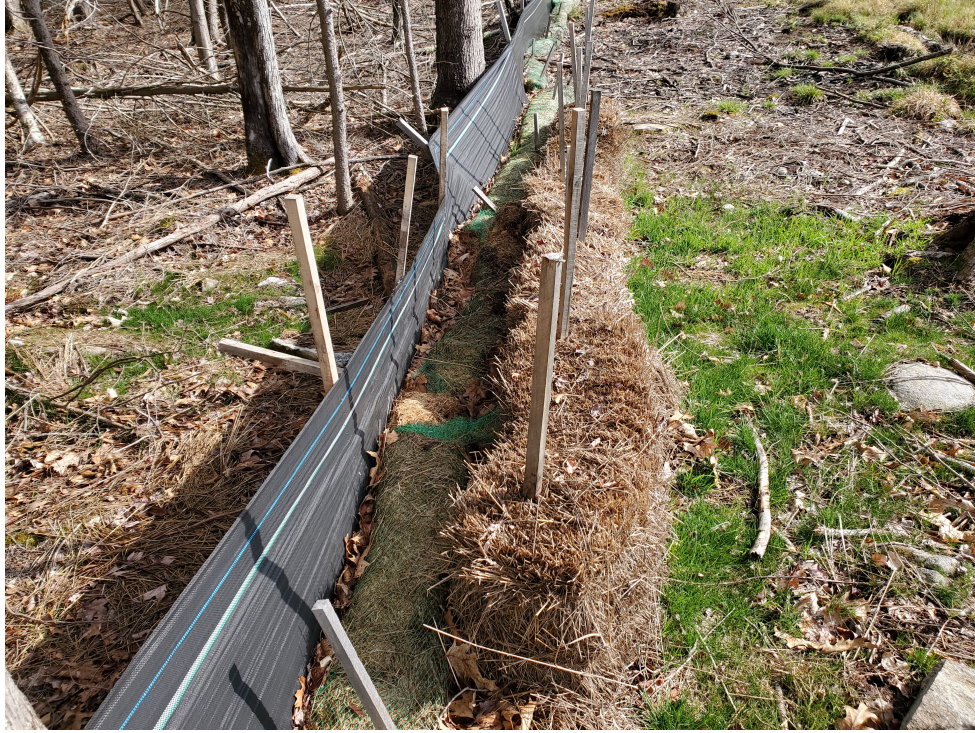
Photo 5

<p>4. Area beyond limits of work at Discharge 2</p>	<p>Hand application of seed</p>	<p><input type="checkbox"/> Yes Enter Date <input checked="" type="checkbox"/> No</p>	<p>On 4/27/2022 BETA observed the recently seeded grass to be thriving.</p>

View of seeded grass at Discharge 2 — facing north
