Inspection Report for North Sturbridge Road Solar Facility

NPDES ID No.: MAR10031G

Inspection Date: 04/27/2022

PHOTOGRAPHIC DOCUMENTATION
North Sturbridge Road Solar Facility
Charlton, Massachusetts
Photographs Documented 04.27.2022

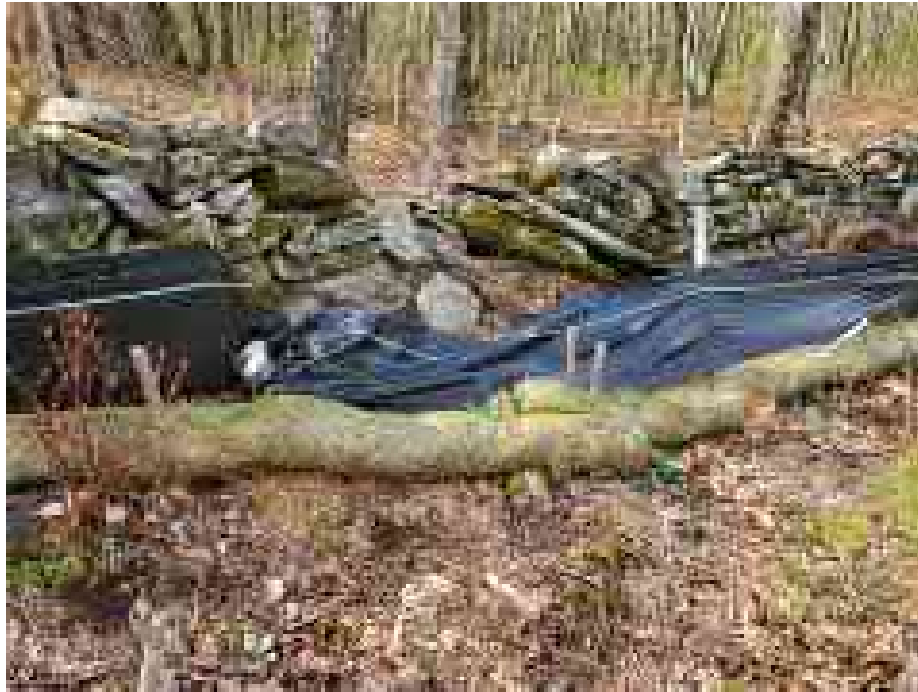
Photo 1

View of damaged silt fence in eastern portion of the Site — facing south east

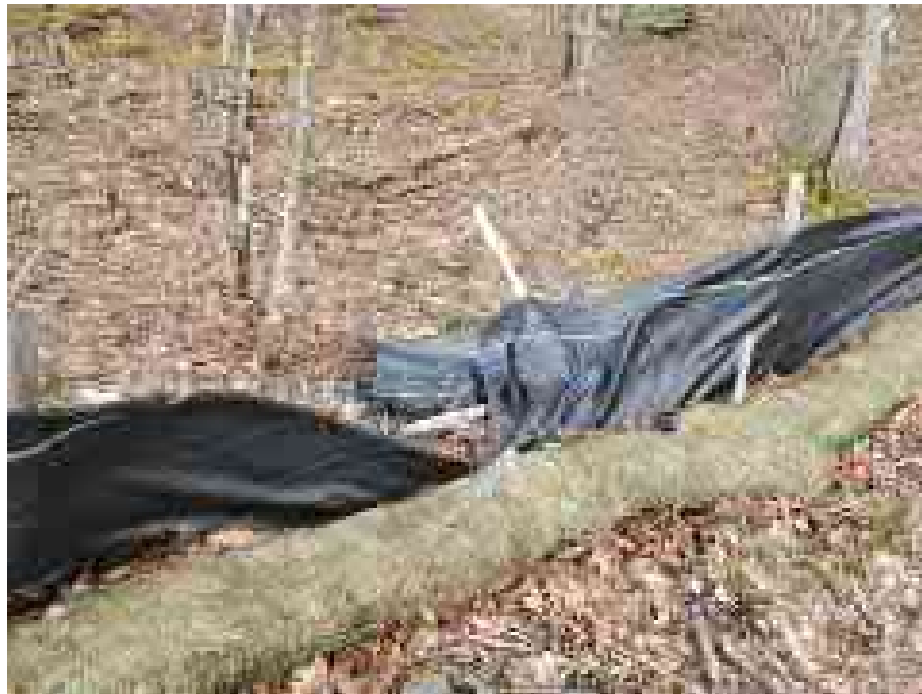
Photo 2

View of damaged silt fence in south east portion of the Site — facing south east

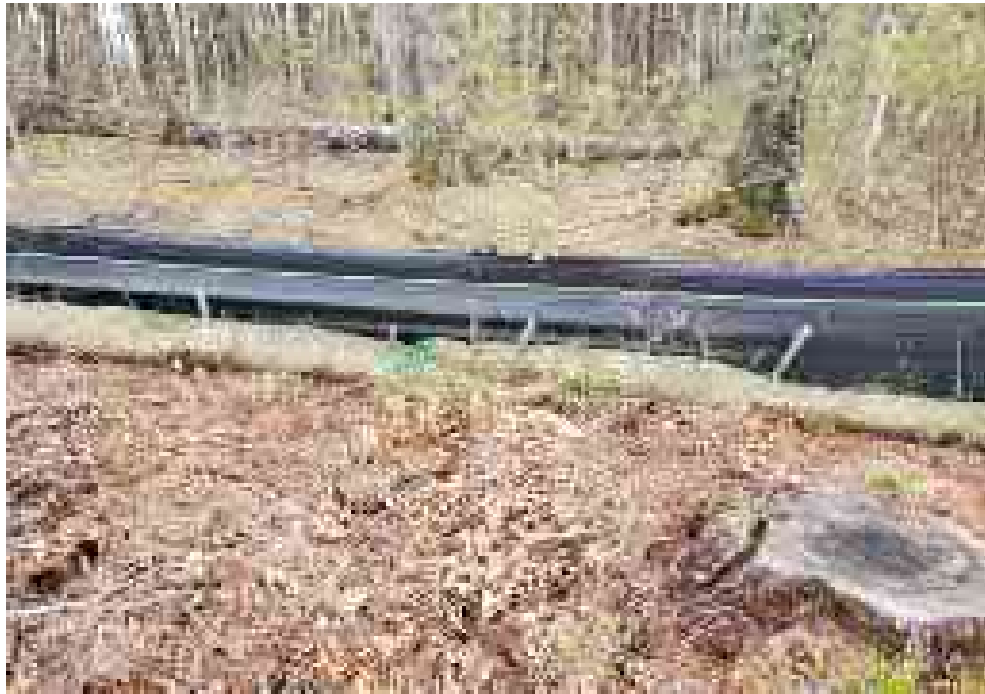
Photo 3

View of damaged silt wattle in northern portion of the Site — facing north

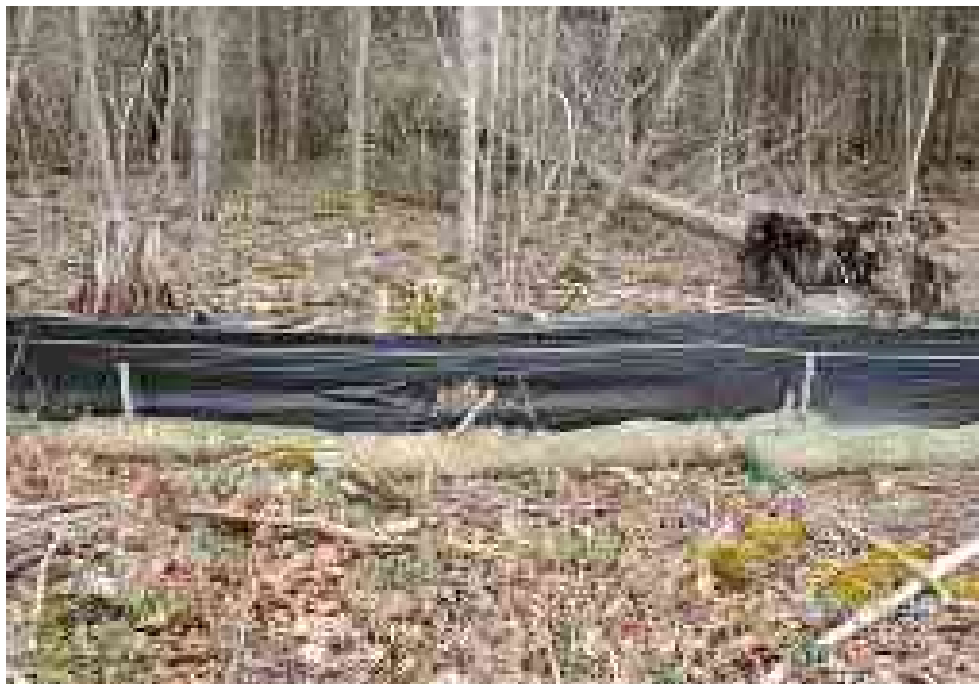
Photo 4

View of damaged silt wattle in north eastern portion of the Site — facing north east
