Inspection Report for North Sturbridge Road Solar Facility

NPDES ID No.: MAR10031G

Inspection Date: 5/4/2022

**FIGURE 1:  
SWPPP  
INSPECTION  
SKETCH  
5/4/2022**

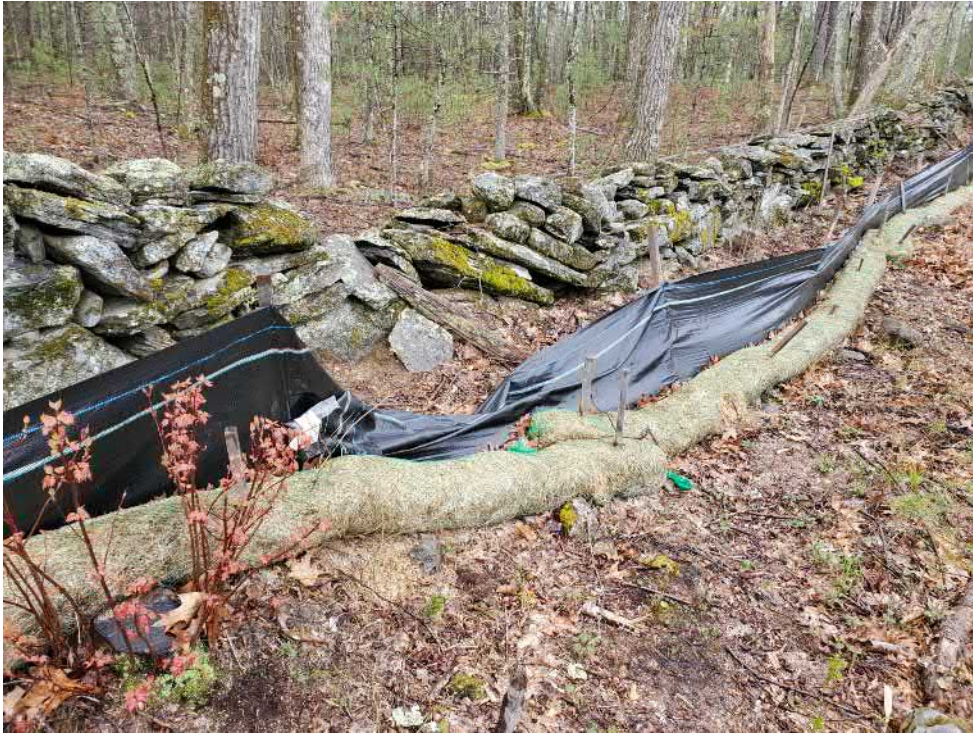
Photo 1

View of damaged silt fence in eastern portion of the Site — facing south

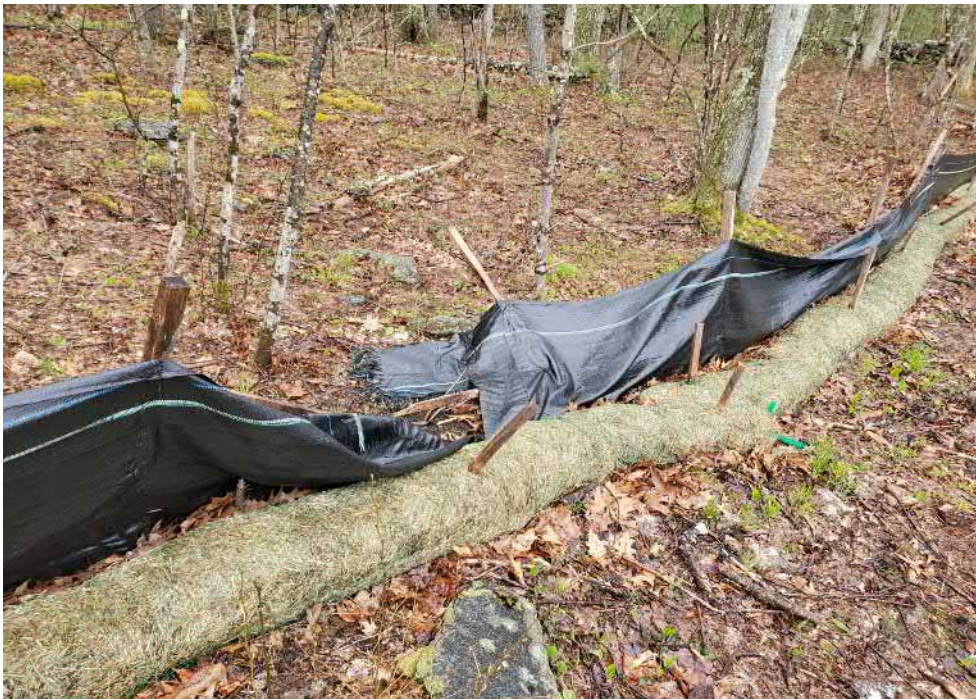
Photo 2

View of damaged silt fence in southern portion of the Site — facing south east

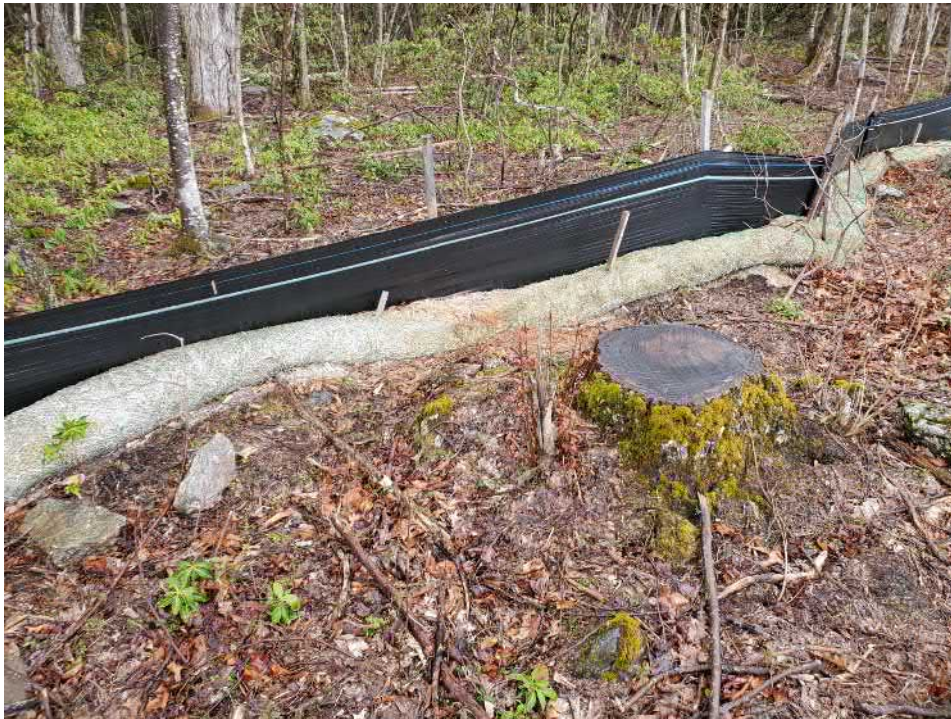
Photo 3

View of damaged silt wattle in northern portion of the Site — facing north

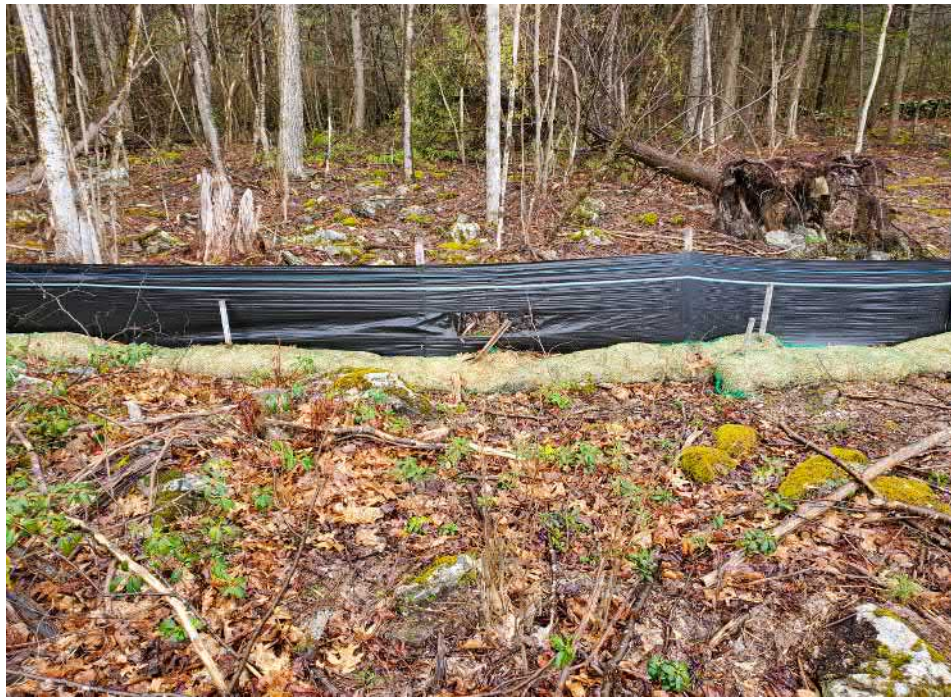
Photo 4

View of damaged silt wattle in northern portion of the Site — facing north

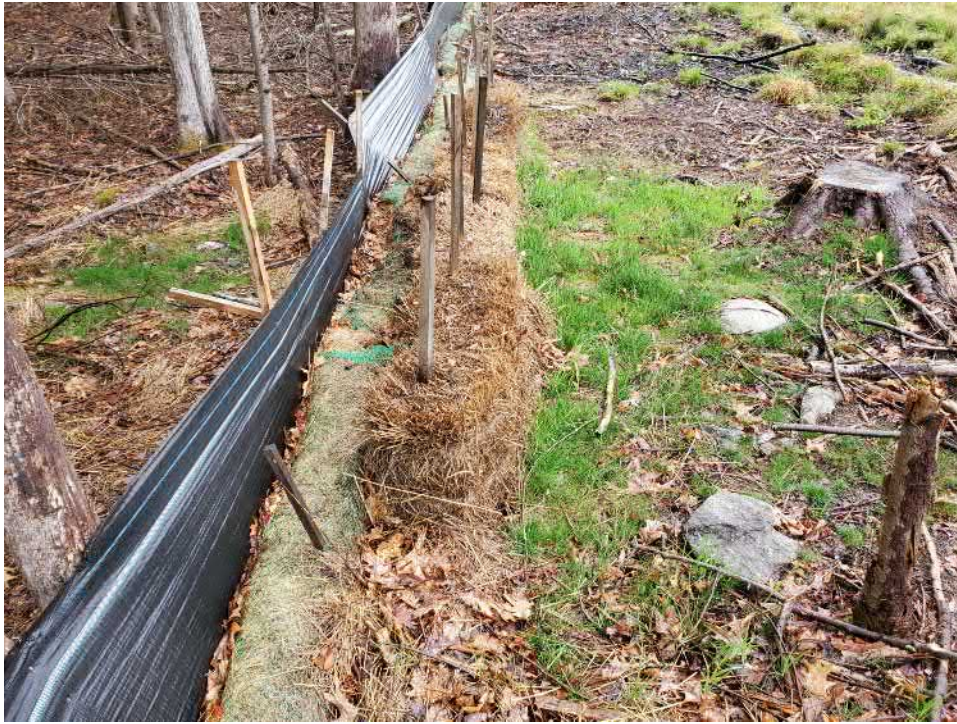
Photo 5

<p>4. Area beyond limits of work at Discharge 2</p>	<p>Hand application of seed</p>	<p><input type="checkbox"/> Yes Enter Date <input checked="" type="checkbox"/> No</p>	<p>4/27/22 BETA observed grass to be established in Discharge 1, Discharge 2 and the access road to the Stockpile area</p>

View of seeded grass at Discharge 2 — facing north
