Inspection Report for North Sturbridge Road Solar Facility NPDES ID No.: MAR10031G

Inspection Date: 5/4/2022

PHOTOGRAPHIC DOCUMENTATION North Sturbridge Road Solar Facility Charlton, Massachusetts Photographs Documented 5.4.2022

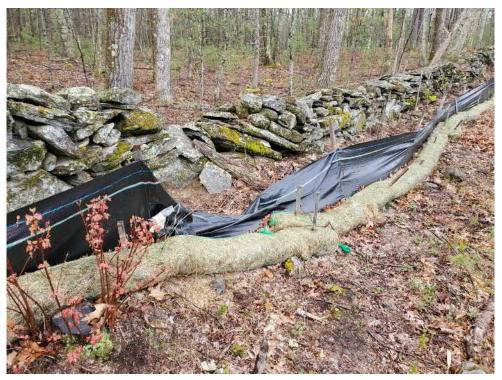
Photo 1

View of damaged silt fence in eastern portion of the Site — facing sout

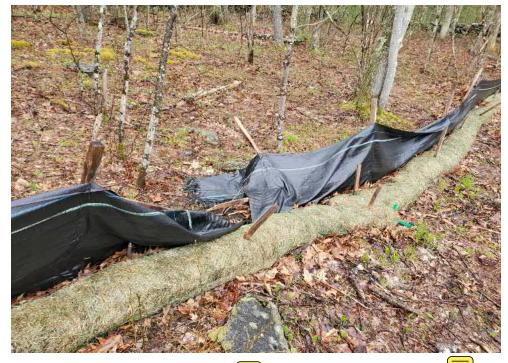
Photo 2

View of damaged silt fence in south portion of the Site — facing south east

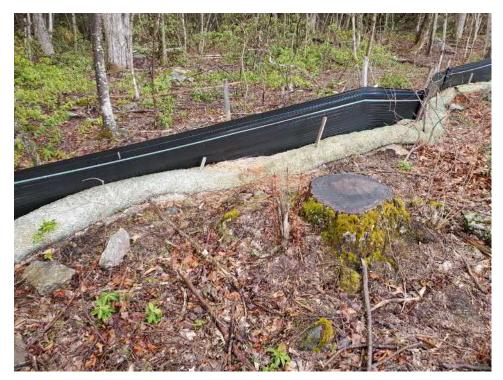
Photo 3

View of damaged silt wattle in northern portion of the Site — facing north

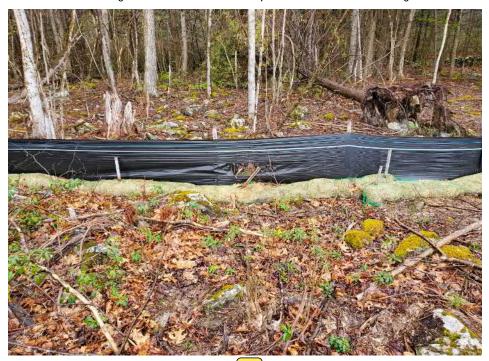
Photo 4

View of damaged silt wattle in north portion of the Site — facing north

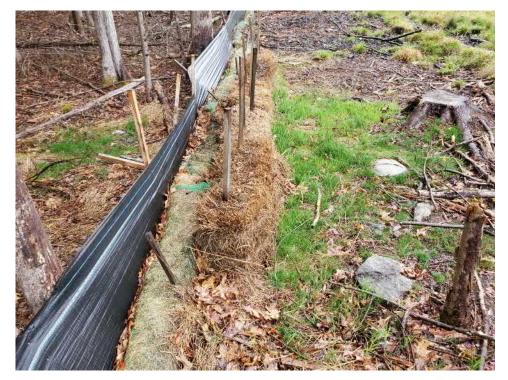
Photo 5

View of seeded grass at Discharge 2 — facing north
