Inspection Report for North Sturbridge Road Solar Facility NPDES ID No.: MAR10031G

Inspection Date: 5/17/2022

PHOTOGRAPHIC DOCUMENTATION North Sturbridge Road Solar Facility Charlton, Massachusetts Photographs Documented 5.17.2022

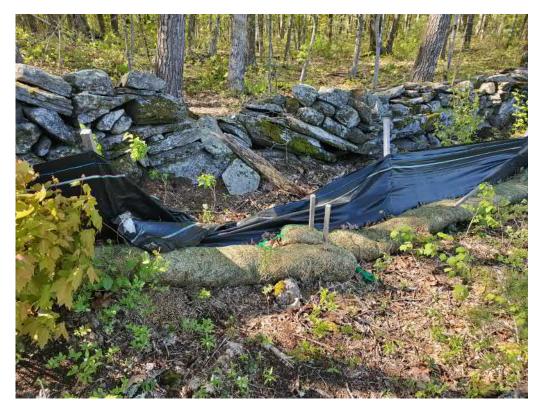
### Photo 1

View of damaged silt fence in eastern portion of the Site — facing southeast

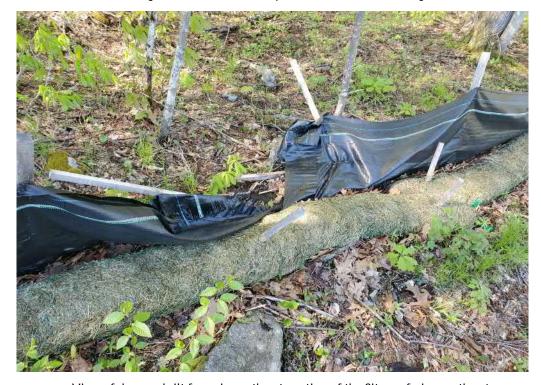
#### Photo 2

View of damaged silt fence in southeast portion of the Site — facing southeast

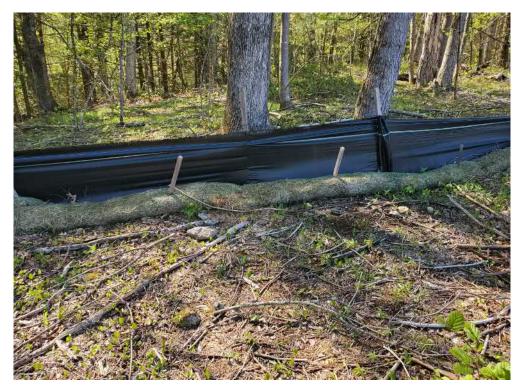
## Photo 3

View of damaged silt wattle in northern portion of the Site — facing north

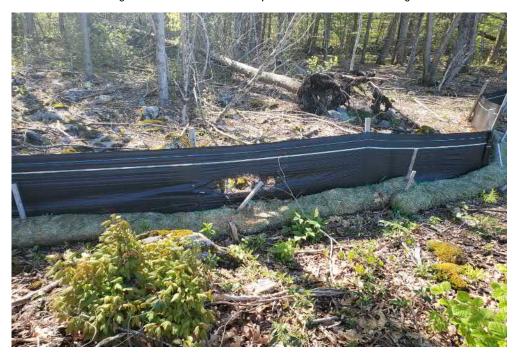
#### Photo 4

View of damaged silt wattle and silt fence in northeastern portion of the Site — facing northeast

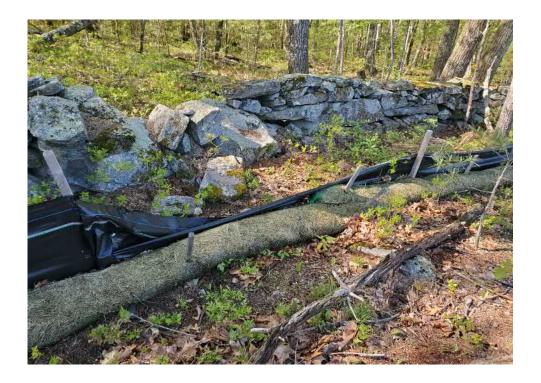
# Photo 5

View of damaged silt fence in southeast portion of the Site — facing southeast
