Inspection Report for North Sturbridge Road Solar Facility

NPDES ID No.: MAR10031G

Inspection Date: 5/17/2022

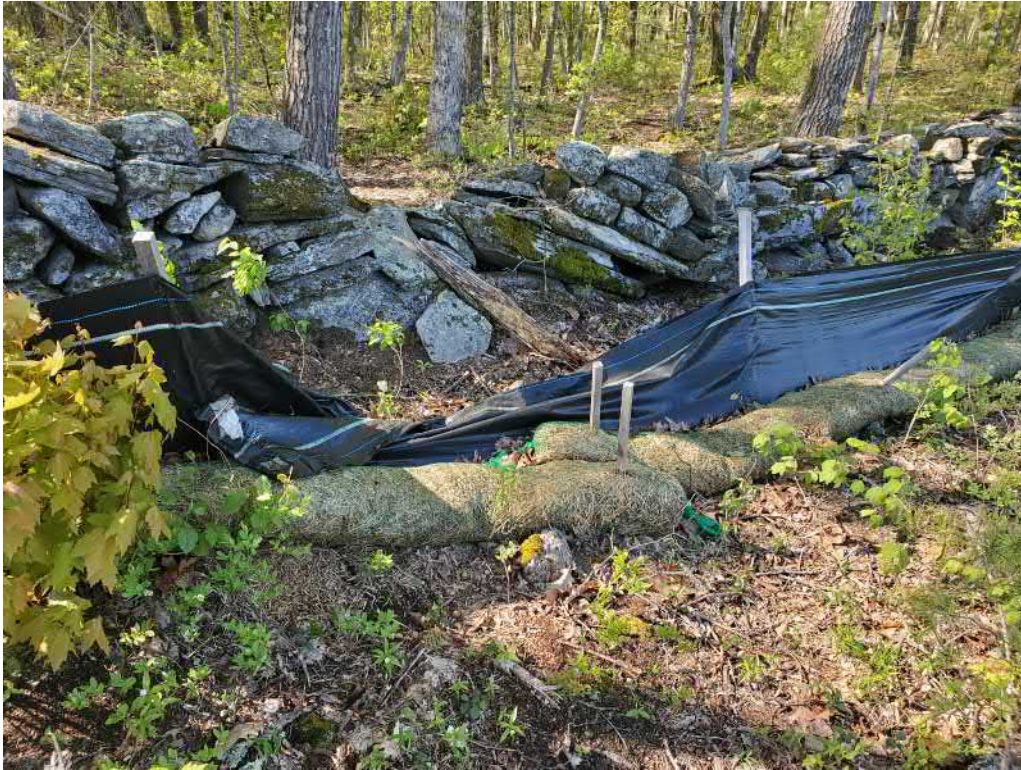
Photo 1

View of damaged silt fence in eastern portion of the Site — facing south

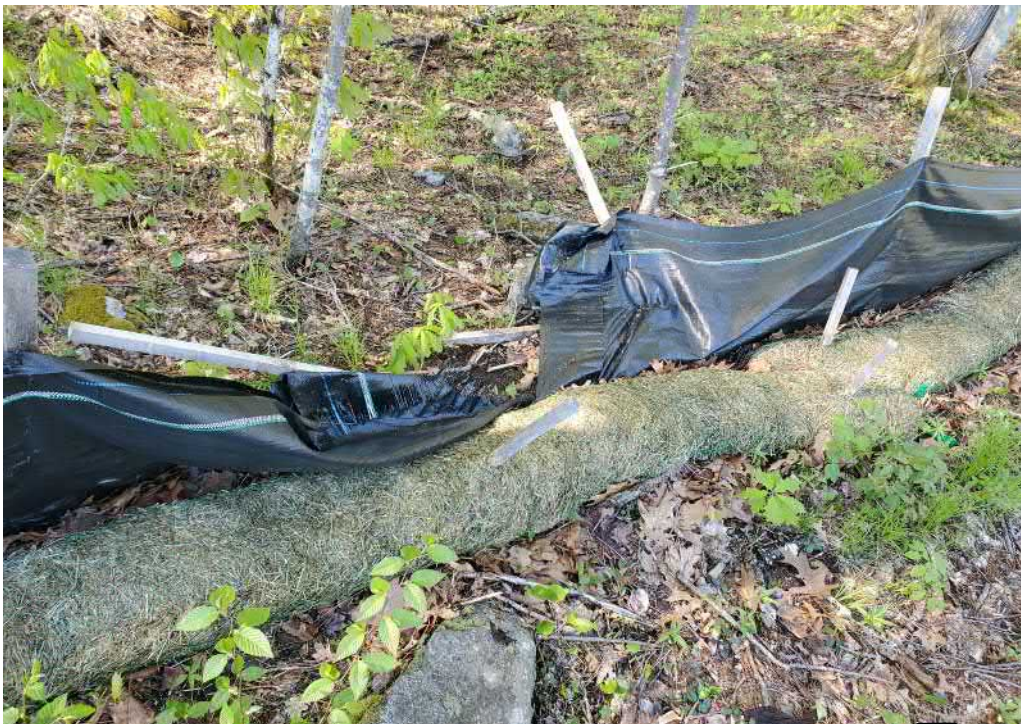
Photo 2

View of damaged silt fence in south east portion of the Site — facing south east

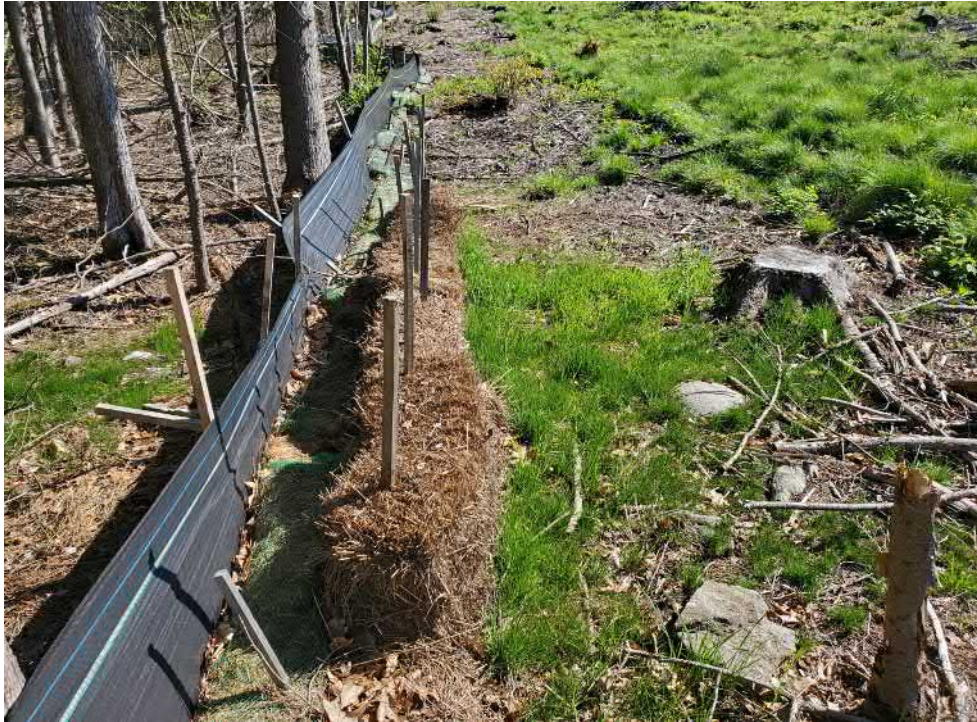
Photo 5

<p>4. Area beyond limits of work at Discharge 2</p>	<p>Hand application of seed</p>	<p><input type="checkbox"/> Yes Enter Date <input checked="" type="checkbox"/> No</p>	<p>On 4/27/2022 BETA observed the recently seeded grass to be thriving.</p>

View of seeded grass at Discharge 2 — facing north

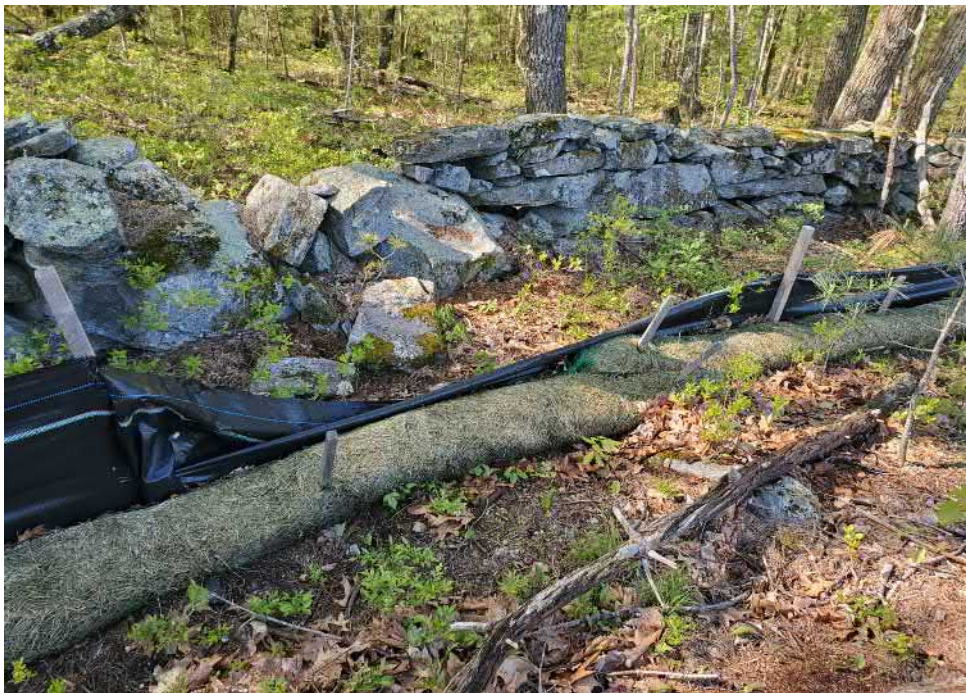
Photo 6

View of damaged silt fence in south portion of the Site — facing southeast
