Inspection Report for North Sturbridge Road Solar Facility

NPDES ID No.: MAR10031G

Inspection Date: 5/17/2022

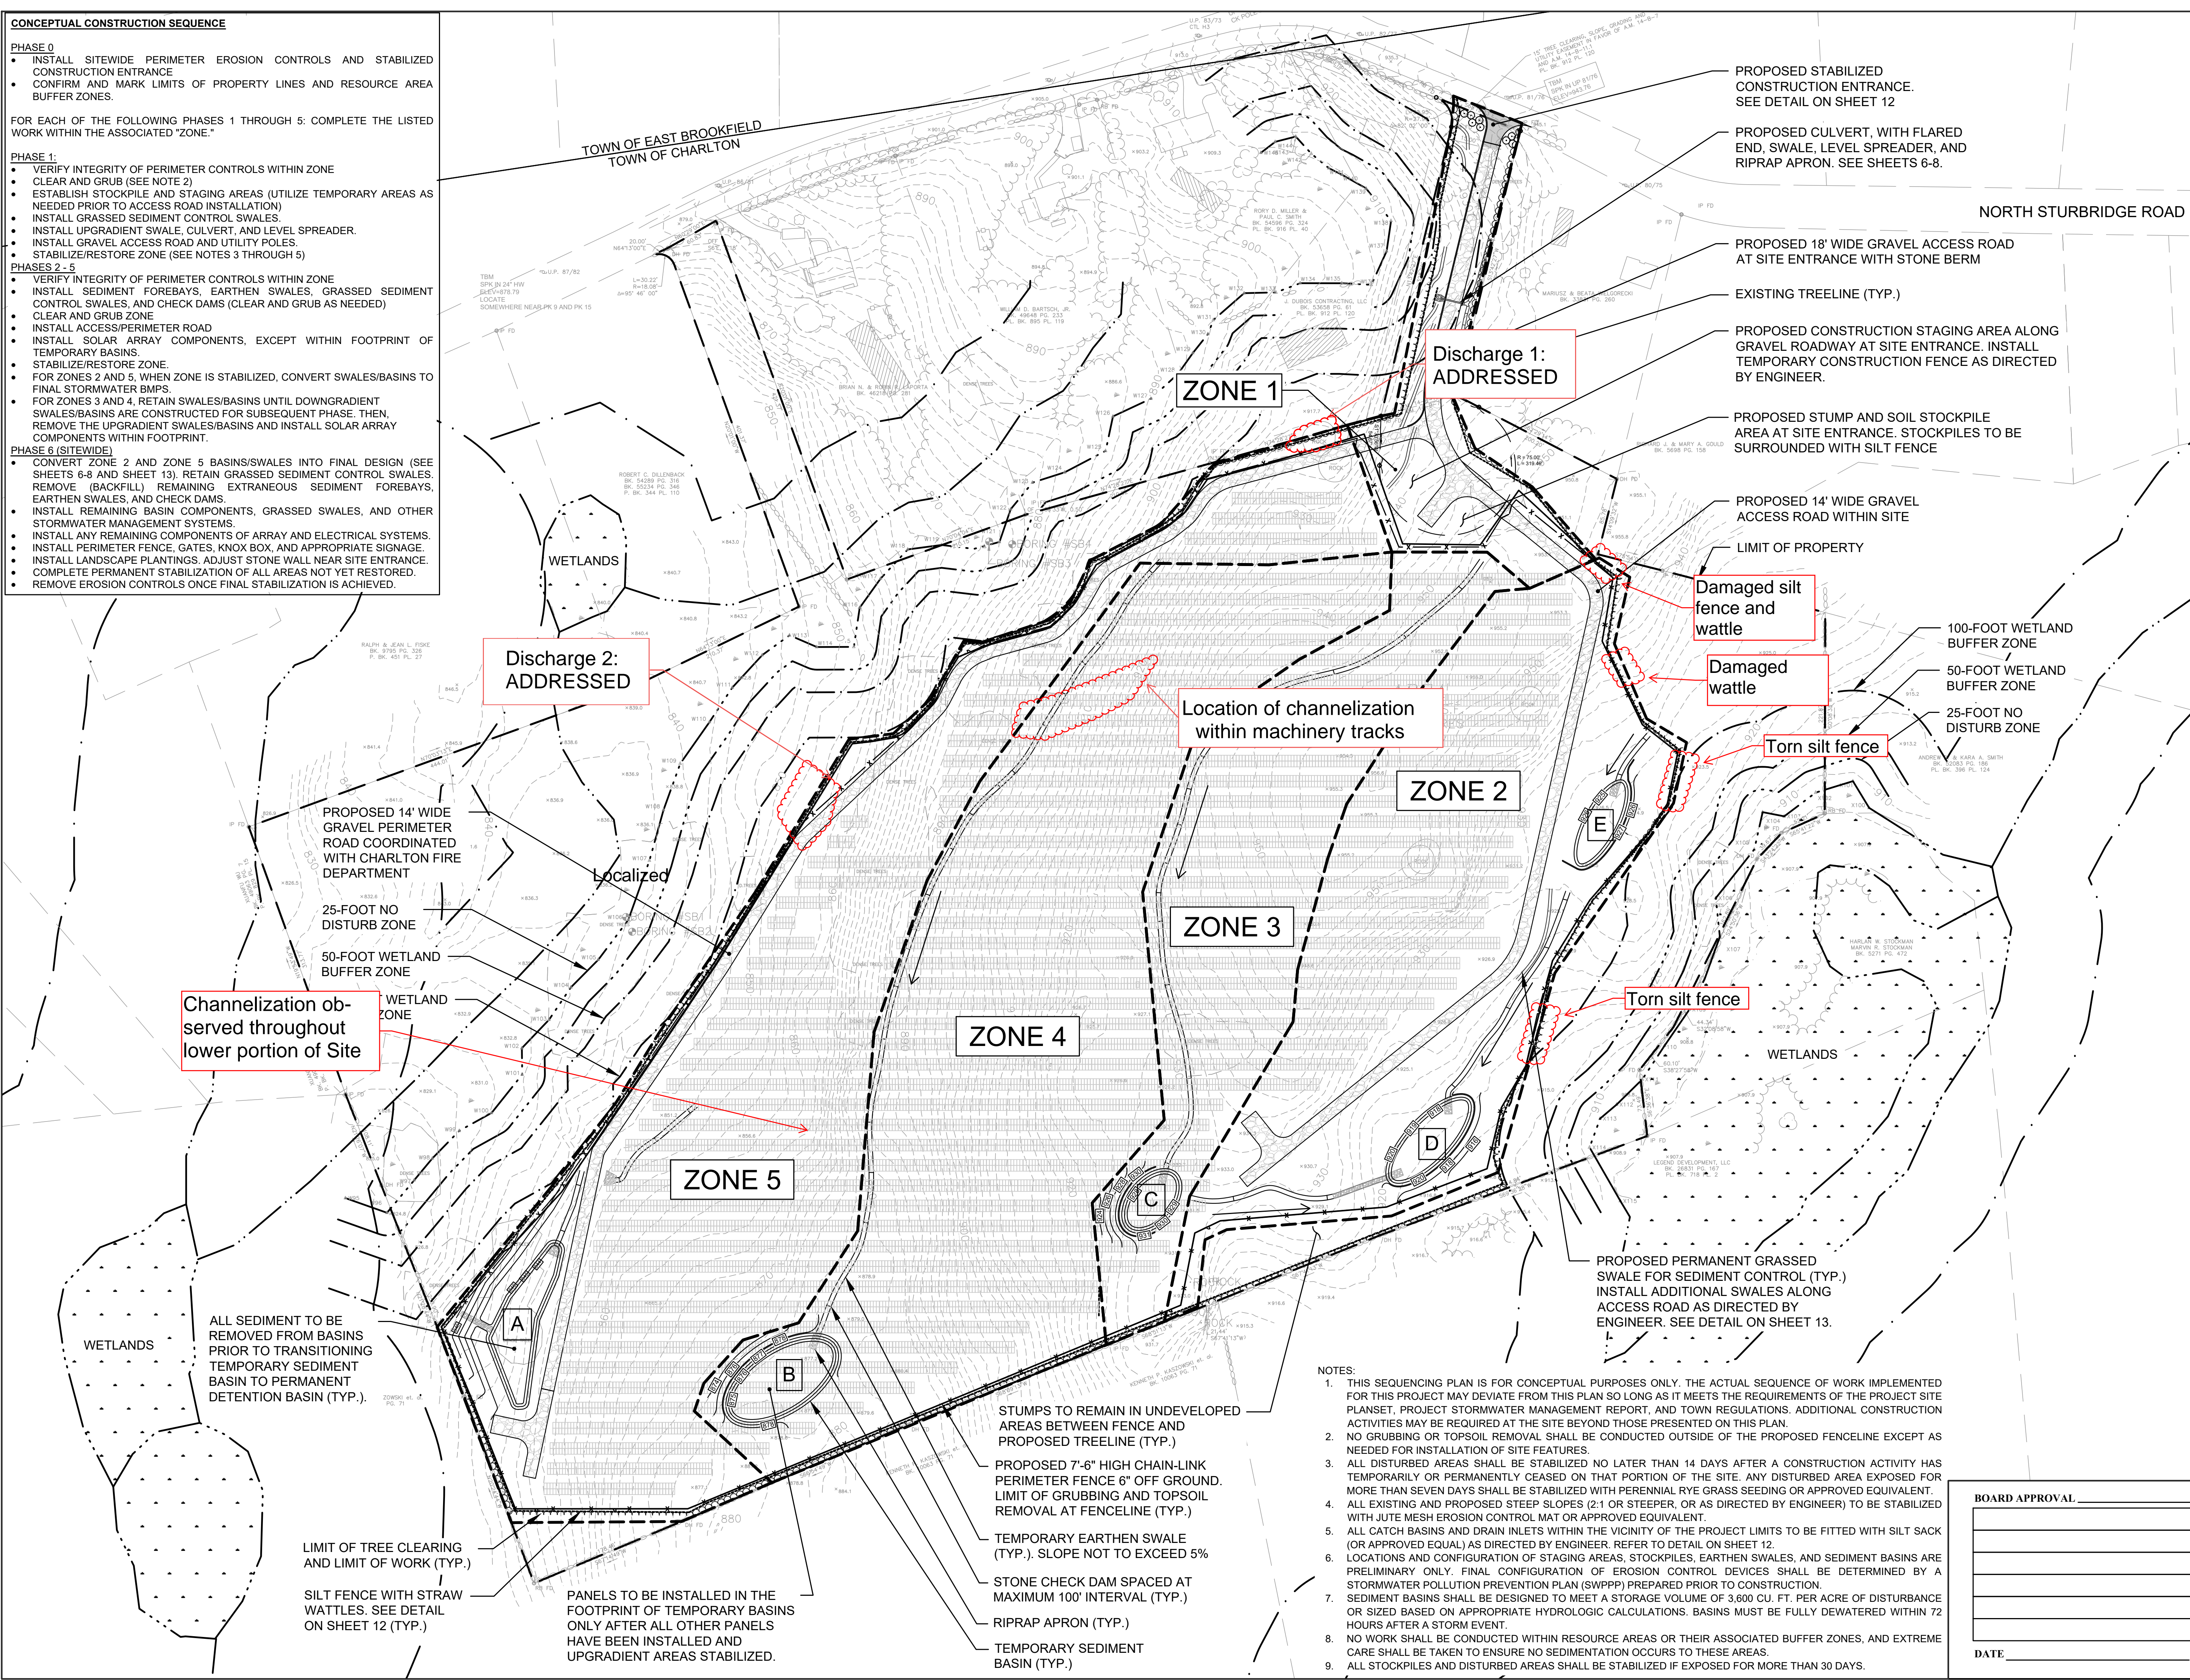
**FIGURE 1:
SWPPP
INSPECTION
SKETCH
5/17/2022**

2. Informal access road along northern portion of the Site	Straw mulch or hydroseed	<input type="checkbox"/> Yes [Enter date] <input checked="" type="checkbox"/> No	Erosion channels are beginning to form within upgradient portions of the informal access road (Figure 1). The contractor indicated that stabilization by smoothing out soils and seeding or spreading mulch would occur on 7/30/2021. Stabilization of this area has not been initiated. After inspection of the area on 8/24/2021, it was determined that

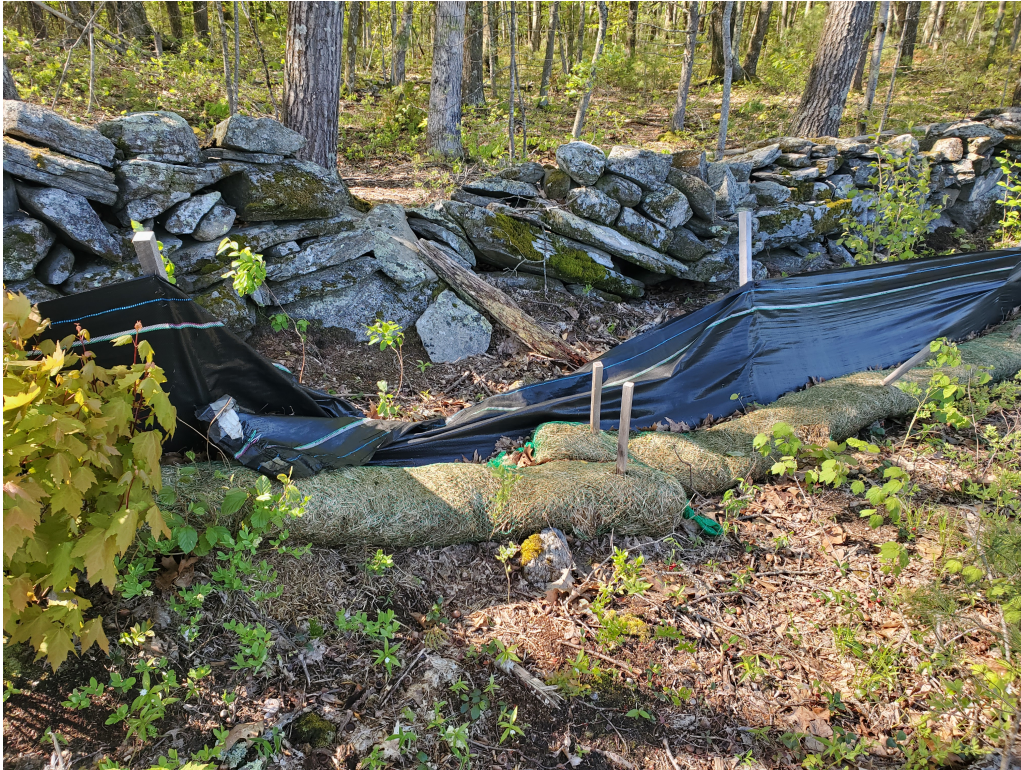
Photo 1

View of damaged silt fence in eastern portion of the Site — facing south east

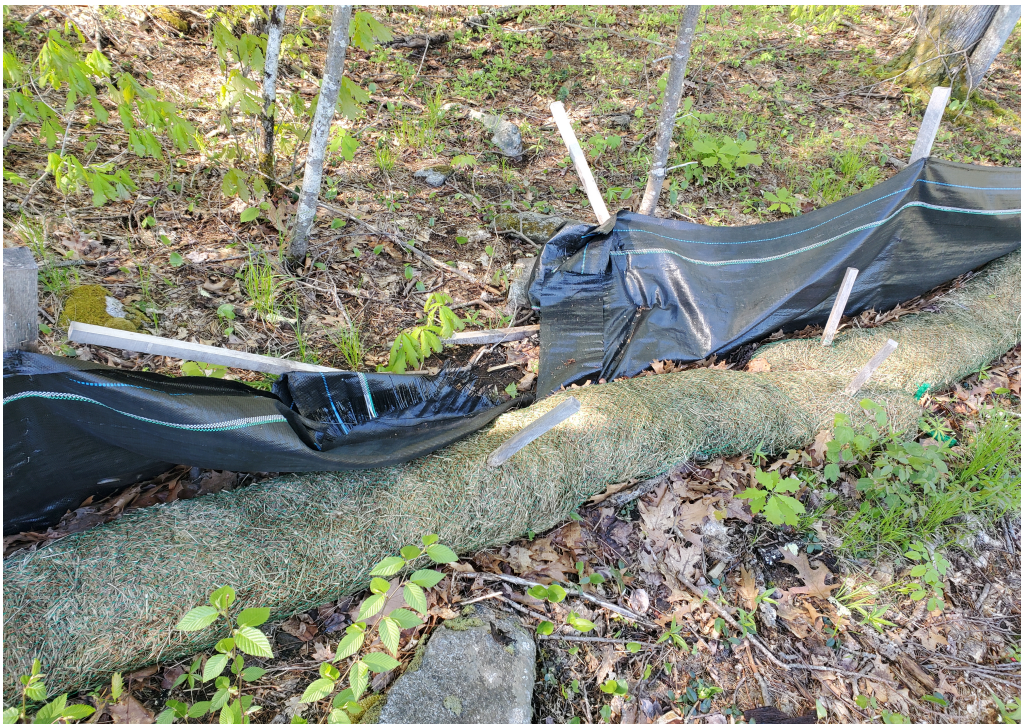
Photo 2

View of damaged silt fence in south east portion of the Site — facing south east

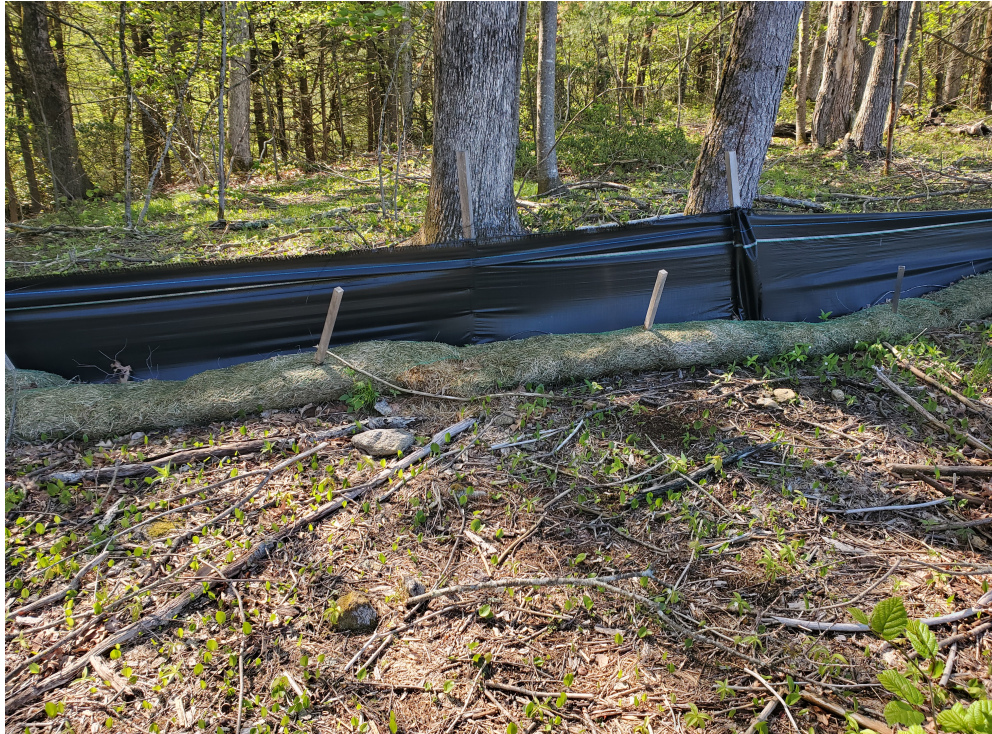
Photo 3

View of damaged silt wattle in northern portion of the Site — facing north

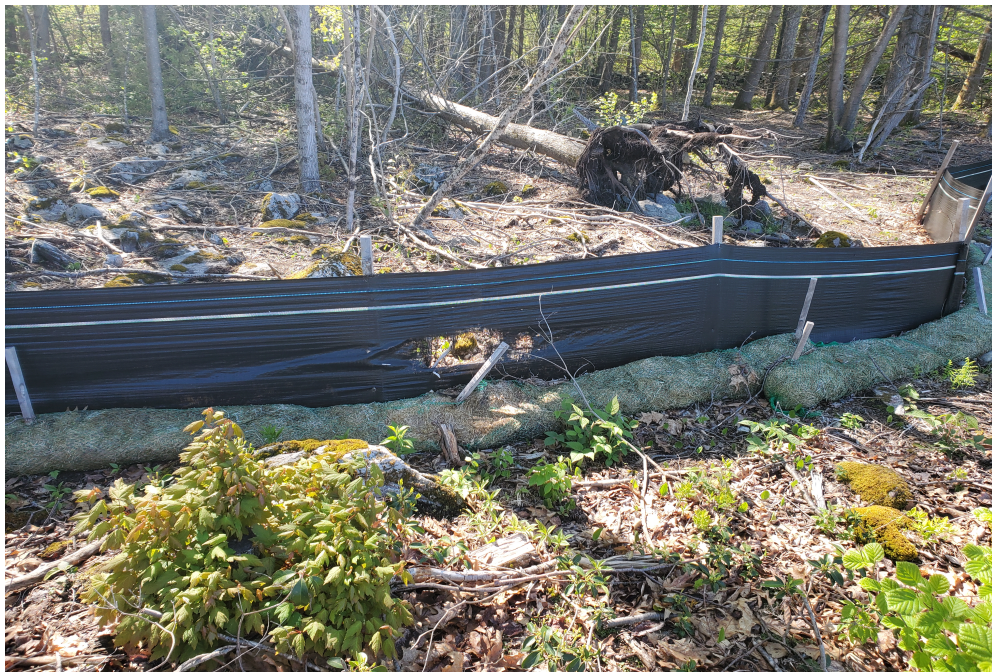
Photo 4

View of damaged silt wattle in north eastern portion of the Site — facing north east

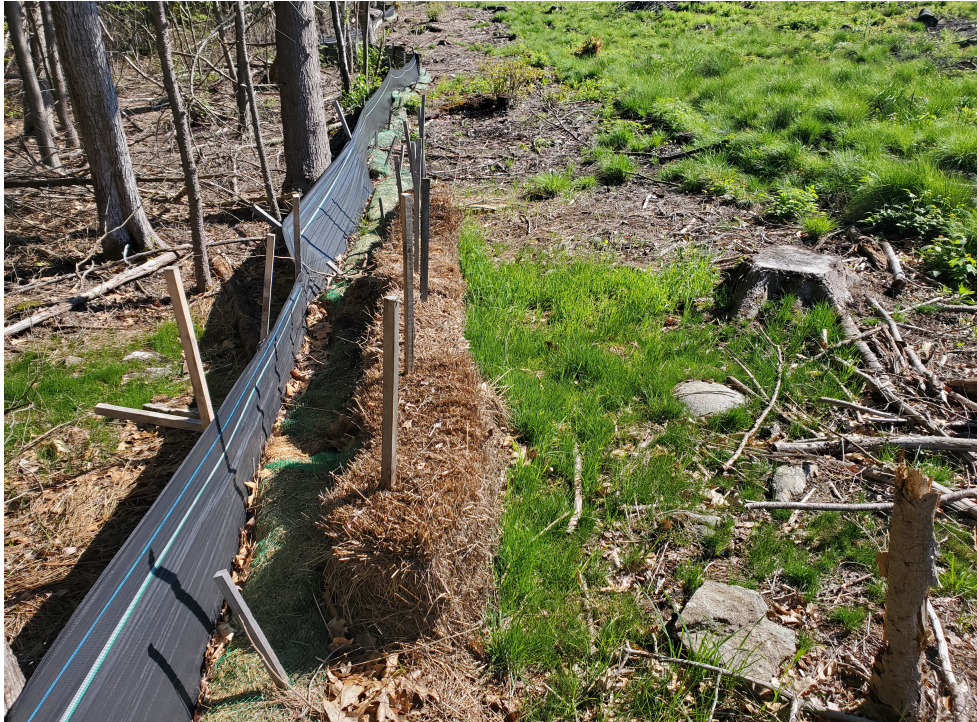
Photo 5

<p>4. Area beyond limits of work at Discharge 2</p>	<p>Hand application of seed</p>	<p><input type="checkbox"/> Yes Enter Date <input checked="" type="checkbox"/> No</p>	<p>On 4/27/2022 BETA observed the recently seeded grass to be thriving.</p>

View of seeded grass at Discharge 2 — facing north

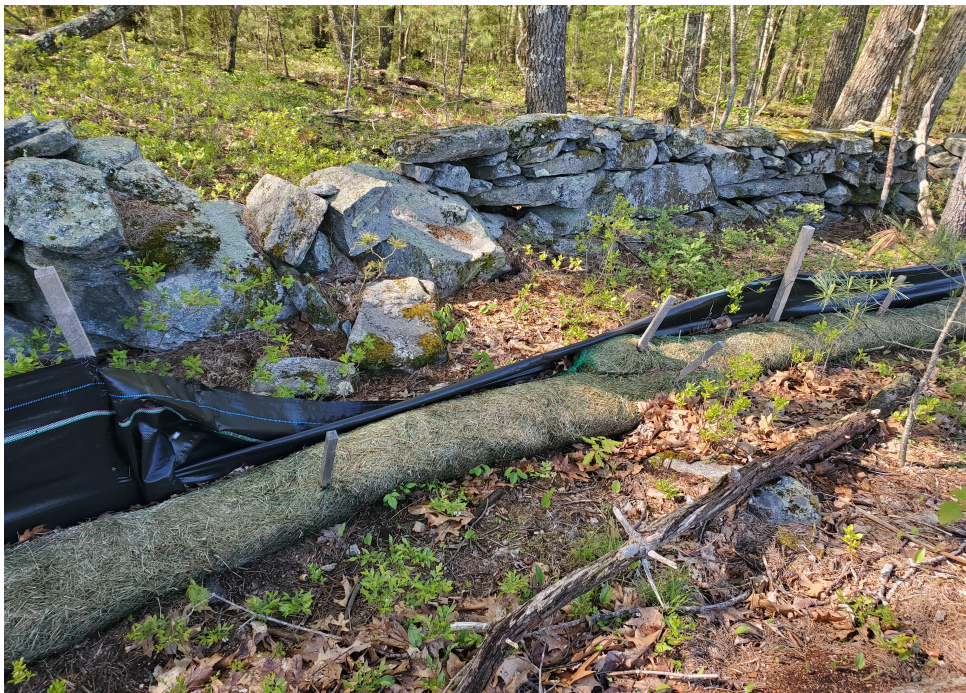
Photo 6

View of damaged silt fence in south east portion of the Site — facing south east
