Inspection Report for North Sturbridge Road Solar Facility

NPDES ID No.: MAR10031G

Inspection Date: 5/17/2022

**FIGURE 1:
SWPPP
INSPECTION
SKETCH
5/17/2022**

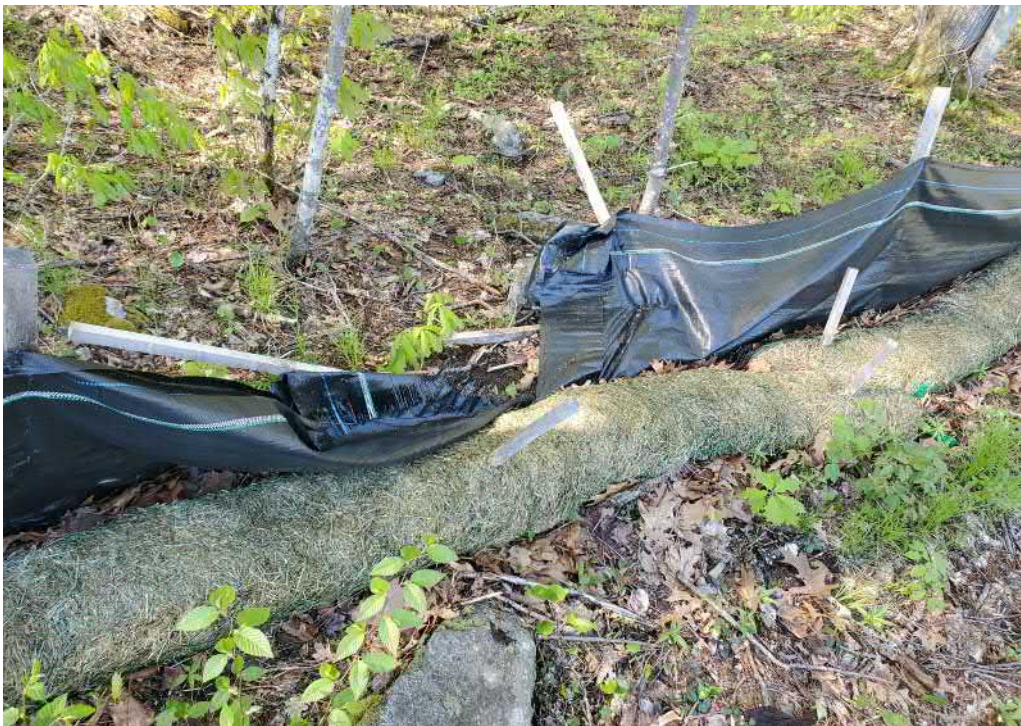
Photo 2

View of damaged silt fence in southern portion of the Site — facing south

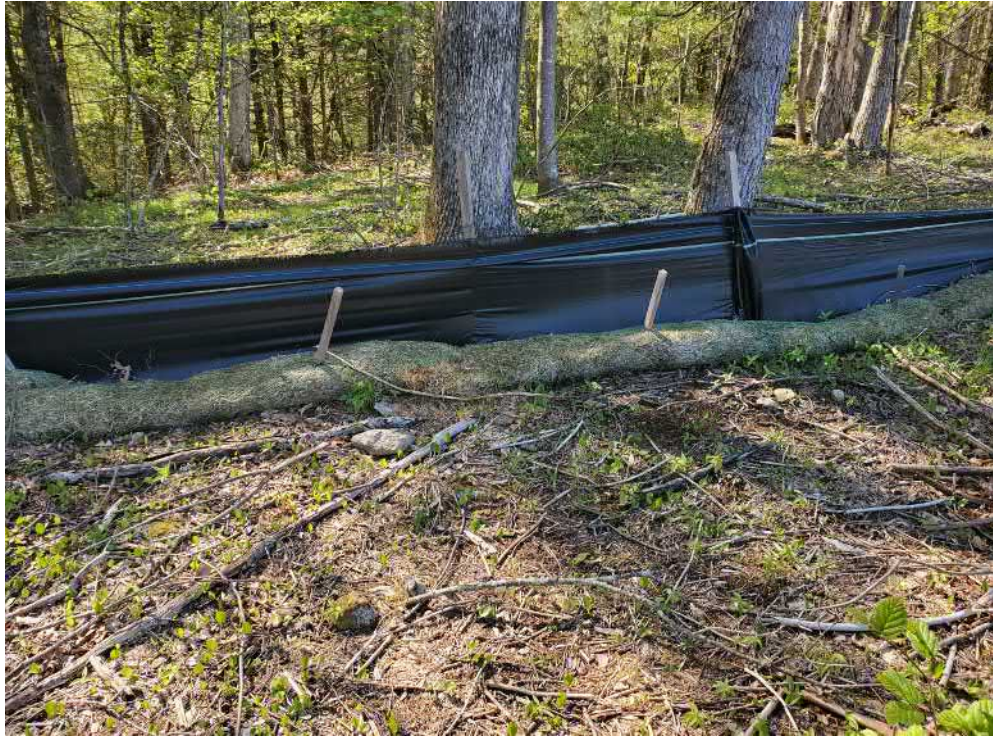
Photo 3

View of damaged silt wattle in northern portion of the Site — facing north

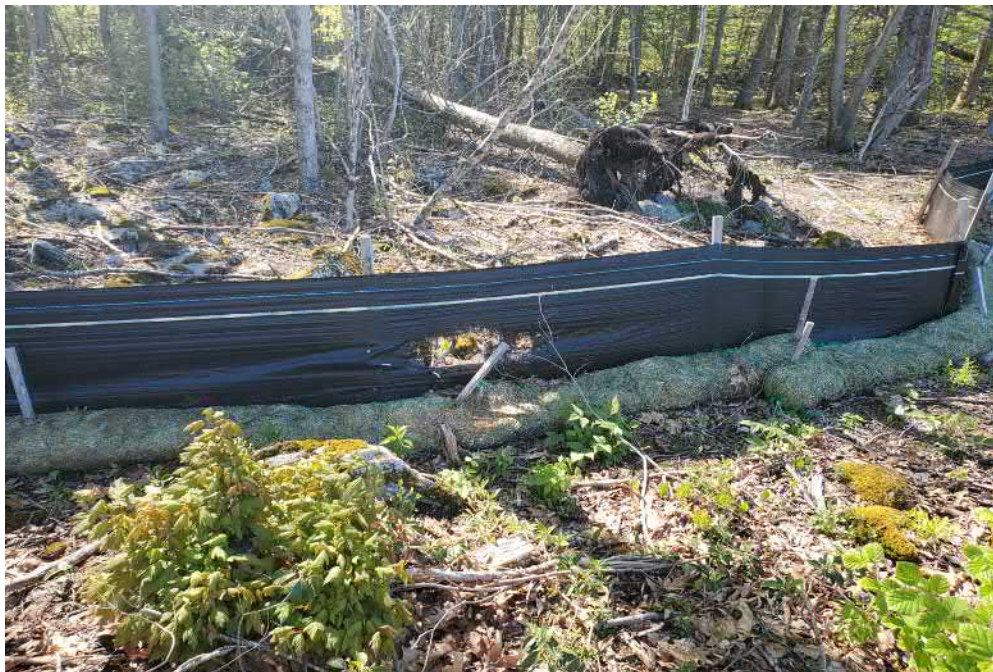
Photo 4

View of damaged silt wattle in northern portion of the Site — facing north

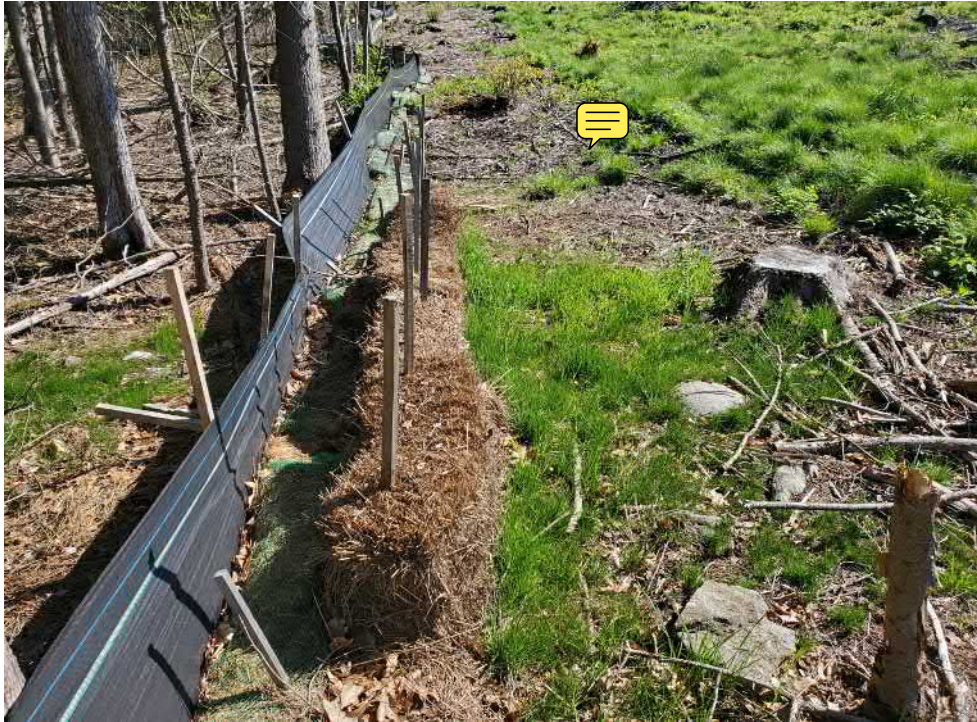
Photo 5

<p>4. Area beyond limits of work at Discharge 2</p>	<p>Hand application of seed</p>	<p><input type="checkbox"/> Yes Enter Date <input checked="" type="checkbox"/> No</p>	<p>On 4/27/2022 BETA observed the recently seeded grass to be thriving.</p>

View of silt fence and grass at Discharge 2 — facing north
