Inspection Report for North Sturbridge Road Solar Facility

NPDES ID No.: MAR10031G

Inspection Date: 5/29/2022

PHOTOGRAPHIC DOCUMENTATION
North Sturbridge Road Solar Facility
Charlton, Massachusetts
Photographs Documented 5.29.2022

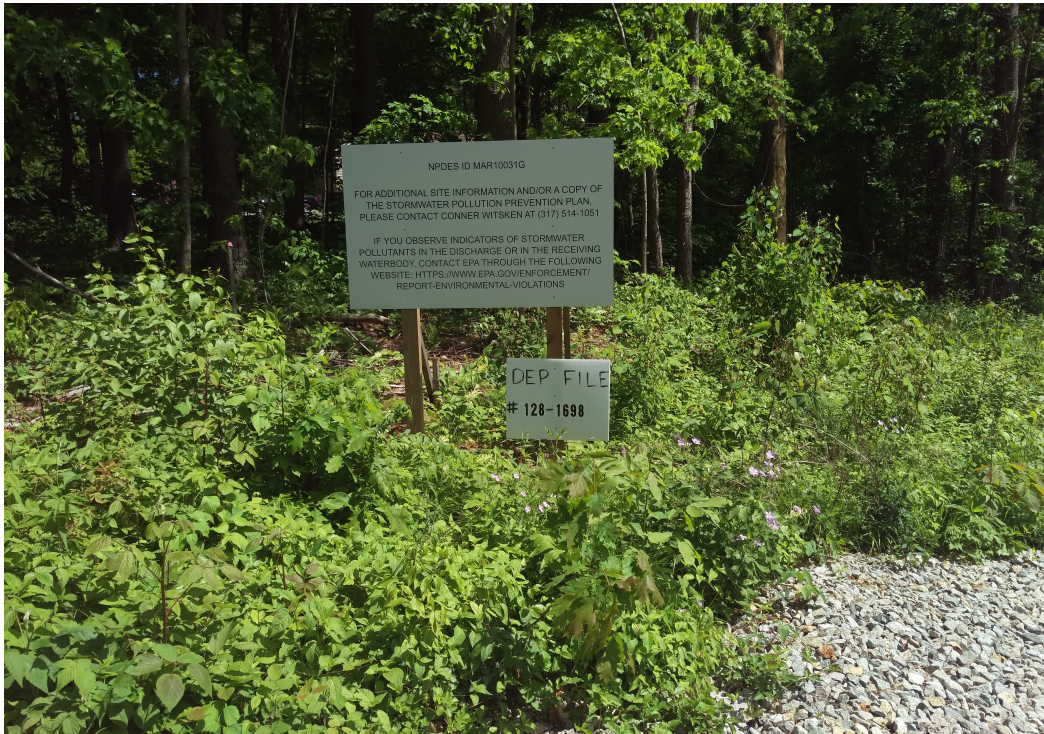
Photo 1

View of NPDES signage at entrance — facing southeast

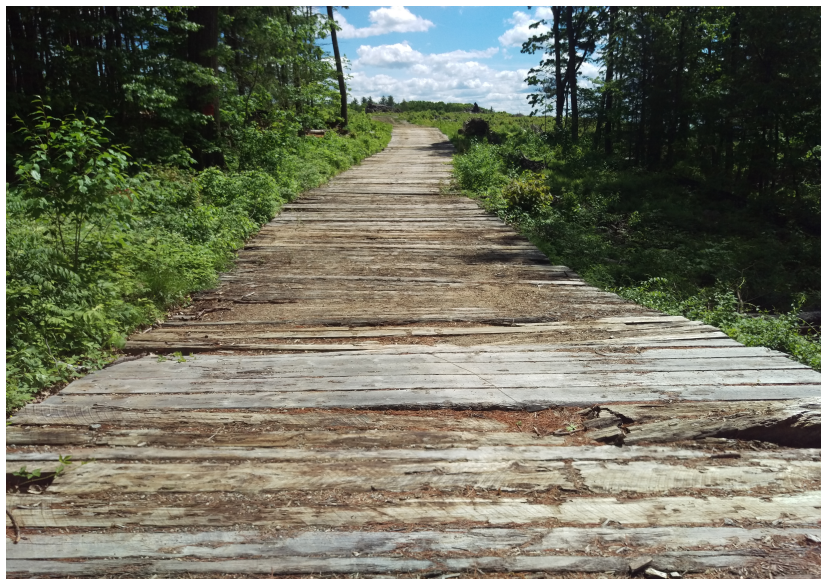
Photo 2

View of construction entrance timber mats — facing south

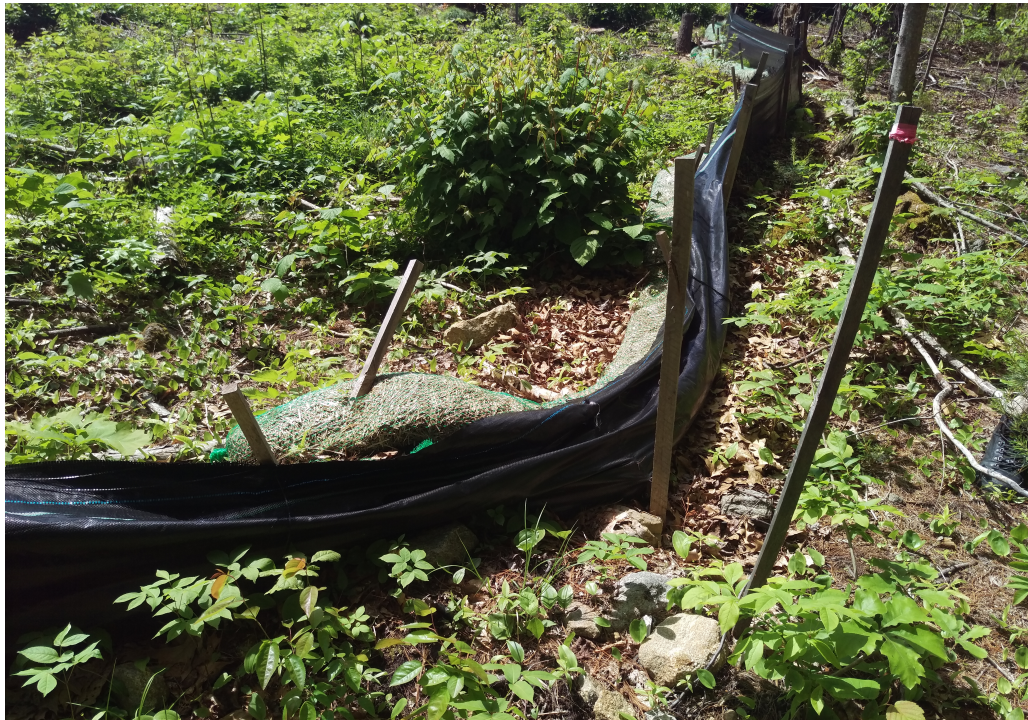
Photo 3

Type/Location of E&S Control	Maintenance Needed?*	Corrective Action Required?*	Date on Which Maintenance or Corrective Action First Identified?	
1. Silt Fence and Straw Wattles	Yes	Yes No	5/29/2022	On 5/29/2022 BETA observed damage to the wattles in the northeast and eastern corners of the Site, damage was first observed on 3/15/2022. BETA also observed the silt fence to be partly torn in the southeastern corner of the Site, damage was first observed on 3/27/2022. General maintenance is needed for the entire silt fence. No evidence of discharge was observed.
2. Stabilized Construction Entrance (Site Entrance – Access Road)	No	No		
3. Stump and Soil Stockpile Area	No	No		
4. Dust Controls	N/A	N/A		
5. Jute Mesh (Steep Slopes)	N/A	N/A		
6. Temporary Seeding	No	No

View of damaged silt fence in northern portion of the Site — facing north

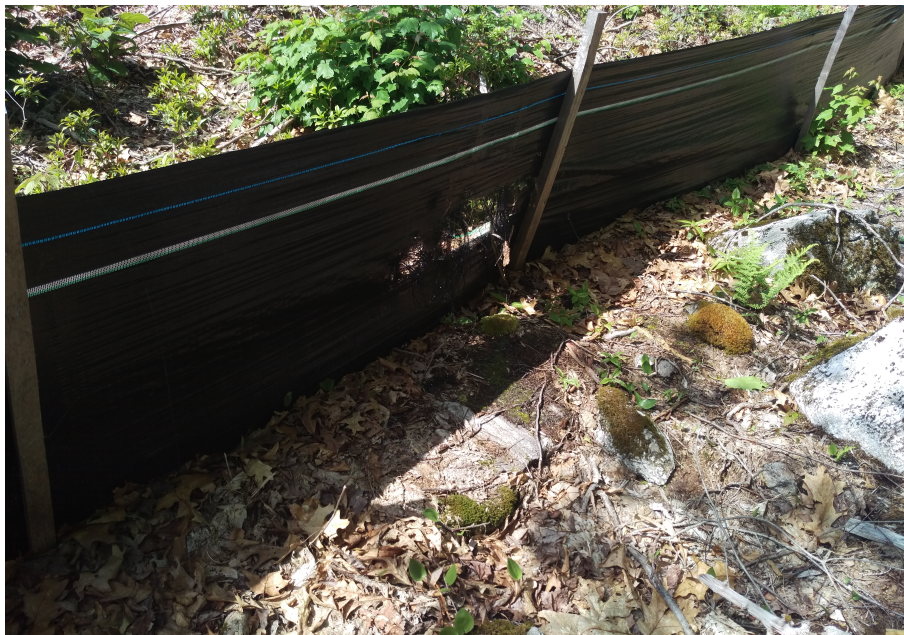
Photo 4

View of damaged silt fence north eastern portion of the Site — facing northwest

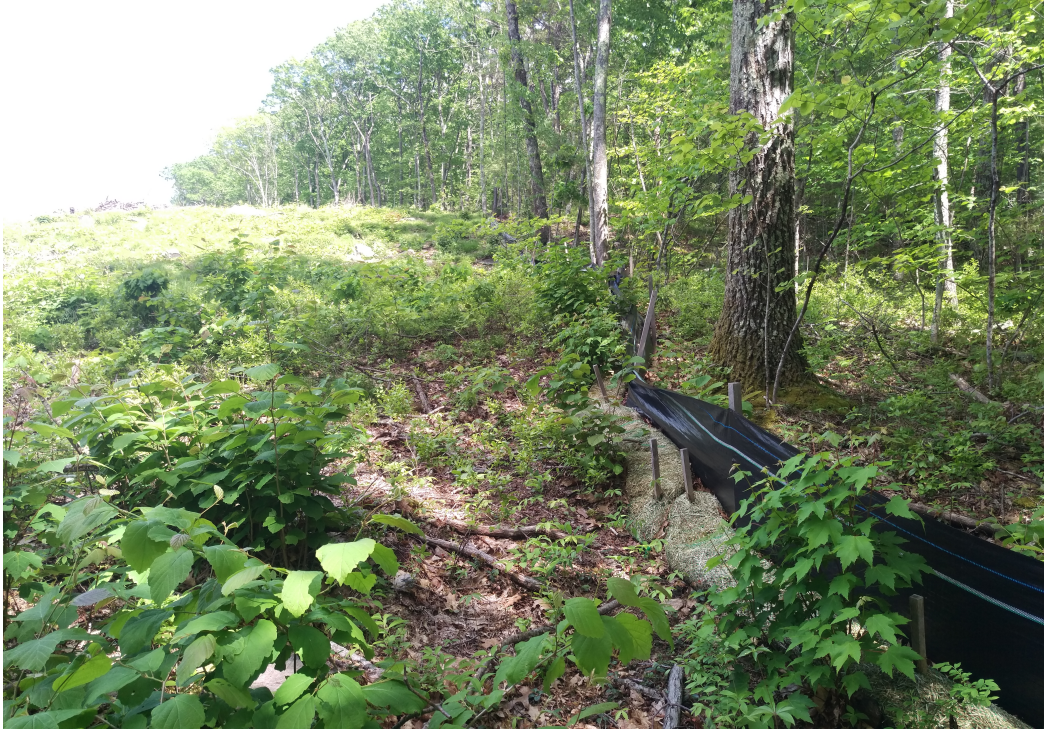
Photo 5

View of damaged silt fence southern portion of the Site — facing east

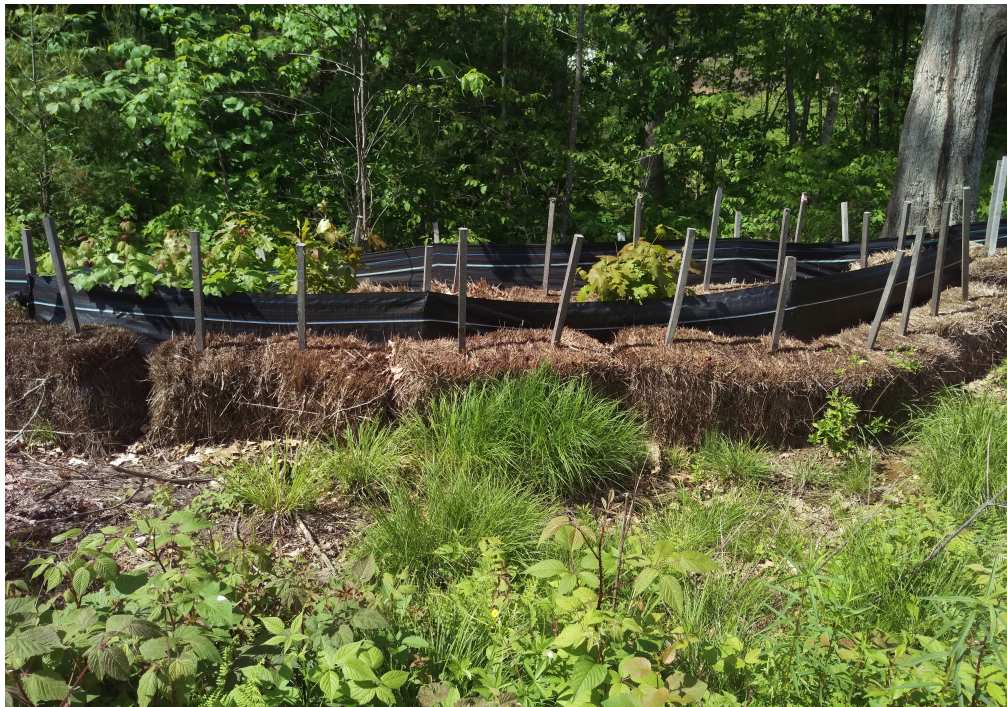
Photo 6

View of intact hay bales in northern portion of the Site — facing north
