Inspection Report for North Sturbridge Road Solar Facility NPDES ID No.: MAR10031G

Inspection Date: 6/9/2022

PHOTOGRAPHIC DOCUMENTATION North Sturbridge Road Solar Facility Charlton, Massachusetts Photographs Documented 6.9.2022

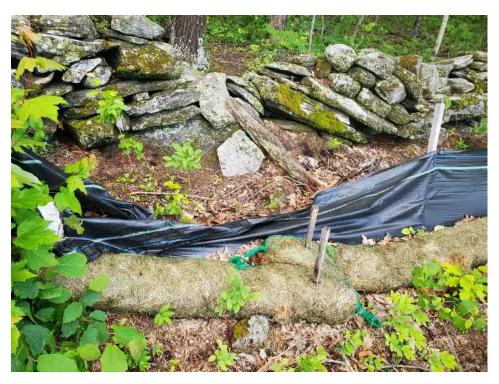
# Photo 1

View of damaged silt fence in eastern portion of the Site — facing southeast

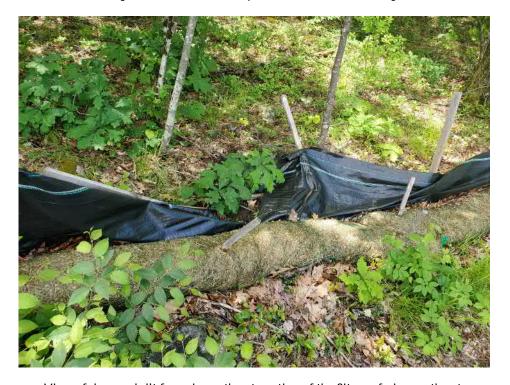
## Photo 2

View of damaged silt fence in southeast portion of the Site — facing southeast

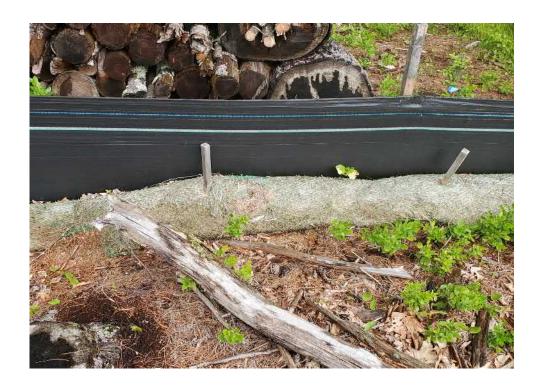
# Photo 3

View of damaged silt wattle in northern portion of the Site — facing north

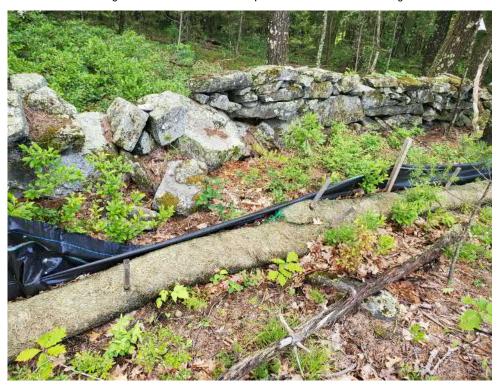
### Photo 4

View of damaged silt fence in southeast portion of the Site — facing southeast
