Inspection Report for North Sturbridge Road Solar Facility

NPDES ID No.: MAR10031G

Inspection Date: 6/9/2022

PHOTOGRAPHIC DOCUMENTATION
North Sturbridge Road Solar Facility
Charlton, Massachusetts
Photographs Documented 6.9.2022

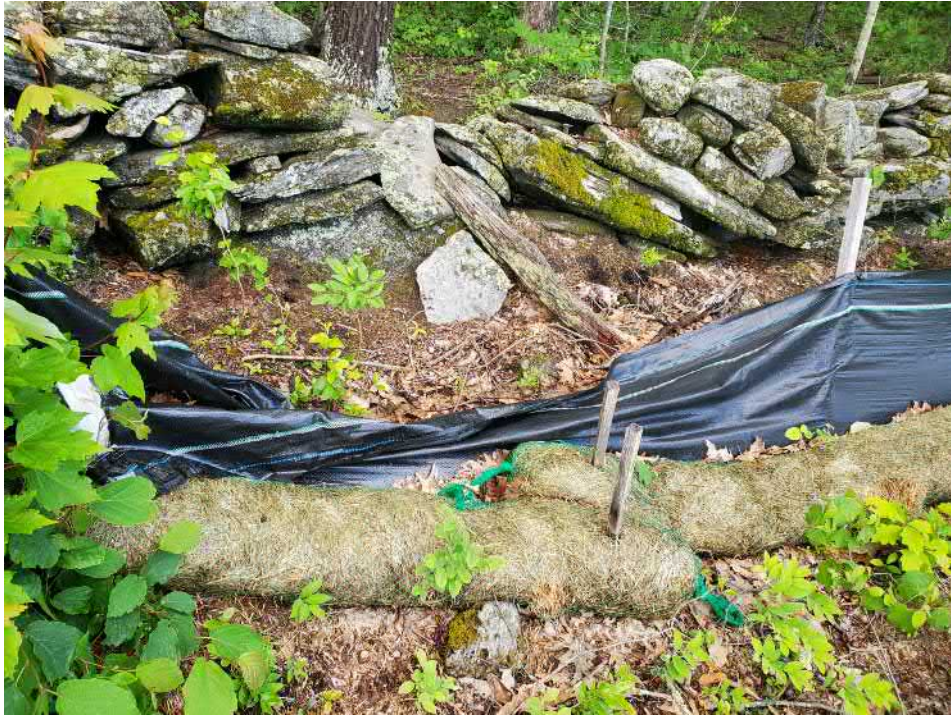
Photo 1

Type/Location of E&S Control	Maintenance Needed?*	Corrective Action Required?*	Date on Which Maintenance or Corrective Action First Identified?	
1. Silt Fence and Straw Wattles	Yes	No	3/15/2022	On 6/9/2022 BETA observed damage to the wattles in the northeast and eastern corners of the Site, damage was first observed on 3/15/2022. BETA also observed the silt fence to be partly torn in the southeastern corner of the Site, damage was first observed on 3/27/2022. General maintenance is needed for the entire silt fence. No evidence of discharge was observed.
2. Stabilized Construction Entrance (Site Entrance – Access Road)	No	No		
3. Stump and Soil Stockpile Area	No	No		
4. Dust Controls	N/A	N/A		
5. Jute Mesh (Steep Slopes)	N/A	N/A		
6. Temporary Seeding	No	No

View of damaged silt fence in eastern portion of the Site — facing southeast

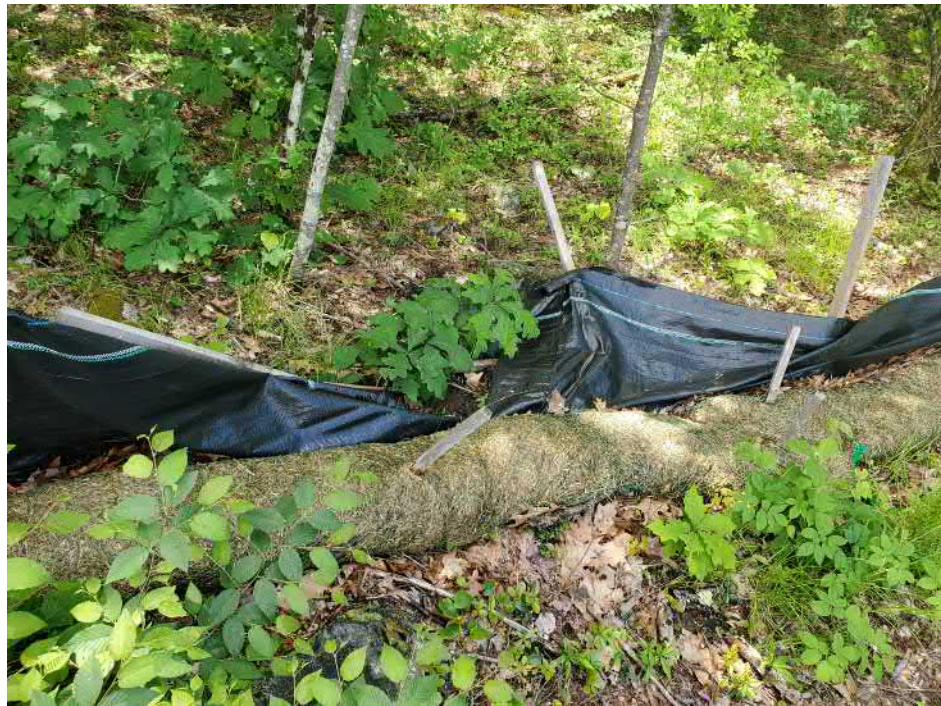
Photo 2

View of damaged silt fence in southeast portion of the Site — facing southeast

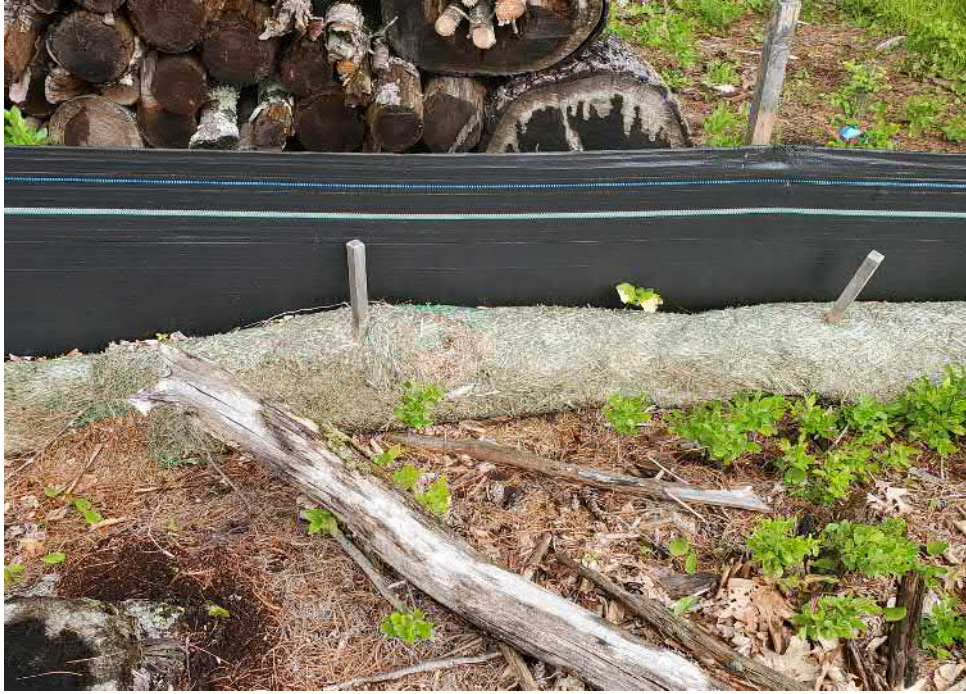
Photo 3

View of damaged silt wattle in northern portion of the Site — facing north

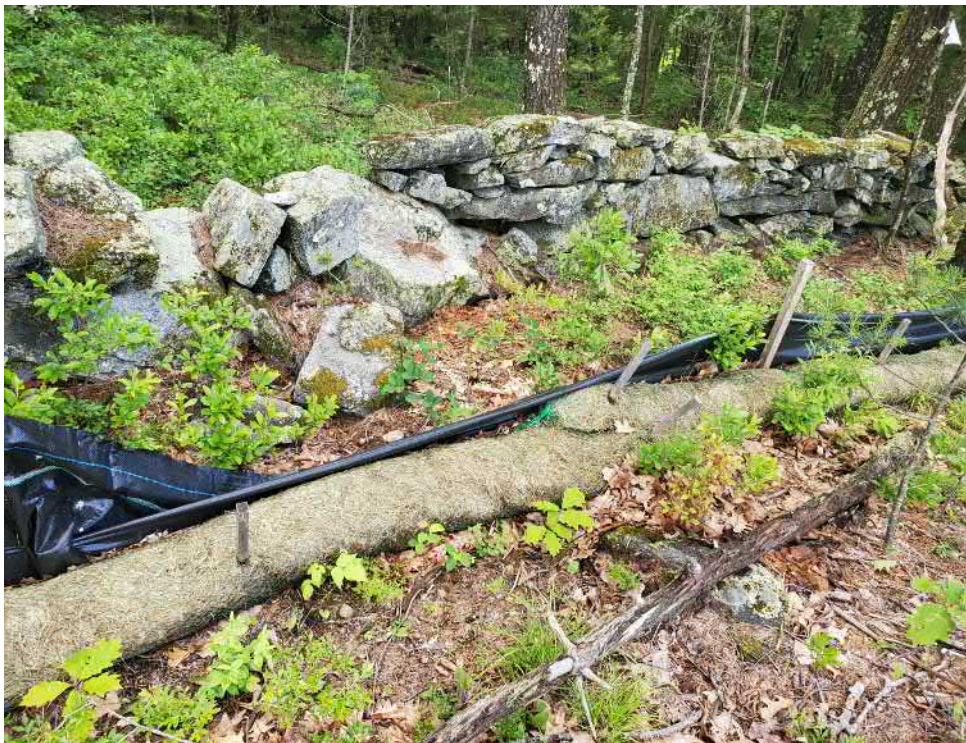
Photo 4

View of damaged silt fence in southeast portion of the Site — facing southeast
