Inspection Report for North Sturbridge Road Solar Facility NPDES ID No.: MAR10031G Inspection Date: 6/9/2022

PHOTOGRAPHIC DOCUMENTATION North Sturbridge Road Solar Facility Charlton, Massachusetts Photographs Documented 6.9.2022

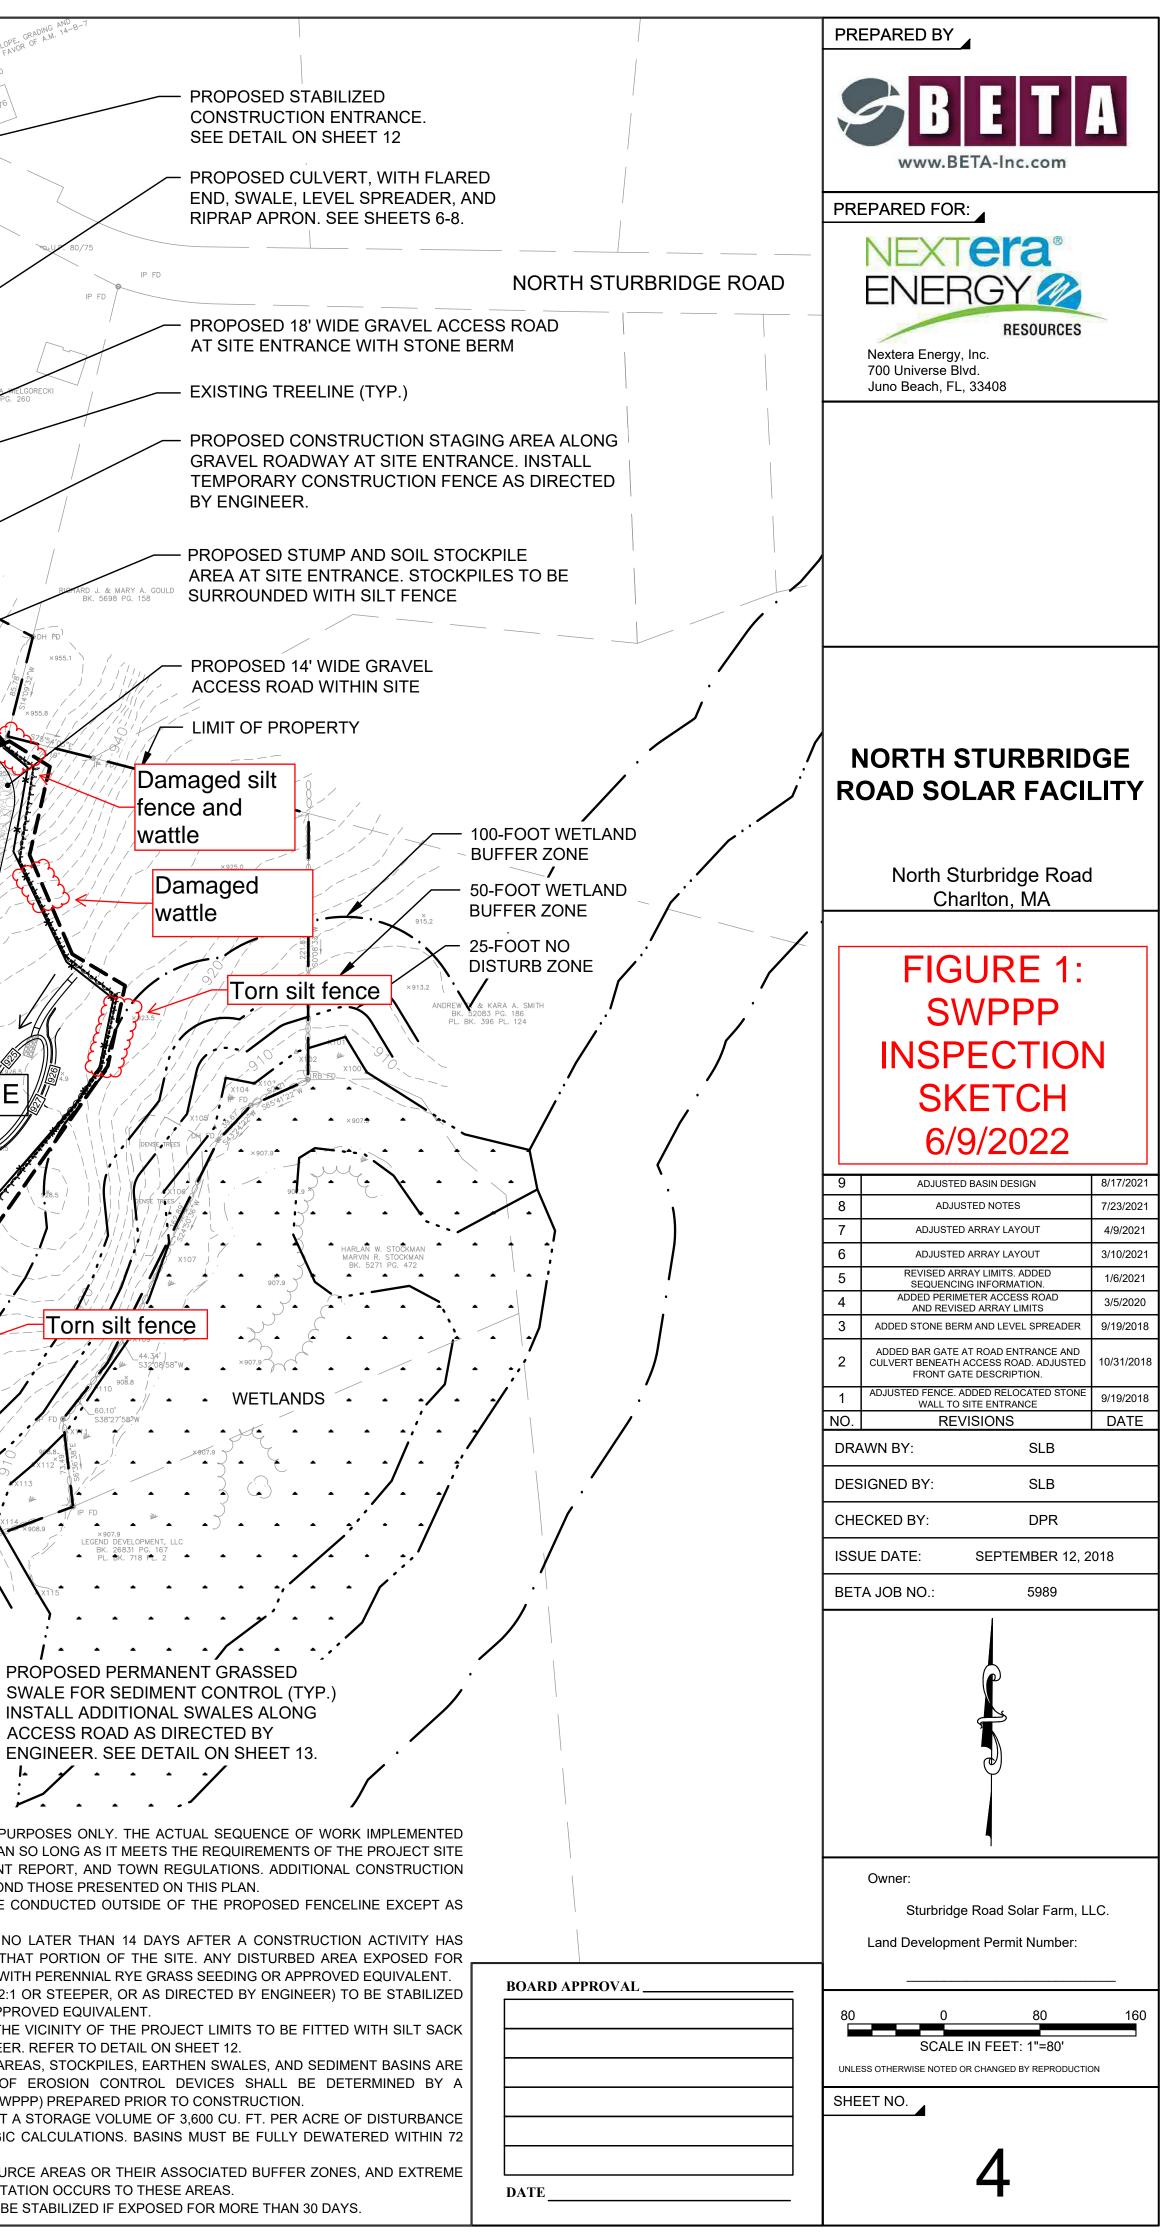
Location of channelization within machinery tracks

Torn silt fence

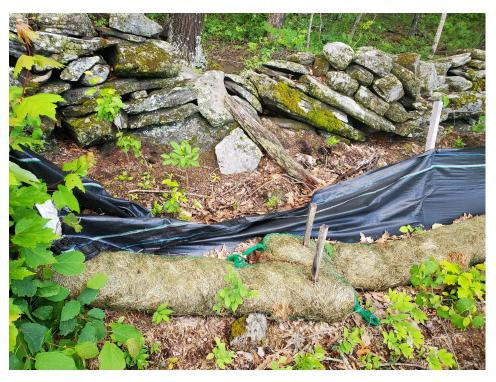
Photo 1

View of damaged silt fence in eastern portion of the Site — facing southeast

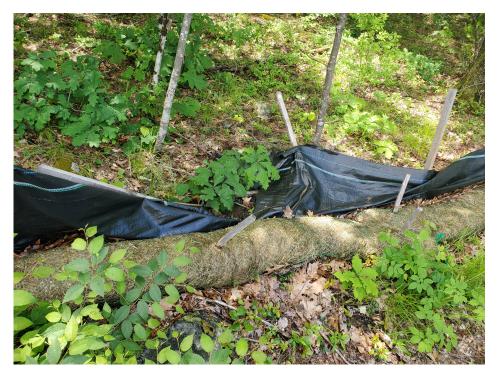
Photo 2

View of damaged silt fence in southeast portion of the Site — facing southeast

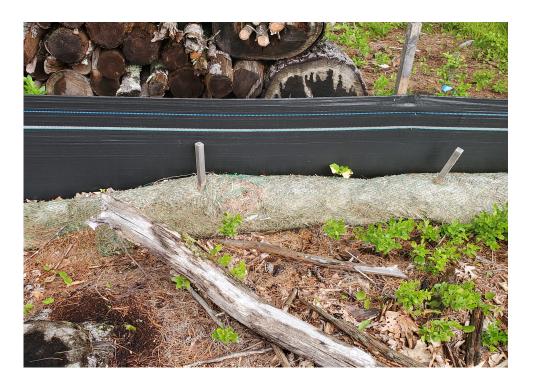
Photo 3

View of damaged silt wattle in northern portion of the Site — facing north

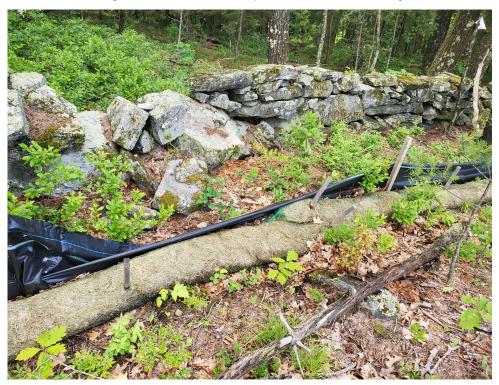
Photo 4

View of damaged silt fence in southeast portion of the Site — facing southeast PHOTOGRAPHIC DOCUMENTATION North Sturbridge Road Solar Facility Charlton, Massachusetts Photographs Documented 6.9.2022
