Inspection Report for North Sturbridge Road Solar Facility NPDES ID No.: MAR10031G

Inspection Date: 6/20/2022

PHOTOGRAPHIC DOCUMENTATION
North Sturbridge Road Solar Facility
Charlton, Massachusetts
Photographs Documented 6.20.2022

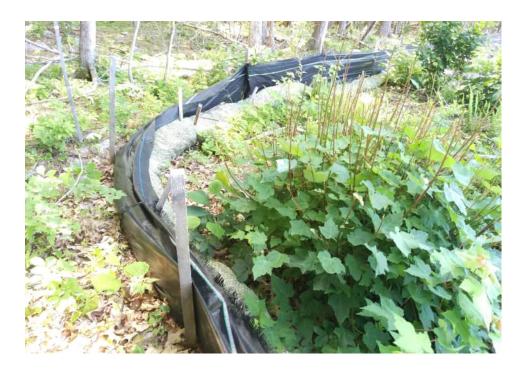
## Photo 1

View of damaged silt fence in eastern portion of the Site — facing east  $% \left( 1\right) =\left( 1\right) \left( 1\right) \left($

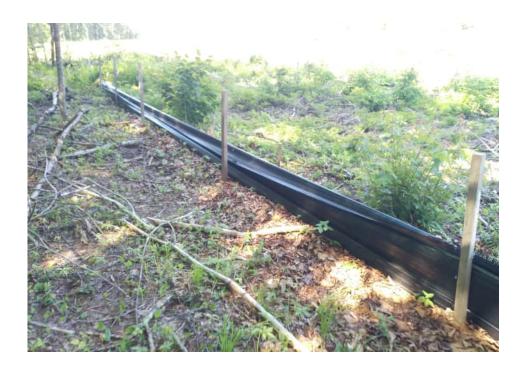
## Photo 2

View of damaged silt fence in southeast portion of the Site — facing southwest

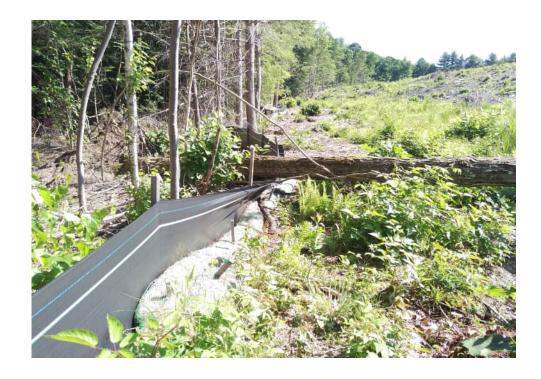
# Photo 3

1. Silt Fence and Straw Wattles	Yes	No	3/15/2022	On 6/20/2022 BETA observed fallen treet damage to the silt fence on the western perimeter of the Site.  On 6/9/2022 BETA observed damage to the wattles in the northeast and eastern corners of the Site, damage was first observed on 3/15/2022. BETA also observed the silt fence to be partly torn in the southeastern corner of the Site, damage was first observed on 3/27/2022. General maintenance is needed for the entire silt fence. No evidence of discharge was observed.		
Stabilized Construction Entrance     (Site Entrance – Access Road)	No	No

View of fallen tree damage to silt fence in northern portion of the Site — facing east

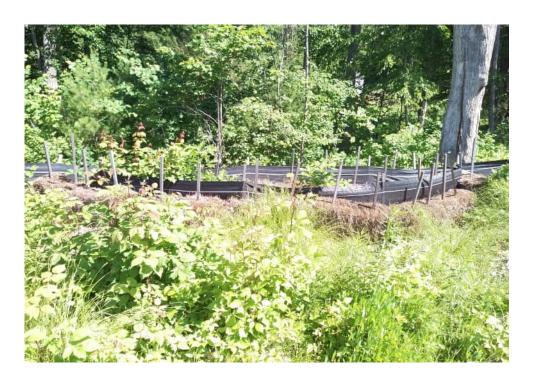
### Photo 4

View of haybales and silt fence in northern portion of the Site — facing north
