Inspection Report for North Sturbridge Road Solar Facility NPDES ID No.: MAR10031G

Inspection Date: 6/20/2022

PHOTOGRAPHIC DOCUMENTATION
North Sturbridge Road Solar Facility
Charlton, Massachusetts
Photographs Documented 6.20.2022

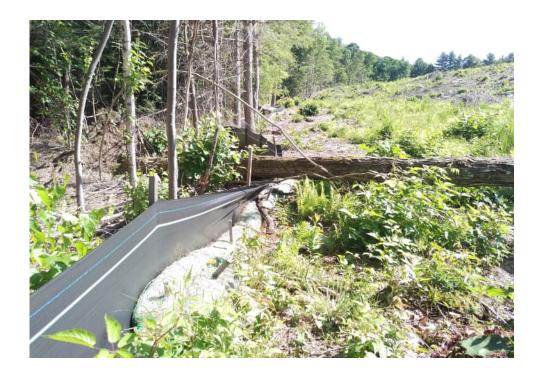
# Photo 3

1. Silt Fence and Straw Wattles	Yes	No	6/20/2022	On 6/20/2022 BETA observed fallen treet damage to the silt fence on the western perimeter of the Site.  On 6/9/2022 BETA observed damage to the wattles in the northeast and eastern corners of the Site, damage was first observed on 3/15/2022. BETA also observed the silt fence to be partly torn in the southeastern corner of the Site, damage was first observed on 3/27/2022. General maintenance is needed for the entire silt fence. No evidence of discharge was observed.			
Stabilized Construction Entrance     (Site Entrance – Access Road)	No	No

View of fallen tree damaged to silt fence in northern portion of the Site — facing east

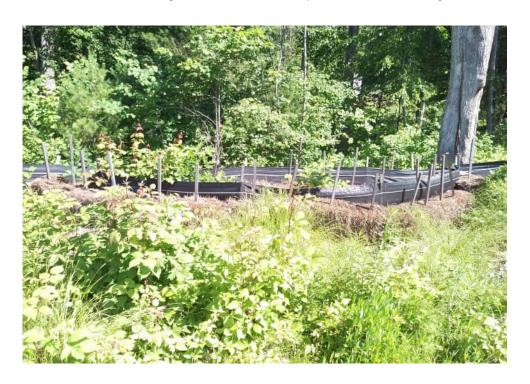
### Photo 4

View of haybales and silt fence in northern portion of the Site — facing north
