Inspection Report for North Sturbridge Road Solar Facility NPDES ID No.: MAR10031G

Inspection Date: 6/28/2022

PHOTOGRAPHIC DOCUMENTATION North Sturbridge Road Solar Facility Charlton, Massachusetts Photographs Documented 6.28.2022

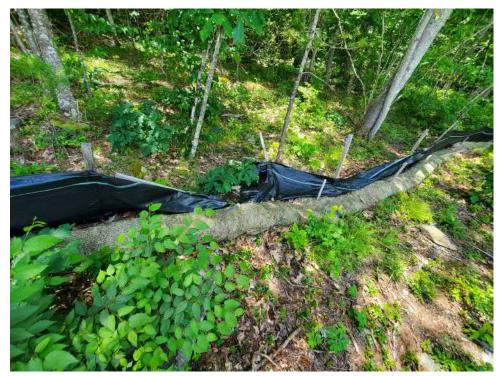
## Photo 1

View of damaged silt fence in eastern portion of the Site — facing east

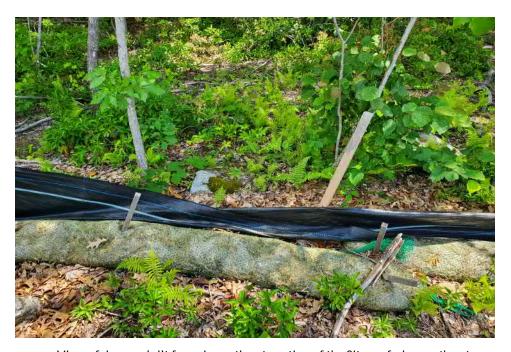
### Photo 2

View of damaged silt fence in southeast portion of the Site — facing southeast

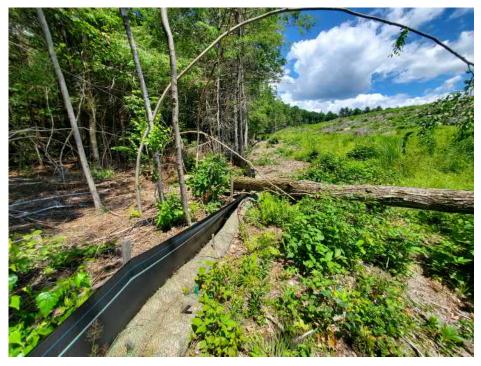
# Photo 3

1. Silt Fence and Straw Wattles	Yes	No	3/15/2022	On 6/28/2022 BETA observed fallen tree damage to the silt fence on the western perimeter of the Site, damage was first observed on 6/20/2022  On 6/28/2022 BETA observed damage to the wattles in the northeast and eastern corners of the Site, damage was first observed on 3/15/2022. BETA also observed the silt fence to be partly torn in the southeastern corner of the Site, damage was first observed on 3/27/2022. General maintenance is needed for the entire silt fence. No evidence of discharge was observed.		
Stabilized Construction Entrance     (Site Entrance – Access Road)	No	No

View of fallen tree damage to silt fence in southwestern portion of the Site — facing north

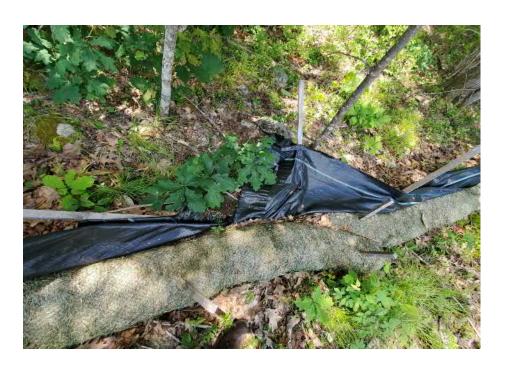
## Photo 4

View of damaged silt fence in southeastern portion of the Site — facing southeast
