Inspection Report for North Sturbridge Road Solar Facility

NPDES ID No.: MAR10031G

Inspection Date: 6/28/2022

**FIGURE 1:
 SWPPP
 INSPECTION
 SKETCH
 6/28/2022**

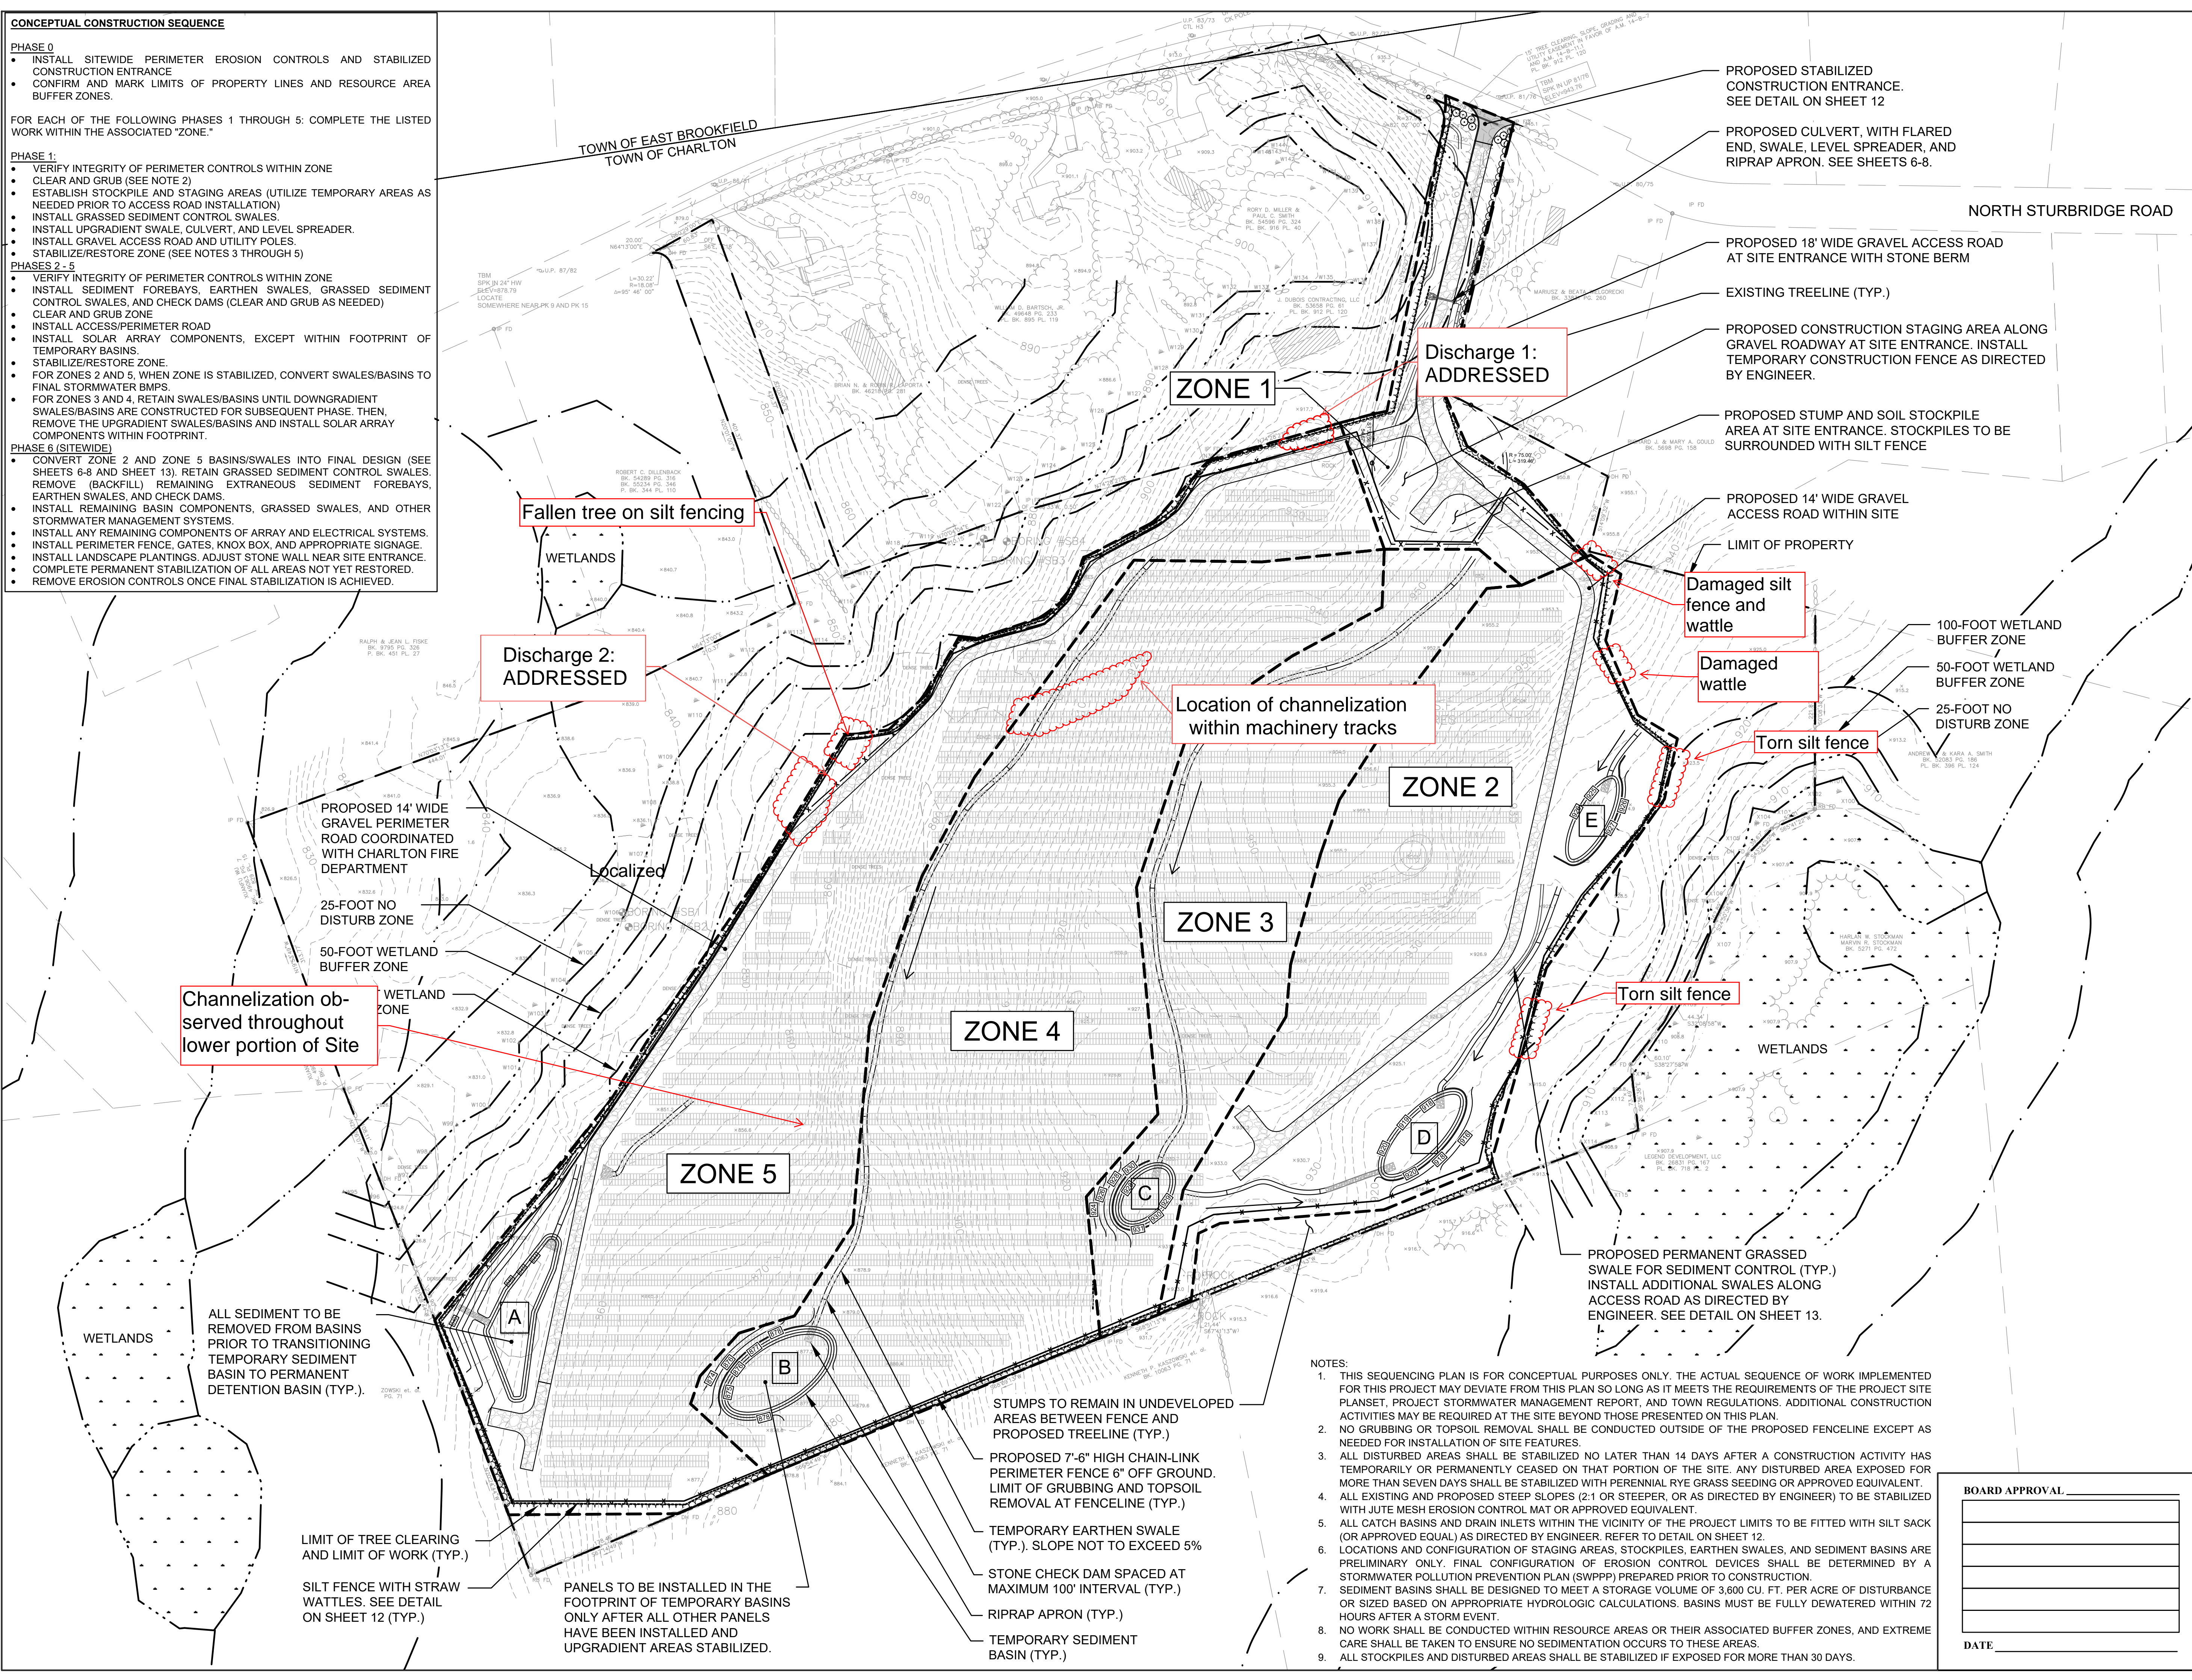
| Stabilization of Exposed Soil (CGP Part 2.2.14) | | | |
|--|---|---|--|
| 2. Informal access road along northern portion of the Site | Straw mulch or hydroseed | <input type="checkbox"/> Yes <input checked="" type="checkbox"/> No | Erosion channels are beginning to form within upgradient portions of the informal access road (Figure 1). The contractor indicated that stabilization by smoothing out soils and seeding or spreading mulch would occur on 7/30/2021. Stabilization of this area has not been initiated. After inspection of the area on 8/24/2021, it was determined that |

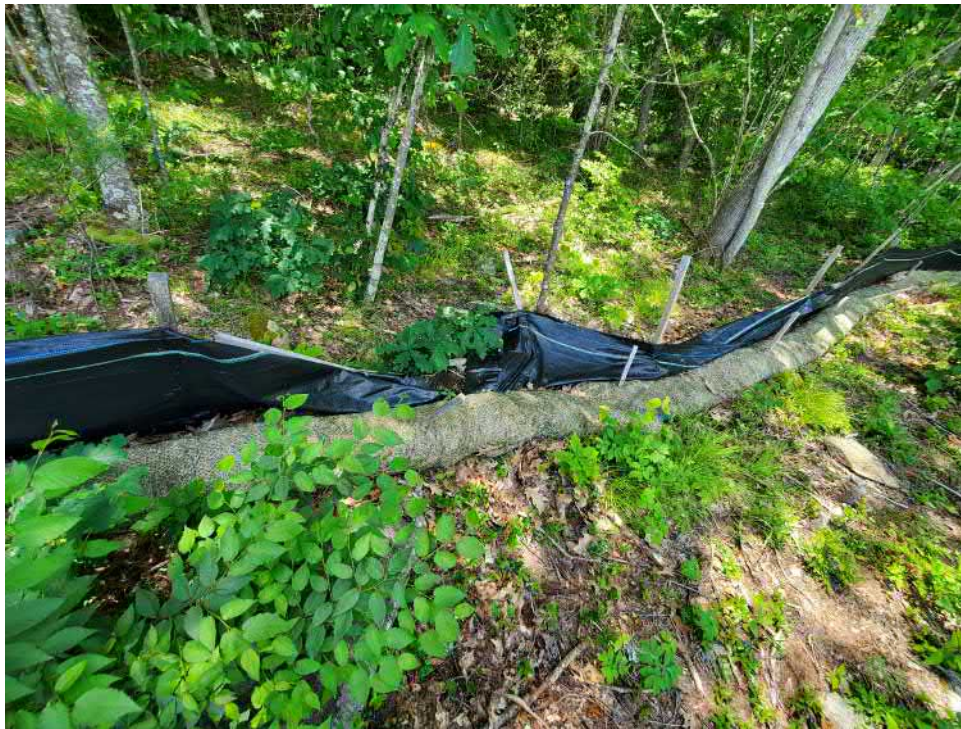
Photo 1

View of damaged silt fence in eastern portion of the Site — facing east

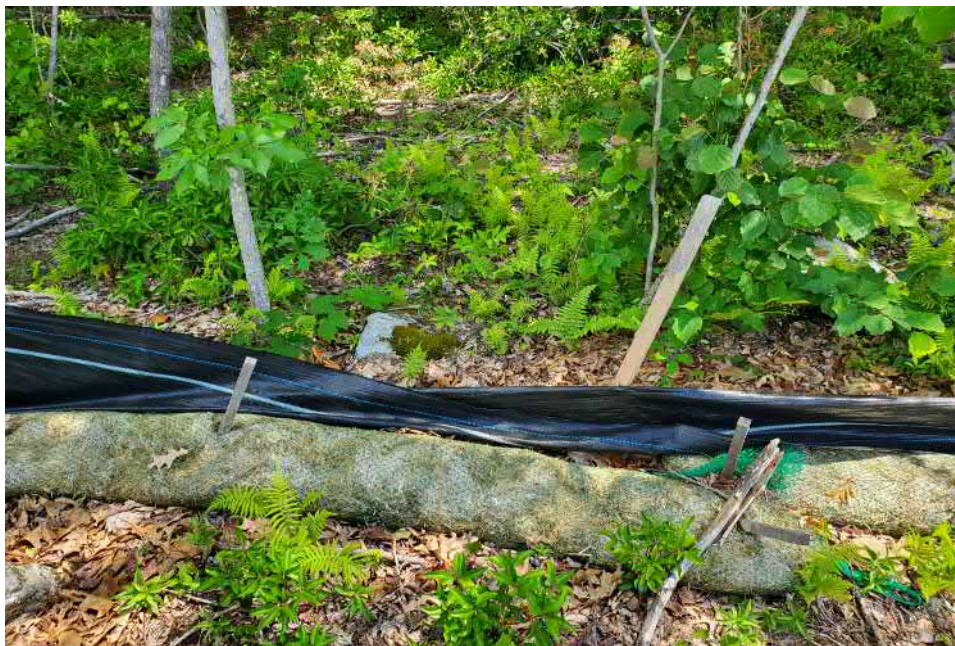
Photo 2

View of damaged silt fence in southeast portion of the Site — facing southeast

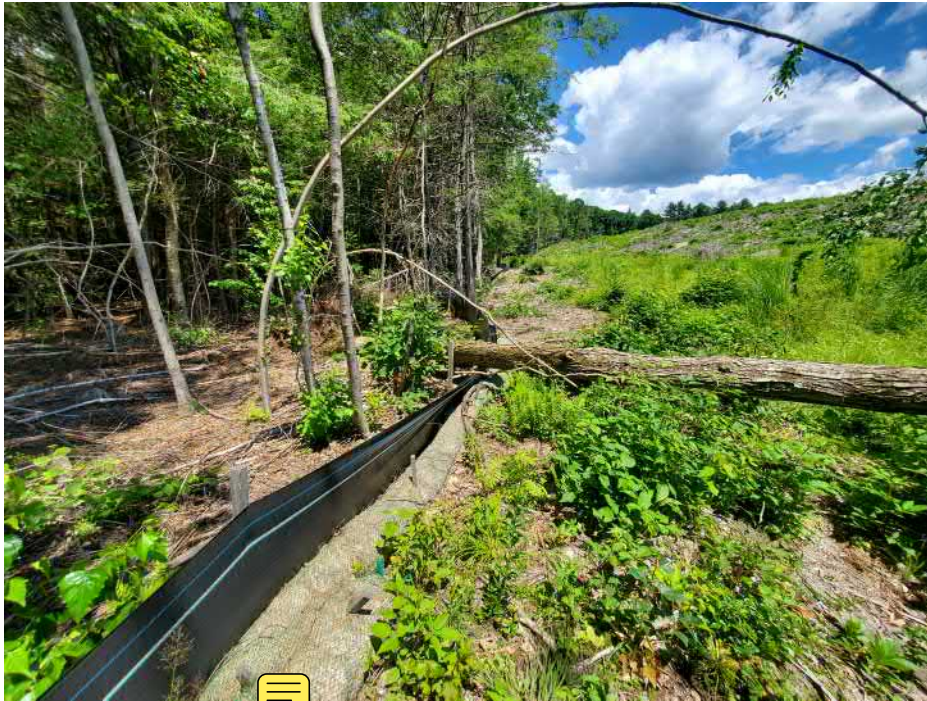
Photo 3

| Type/Location of E&S Control | Maintenance Needed?* | Corrective Action Required?* | Date on Which Maintenance or Corrective Action First Identified? | |
|---|---|---|--|---|
| 1. Silt Fence and Straw Wattles | Yes | No | 6/20/2022 | <p>On 6/28/2022 BETA observed fallen tree damage to the silt fence on the western perimeter of the Site, damage was first observed on 6/20/2022</p> <p>On 6/28/2022 BETA observed damage to the wattles in the northeast and eastern corners of the Site, damage was first observed on 3/15/2022. BETA also observed the silt fence to be partly torn in the southeastern corner of the Site, damage was first observed on 3/27/2022. General maintenance is needed for the entire silt fence. No evidence of discharge was observed.</p> |

View of fallen tree damaged to silt fence in southwestern portion of the Site — facing north

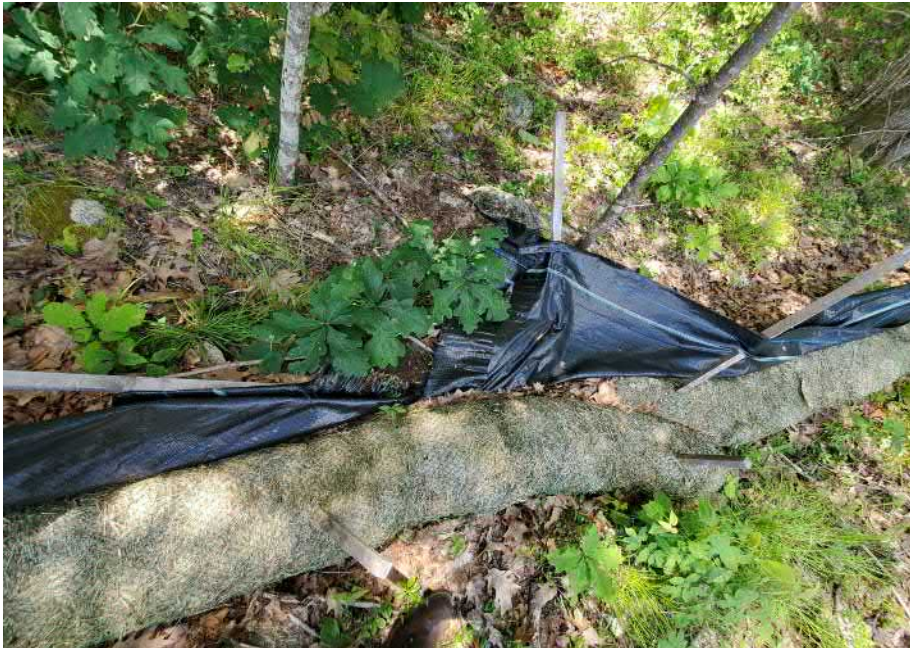
Photo 4

View of damaged silt fence in southeastern portion of the Site — facing southeast
