Inspection Report for North Sturbridge Road Solar Facility NPDES ID No.: MAR10031G

Inspection Date: 6/28/2022

PHOTOGRAPHIC DOCUMENTATION North Sturbridge Road Solar Facility Charlton, Massachusetts Photographs Documented 6.28.2022

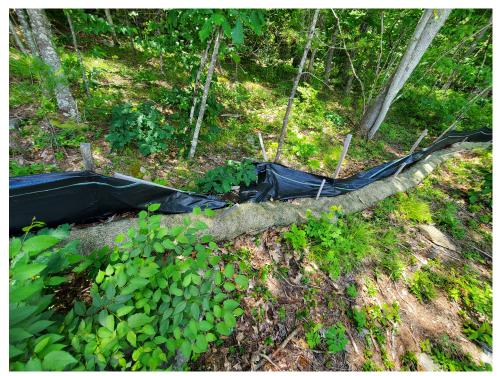
## Photo 1

Condition and Effectiveness of Erosion and Sediment (E&S) Controls (CGP Part 2.2)						
Type/Location of E&S Control	Maintenance Needed?*	Corrective Action Required?*	Date on Which Maintenance or Corrective Action First Identified?			
Silt Fence and Straw Wattles	Yes	No	6/20/2022	On 6/28/2022 BETA observed fallen tree damage to the silt fence on the western perimeter of the Site, damage was first observed on 6/20/2022  On 6/28/2022 BETA observed damage to the wattles in the northeast and eastern corners of the Site, damage was first observed on 3/15/2022. BETA also observed the silt fence to be partly torn in the southeastern corner of the Site, damage was first observed on 3/27/2022. General maintenance is needed for the entire silt fence. No evidence of discharge was observed.		
Stabilized Construction Entrance     (Site Entrance – Access Road)	No	No

View of damaged silt fence in eastern portion of the Site — facing east

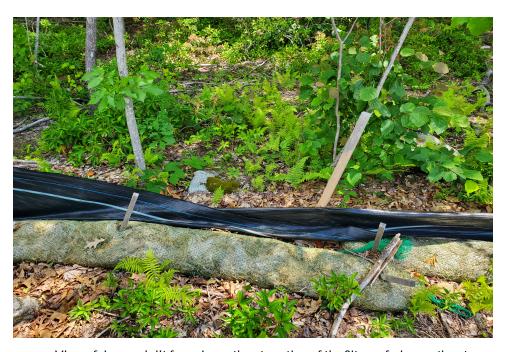
### Photo 2

View of damaged silt fence in southeast portion of the Site — facing southeast

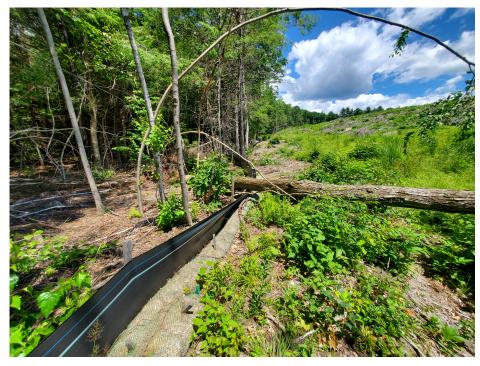
# Photo 3

View of fallen tree damaged to silt fence in southwestern portion of the Site — facing north

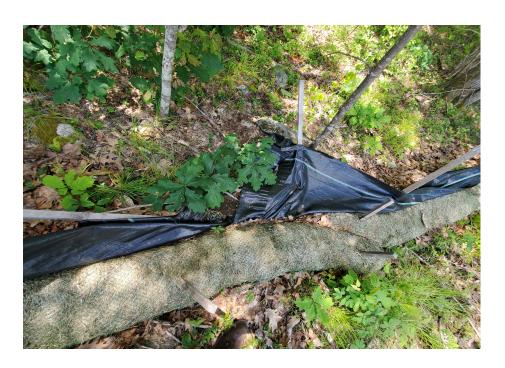
## Photo 4

View of damaged silt fence in southeastern portion of the Site — facing southeast
