Inspection Report for North Sturbridge Road Solar Facility NPDES ID No.: MAR10031G

Inspection Date: 7/5/2022

PHOTOGRAPHIC DOCUMENTATION North Sturbridge Road Solar Facility Charlton, Massachusetts Photographs Documented 7.5.2022

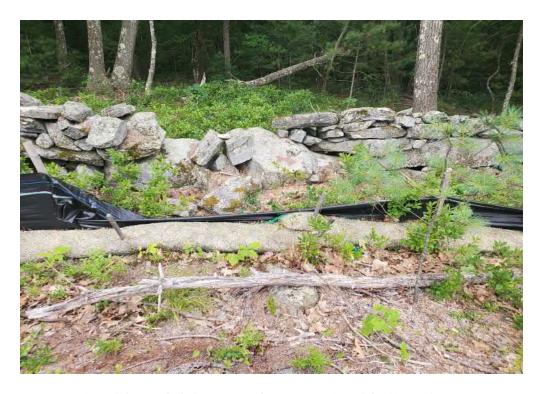
Photo 1

View of damaged silt fence in northeastern portion of the Site — facing east

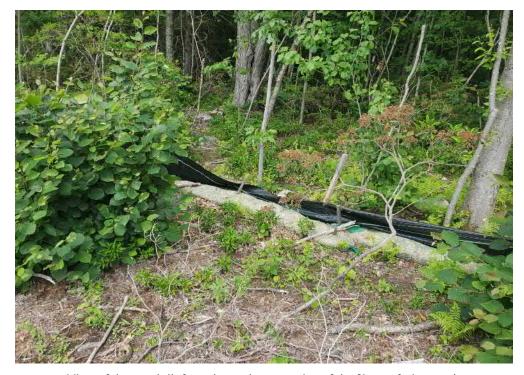
Photo 2

View of damaged silt fence in southeast portion of the Site — facing northeast

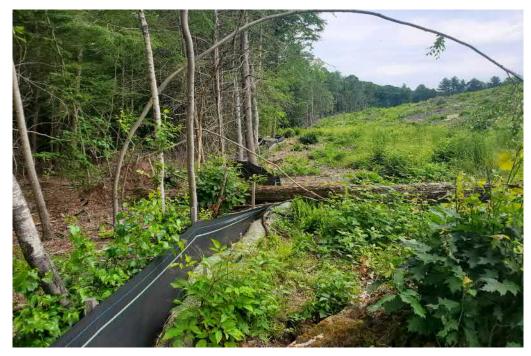
Photo 3

1. Silt Fence and Straw Wattles	Yes	No	3/15/2022	On 7/5/2022 BETA observed fallen tree damage to the silt fence on the western perimeter of the Site, damage was first observed on 6/20/2022 On 7/5/2022 BETA observed damage to the wattles in the northeast and eastern corners of the Site, damage was first observed on 3/15/2022. BETA also observed the silt fence to be partly torn in the southeastern corner of the Site, damage was first observed on 3/27/2022. General maintenance is needed for the entire silt fence. No evidence of discharge was observed.			
Stabilized Construction Entrance (Site Entrance – Access Road)	No	No

View of fallen tree damage to silt fence in southwestern portion of the Site — facing north

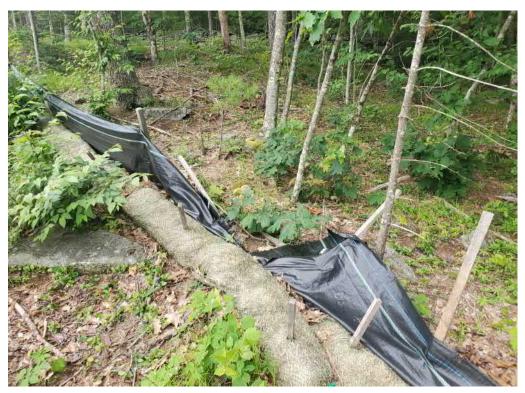
Photo 4

View of damaged silt fence in southeastern portion of the Site — facing northeast
