Inspection Report for North Sturbridge Road Solar Facility NPDES ID No.: MAR10031G Inspection Date: 7/5/2022

PHOTOGRAPHIC DOCUMENTATION North Sturbridge Road Solar Facility Charlton, Massachusetts Photographs Documented 7.5.2022

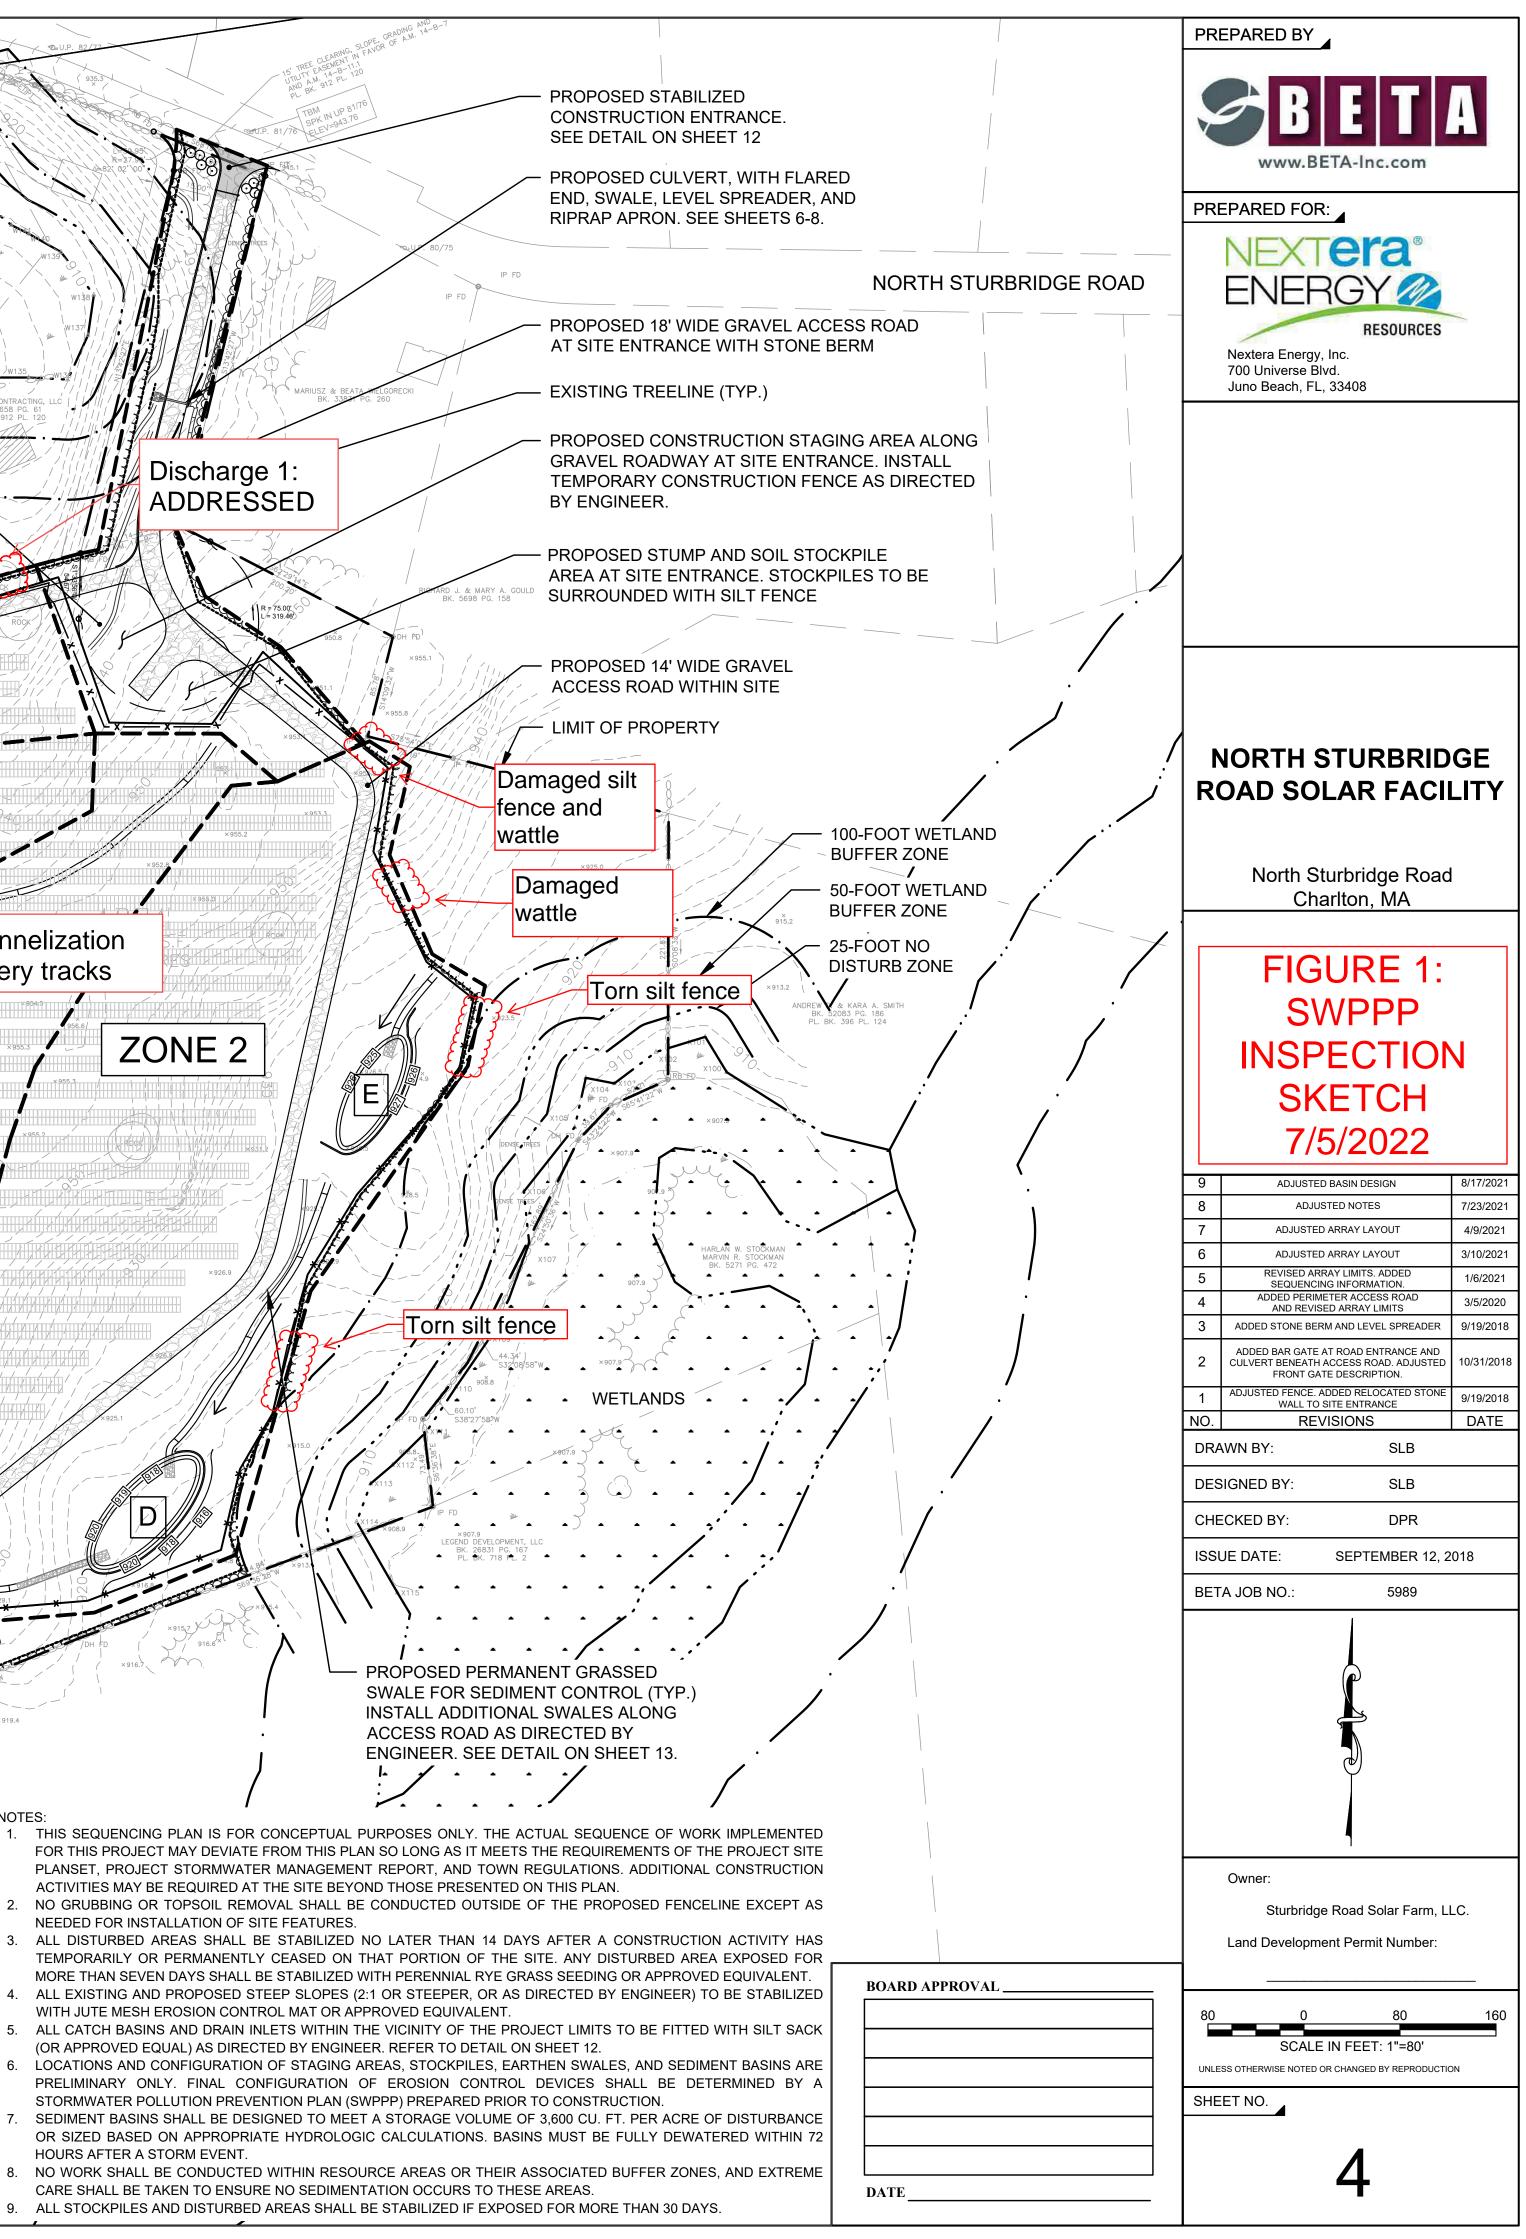
Discharge 1: ADDRESSED

Location of channelization within machinery tracks

Torn silt fence

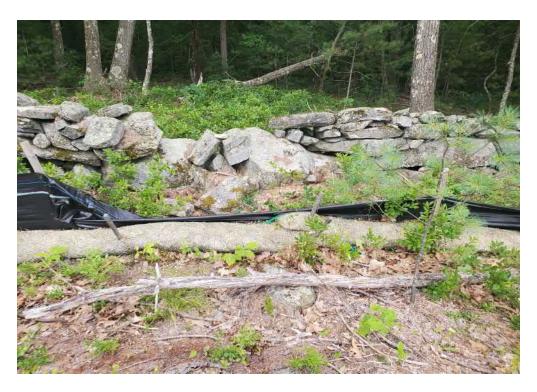
Photo 1

View of damaged silt fence in northeastern portion of the Site — facing east

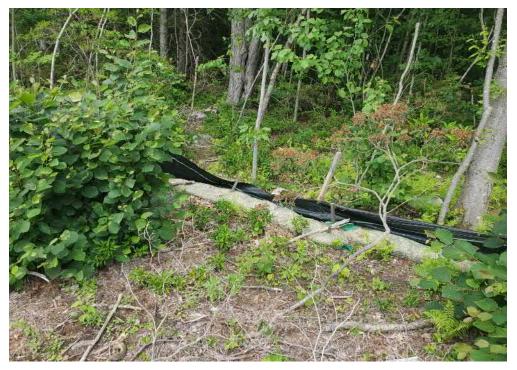
Photo 2

View of damaged silt fence in southeast portion of the Site — facing northeast

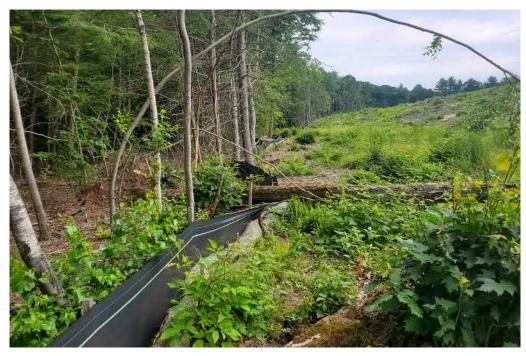
Photo 3

1. Silt Fence and Straw Wattles	Yes	No	3/27/2022	On 7/5/2022 BETA observed fallen tree damage to the silt fence on the western perimeter of the Site, damage was first observed on 6/20/2022 On 7/5/2022 BETA observed damage to the wattles in the north- east and eastern corners of the Site, damage was first ob- served on 3/15/2022. BETA also observed the silt fence to be partly torn in the southeastern corner of the Site, damage was first observed on 3/27/2022. General maintenance is needed for the entire silt fence. No evidence of discharge was observed.

View of fallen tree damaged to silt fence in southwestern portion of the Site — facing north

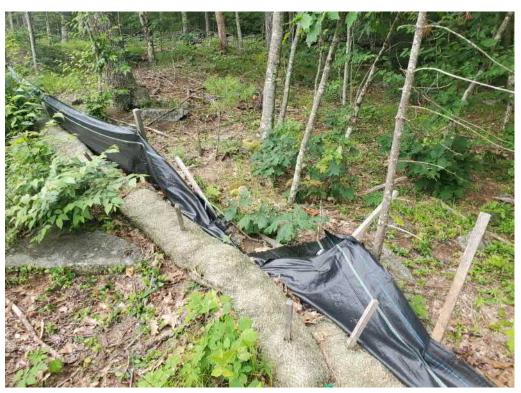
Photo 4

View of damaged silt fence in southeastern portion of the Site — facing northeast
