Inspection Report for North Sturbridge Road Solar Facility NPDES ID No.: MAR10031G Inspection Date: 7/5/2022

PHOTOGRAPHIC DOCUMENTATION North Sturbridge Road Solar Facility Charlton, Massachusetts Photographs Documented 7.5.2022

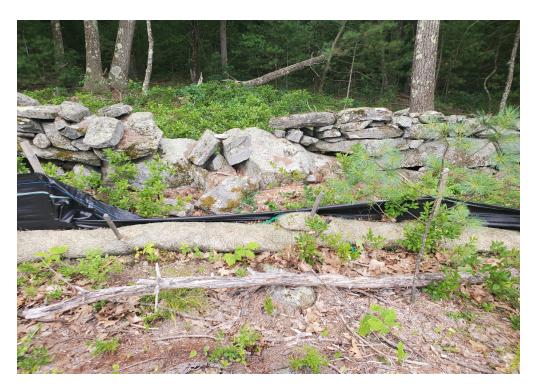
Photo 1

View of damaged silt fence in northeastern portion of the Site — facing east

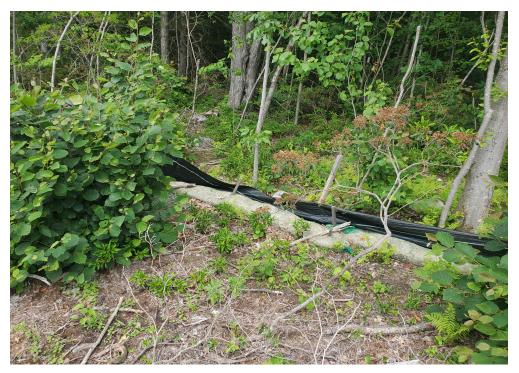
Photo 2

View of damaged silt fence in southeast portion of the Site — facing northeast

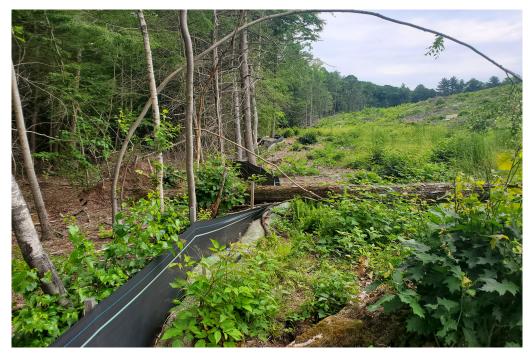
Photo 3

1. Silt Fence and Straw Wattles	Yes	No	3/27/2022	On 7/5/2022 BETA observed fallen tree damage to the silt fence on the western perimeter of the Site, damage was first observed on 6/20/2022 On 7/5/2022 BETA observed damage to the wattles in the north- east and eastern corners of the Site, damage was first ob- served on 3/15/2022. BETA also observed the silt fence to be partly torn in the southeastern corner of the Site, damage was first observed on 3/27/2022. General maintenance is needed for the entire silt fence. No evidence of discharge was observed.

View of fallen tree damaged to silt fence in southwestern portion of the Site — facing north

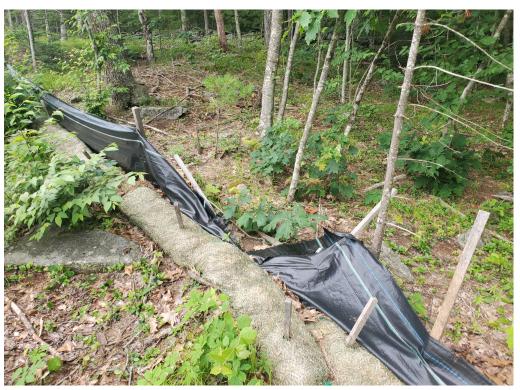
Photo 4

View of damaged silt fence in southeastern portion of the Site — facing northeast
