Inspection Report for North Sturbridge Road Solar Facility

NPDES ID No.: MAR10031G

Inspection Date: 7/13/2022

**FIGURE 1:
SWPPP
INSPECTION
SKETCH
7/13/2022**

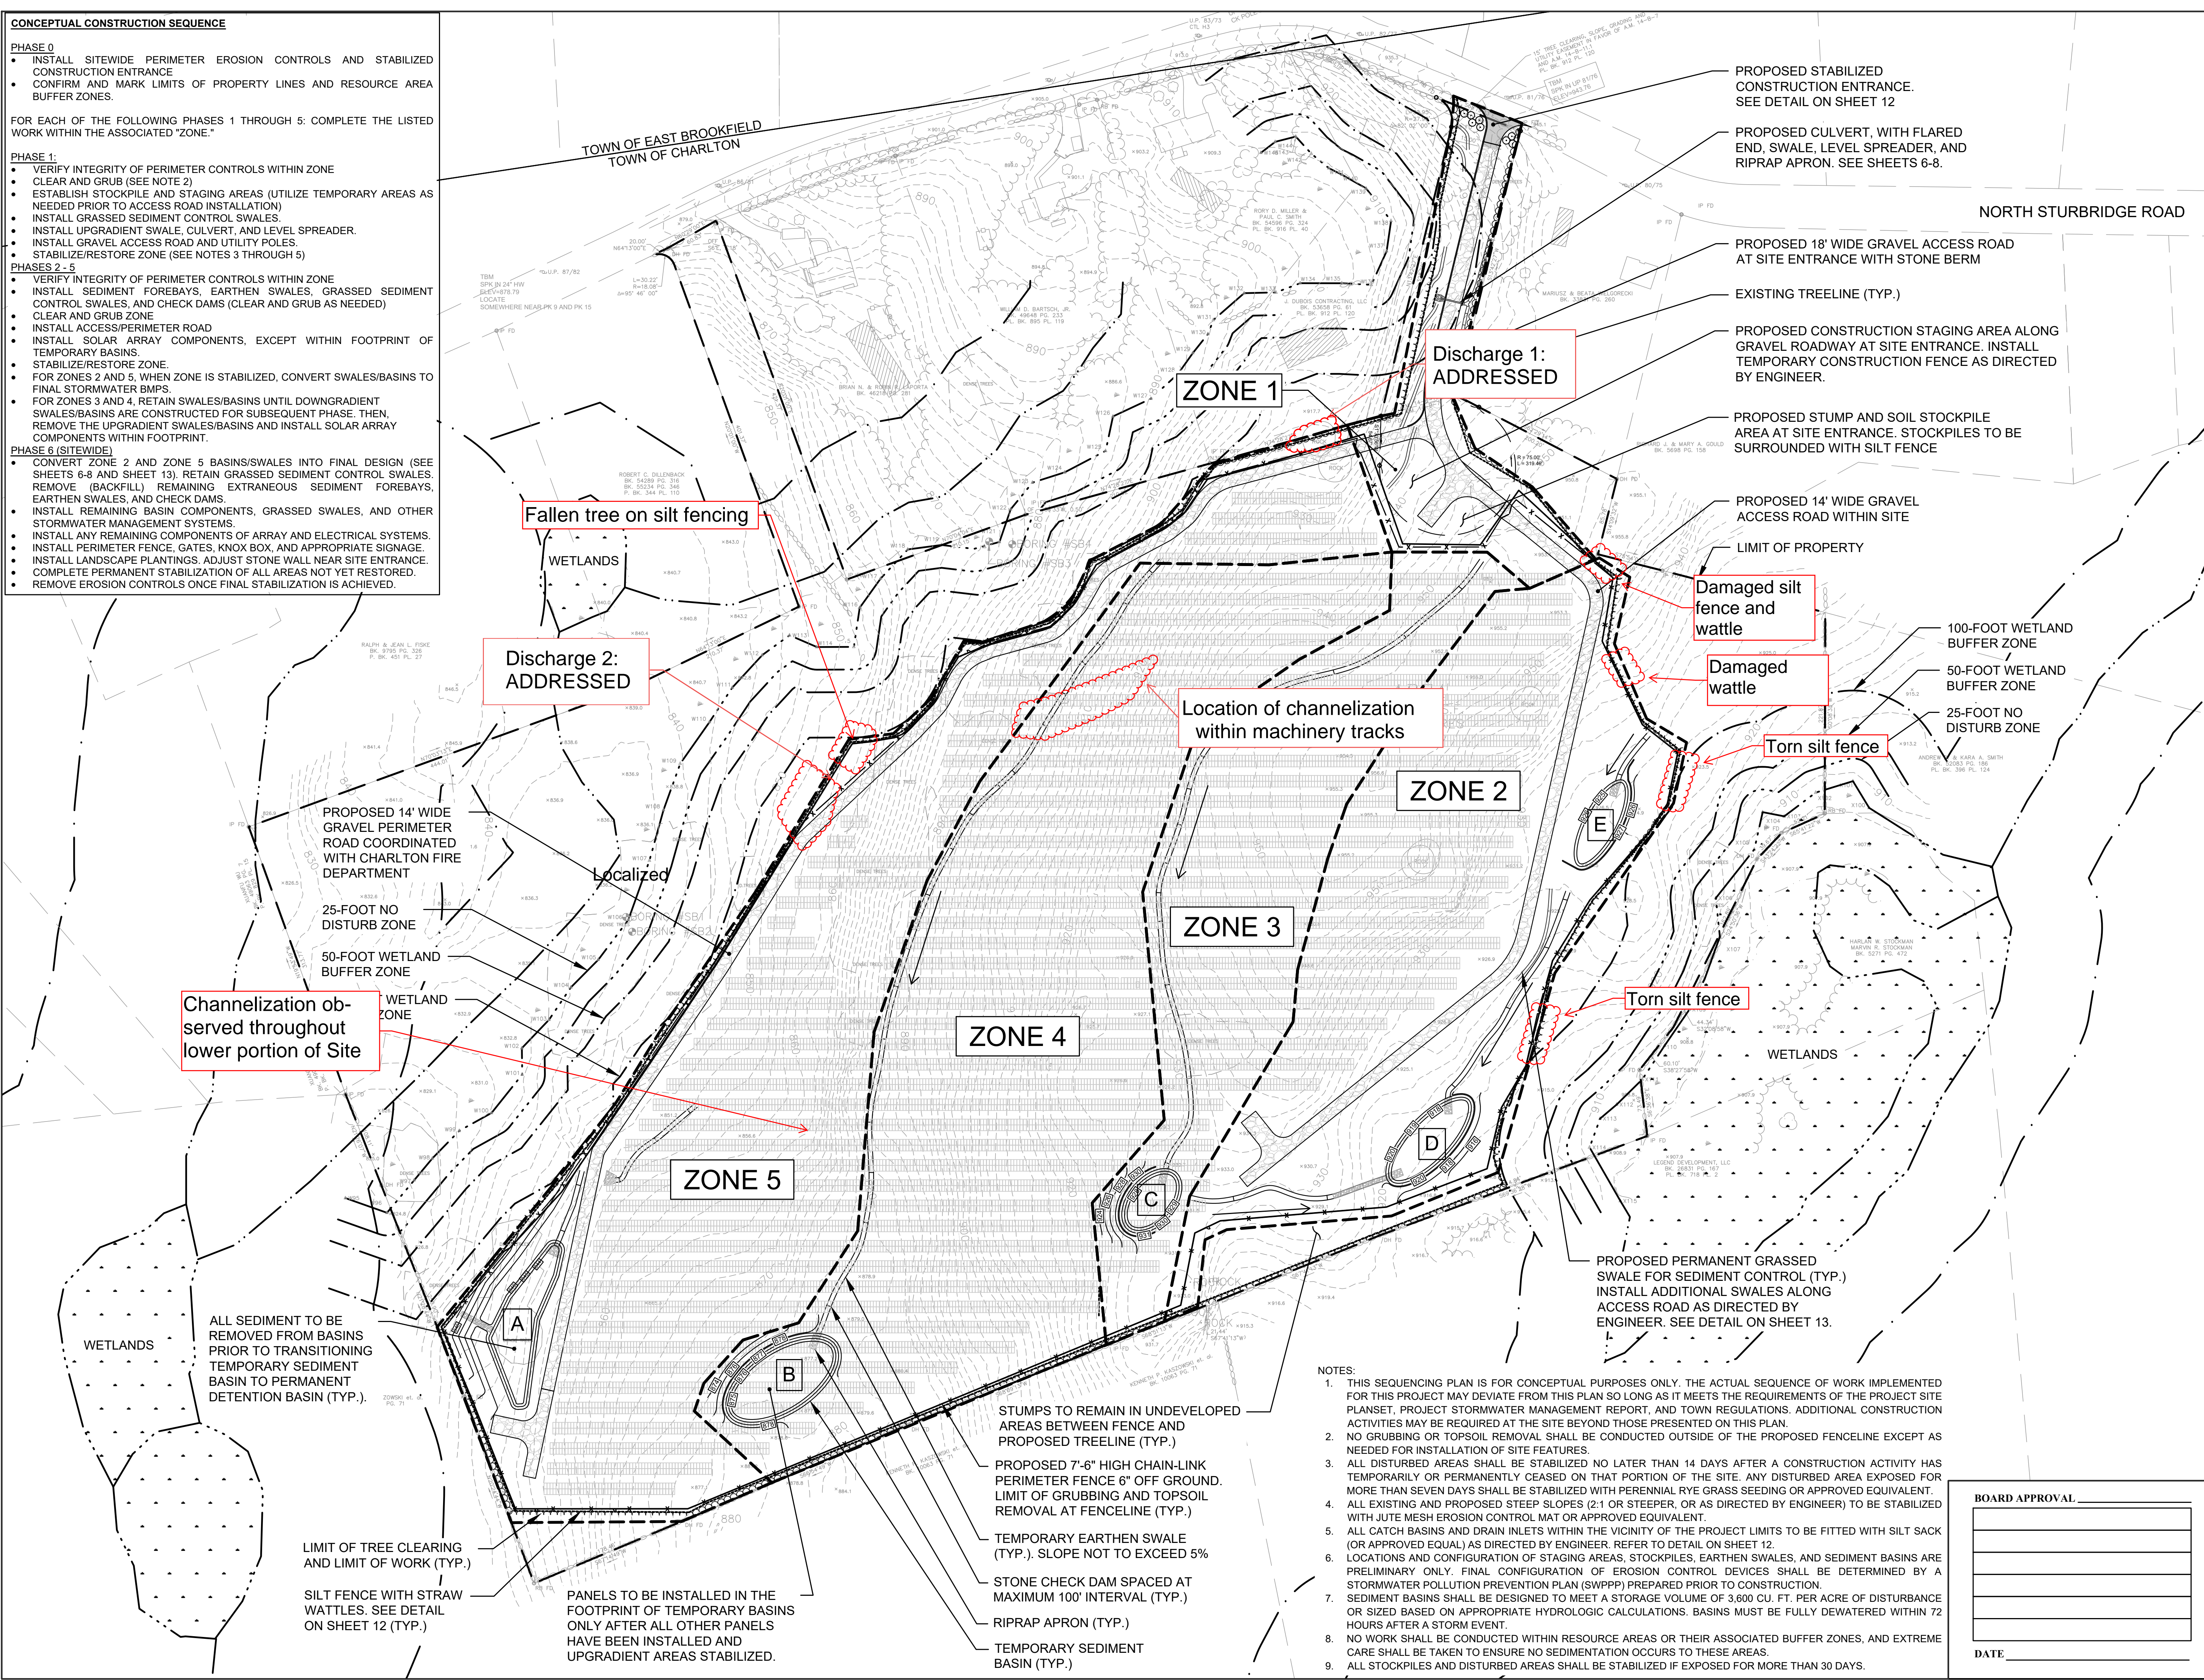
2. Informal access road along northern portion of the Site	Straw mulch or hydroseed	<input type="checkbox"/> Yes <input checked="" type="checkbox"/> No	Erosion channels are beginning to form within upgradient portions of the informal access road (Figure 1). The contractor indicated that stabilization by smoothing out soils and seeding or spreading mulch would occur on 7/30/2021. Stabilization of this area has not been initiated. After inspection of the area on 8/24/2021, it was determined that

Damaged silt fence and wattle

Damaged wattle

Torn silt fence

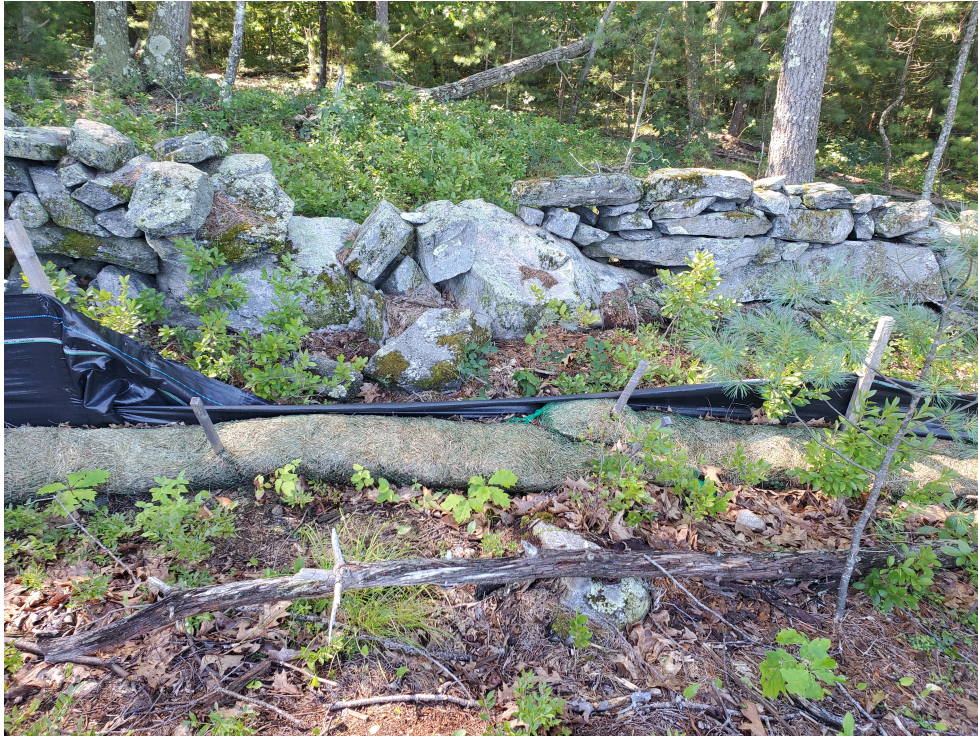
Photo 1

View of damaged silt fence in northeastern portion of the Site — facing east

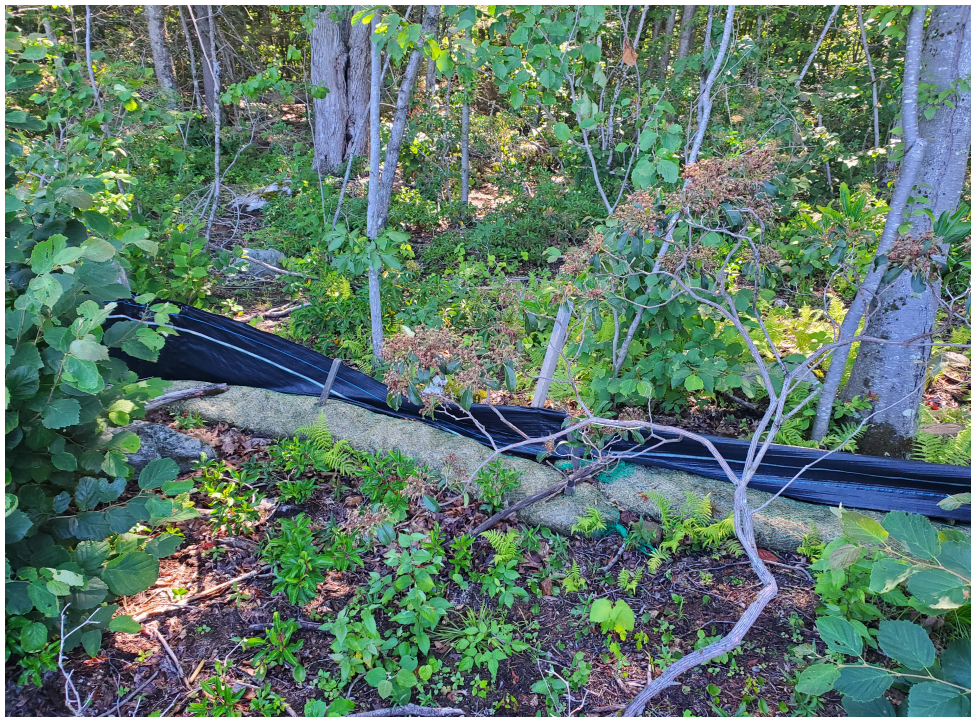
Photo 2

View of damaged silt fence in southeast portion of the Site — facing northeast

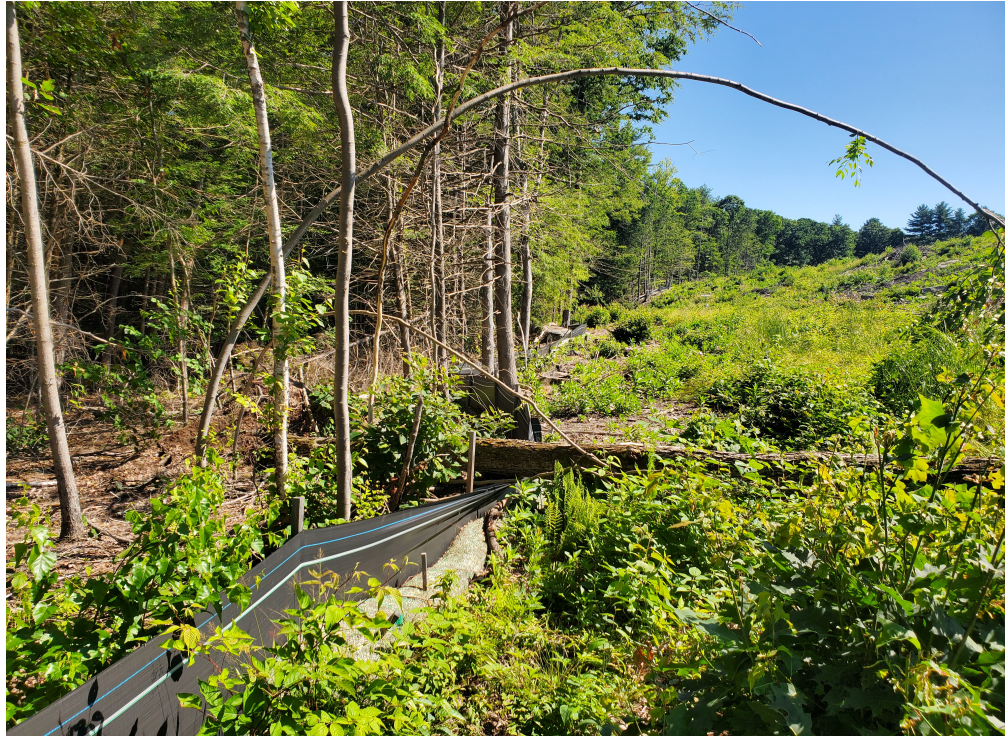
Photo 3

Type/Location of E&S Control	Maintenance Needed?*	Corrective Action Required?*	Date on Which Maintenance or Corrective Action First Identified?	Notes
1. Silt Fence and Straw Wattles	Yes	No	3/15/2022	On 7/13/2022 BETA observed fallen tree damage to the silt fence on the western perimeter of the Site, damage was first observed on 6/20/2022 On 7/13/2022 BETA observed damage to the wattles in the north-east and eastern corners of the Site, damage was first observed on 3/15/2022. BETA also observed the silt fence to be partly torn in the southeastern corner of the Site, damage was first observed on 3/27/2022. General maintenance is needed for the entire silt fence. No evidence of discharge was observed.

View of fallen tree damage to silt fence in southwestern portion of the Site — facing north

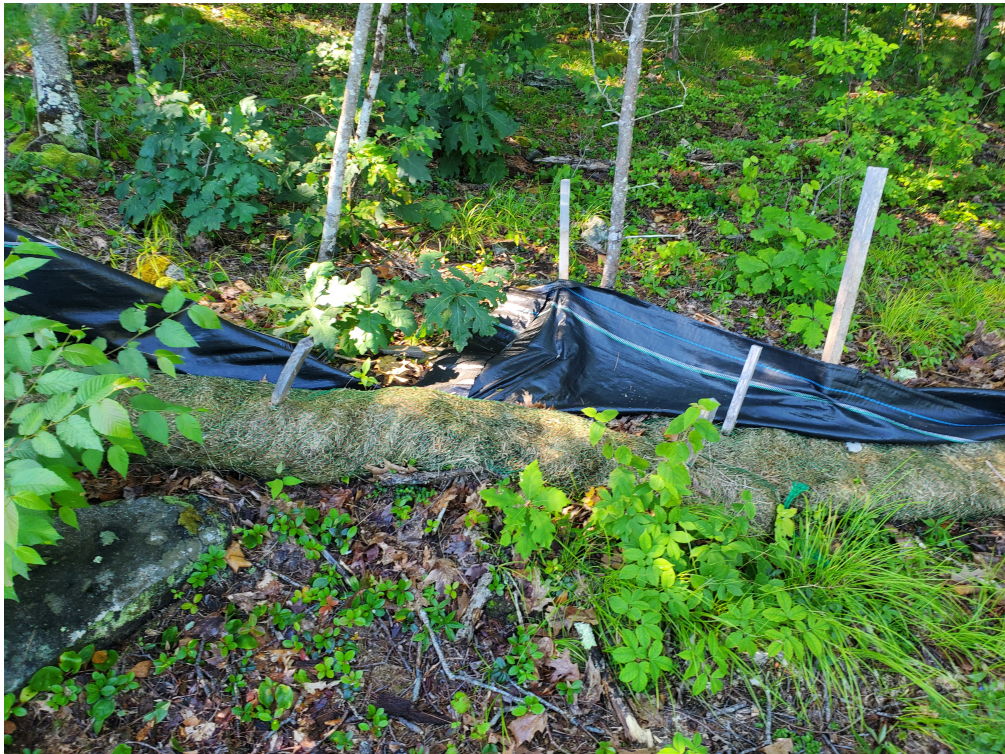
Photo 4

View of damaged silt fence in southeastern portion of the Site — facing northeast
