Inspection Report for North Sturbridge Road Solar Facility

NPDES ID No.: MAR10031G

Inspection Date: 7/14/2022

**FIGURE 1:
SWPPP
INSPECTION
SKETCH
7/14/2022**

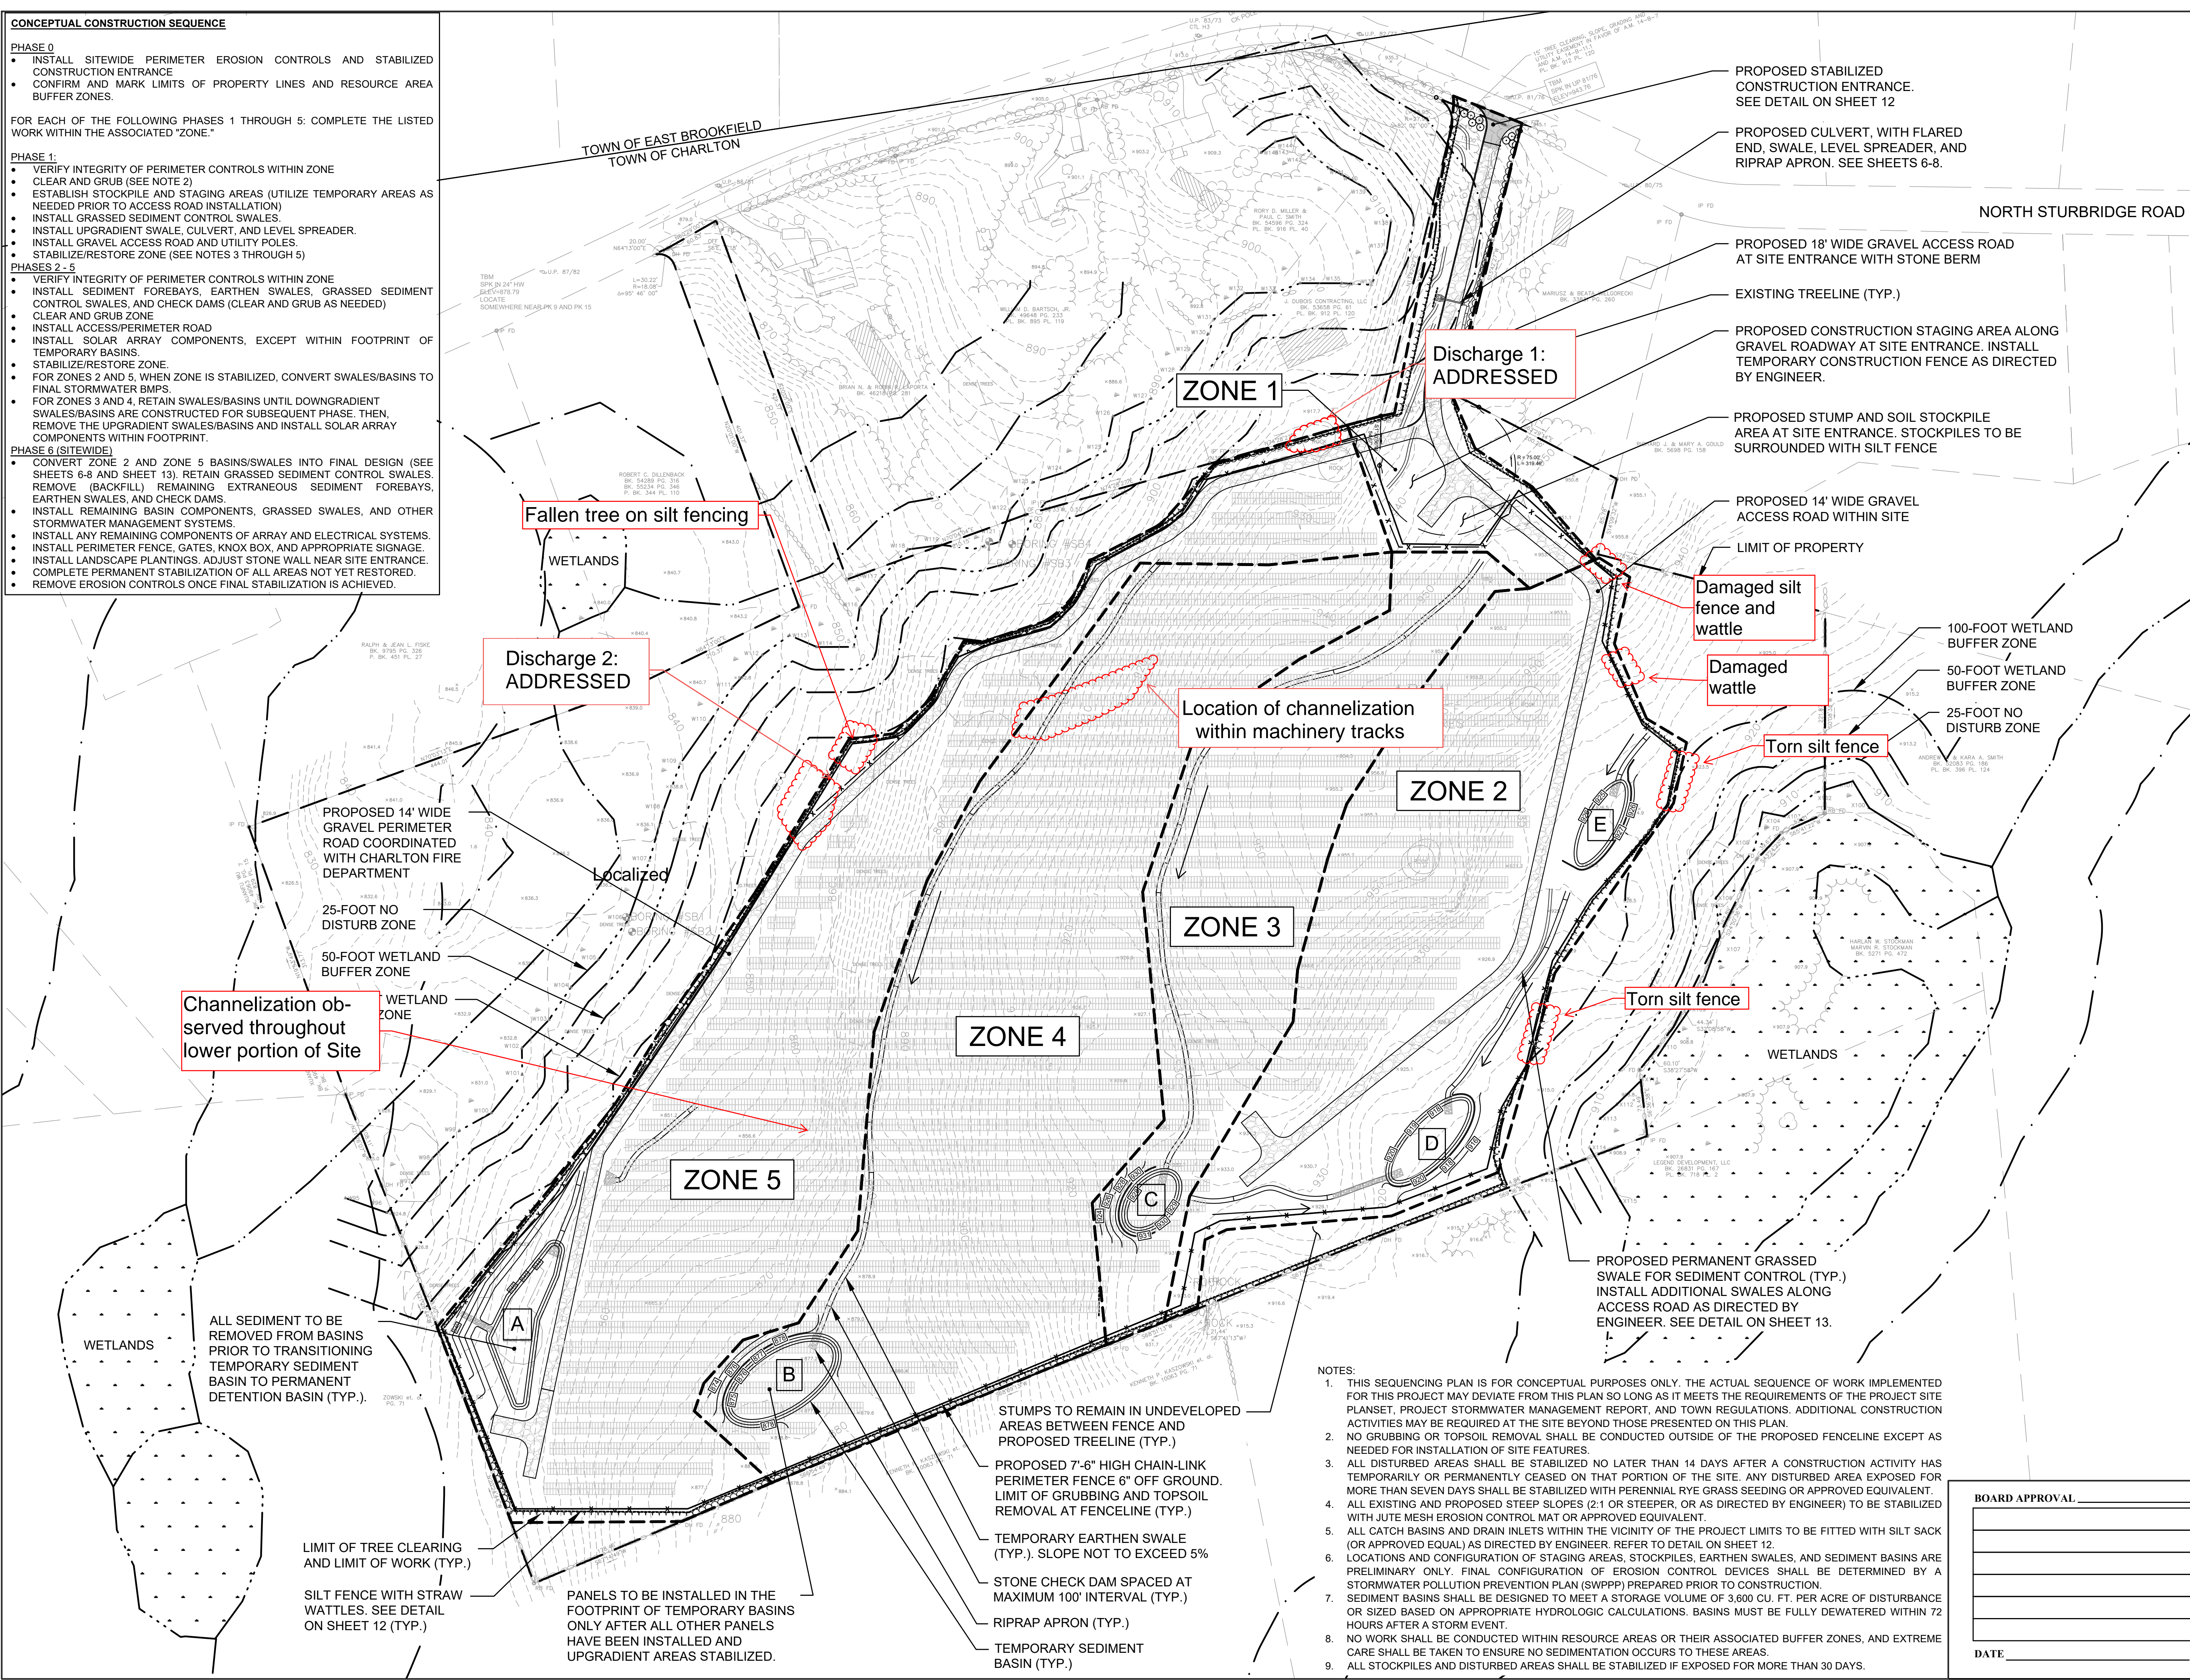
| Stabilization of Exposed Soil (CGP Part 2.2.14) | | | |
|--|---|---|--|
| 2. Informal access road along northern portion of the Site | Straw mulch or hydroseed | <input type="checkbox"/> Yes <input checked="" type="checkbox"/> No | Erosion channels are beginning to form within upgradient portions of the informal access road (Figure 1). The contractor indicated that stabilization by smoothing out soils and seeding or spreading mulch would occur on 7/30/2021. Stabilization of this area has not been initiated. After inspection of the area on 8/24/2021, it was determined that |

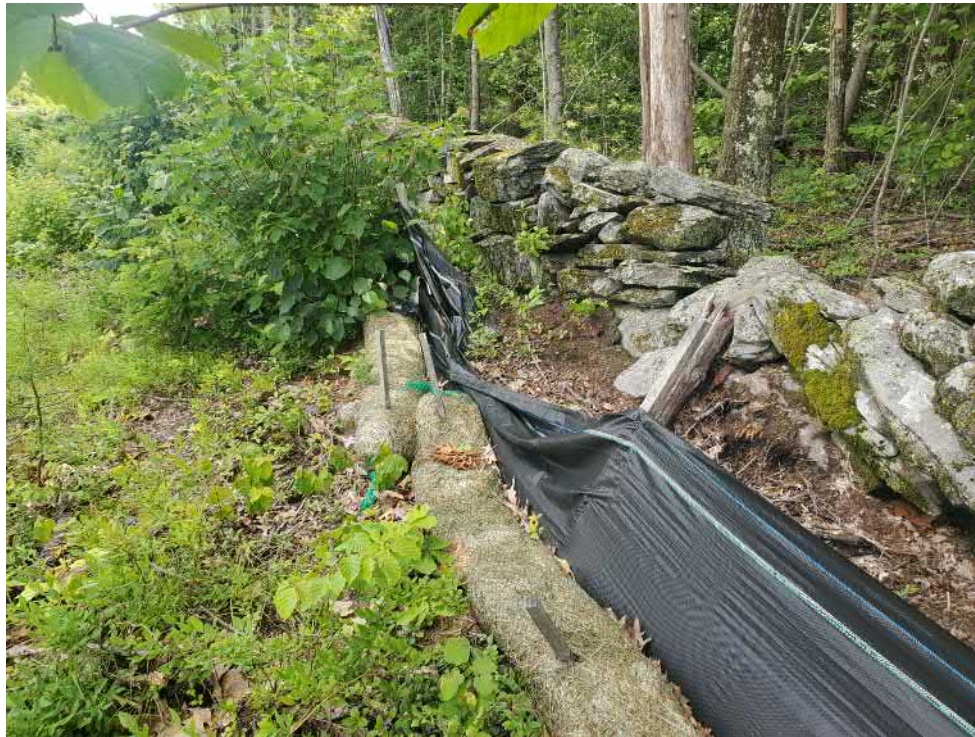
Photo 1

| Type/Location of E&S Control | Maintenance Needed?* | Corrective Action Required?* | Date on Which Maintenance or Corrective Action First Identified? | Notes |
|---|---|---|--|---|
| 1. Silt Fence and Straw Wattles | Yes | No | 3/15/2022 | On 7/13/2022 BETA observed fallen tree damage to the silt fence on the western perimeter of the Site, damage was first observed on 6/20/2022 On 7/13/2022 BETA observed damage to the wattles in the north-east and eastern corners of the Site, damage was first observed on 3/15/2022. BETA also observed the silt fence to be partly torn in the southeastern corner of the Site, damage was first observed on 3/27/2022. General maintenance is needed for the entire silt fence. No evidence of discharge was observed. |

View of damaged silt fence in northeastern portion of the Site — facing east

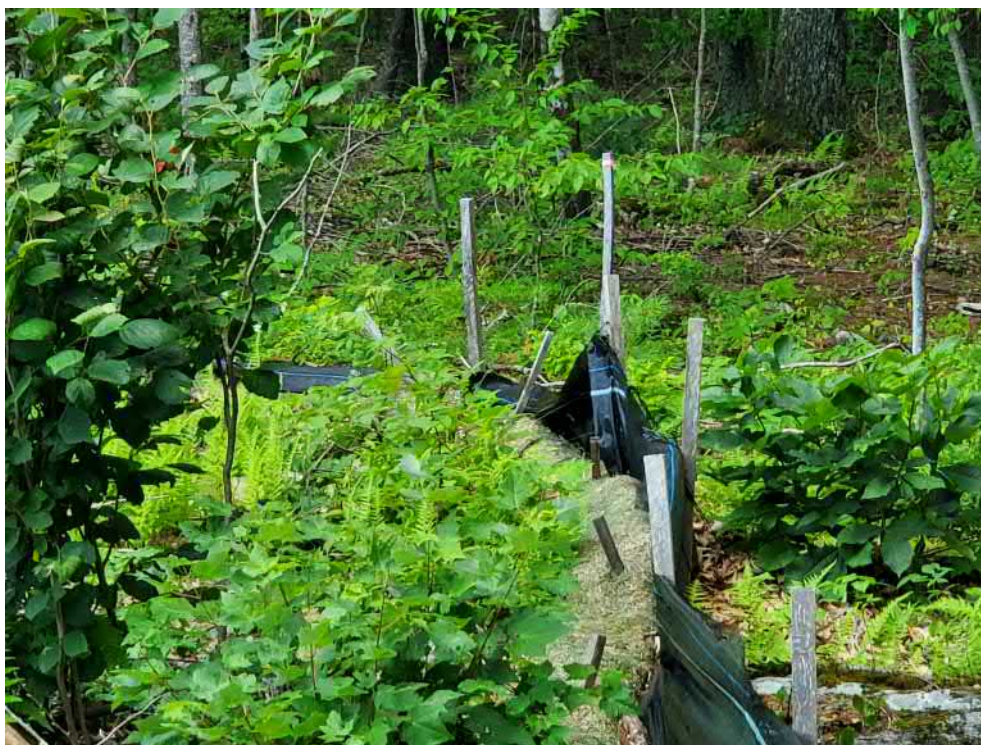
Photo 2

View of damaged silt fence in northeast portion of the Site — facing northeast

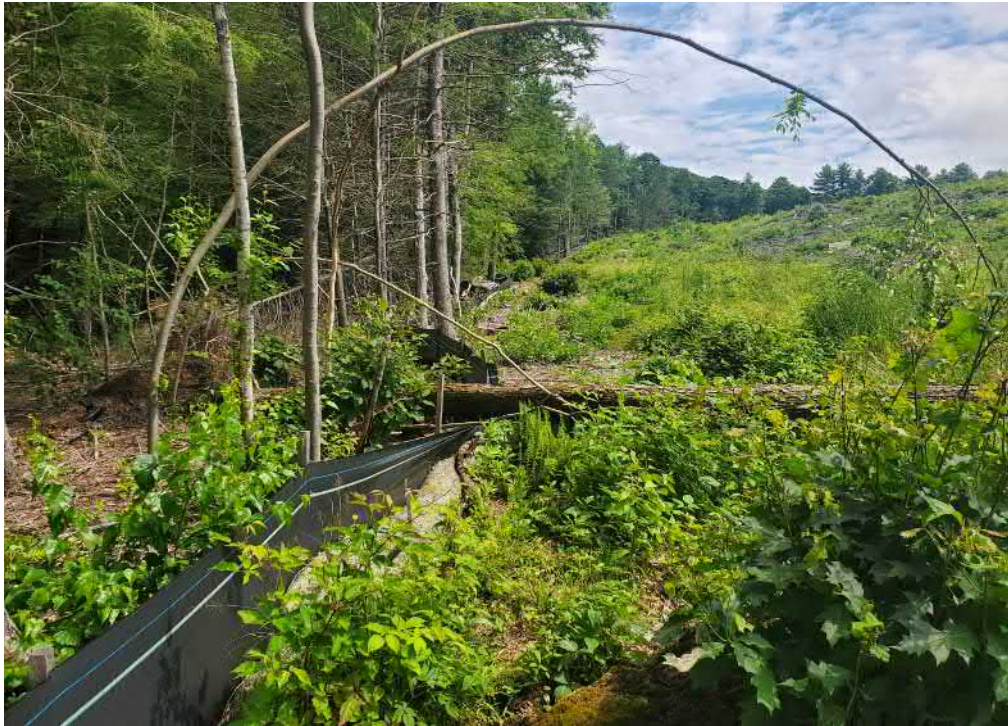
Photo 3

View of fallen tree damage to silt fence in southwestern portion of the Site — facing north

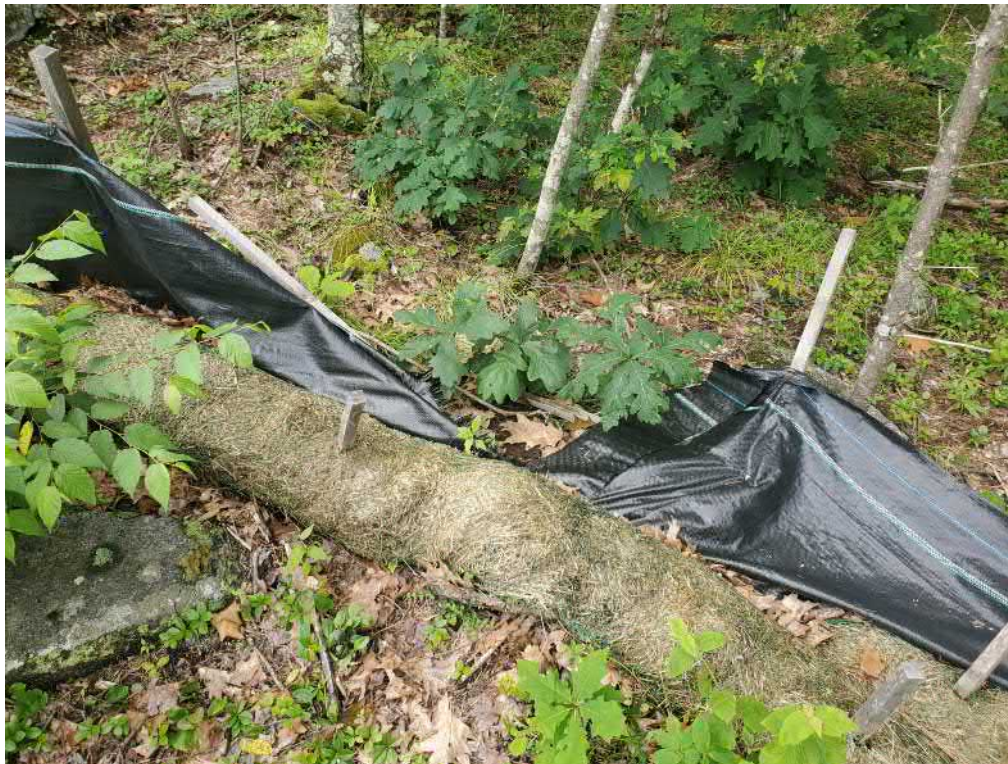
Photo 4

View of damaged silt fence in southeastern portion of the Site — facing northeast
