Inspection Report for North Sturbridge Road Solar Facility NPDES ID No.: MAR10031G

Inspection Date: 7/19/2022

PHOTOGRAPHIC DOCUMENTATION North Sturbridge Road Solar Facility Charlton, Massachusetts Photographs Documented 7.19.2022

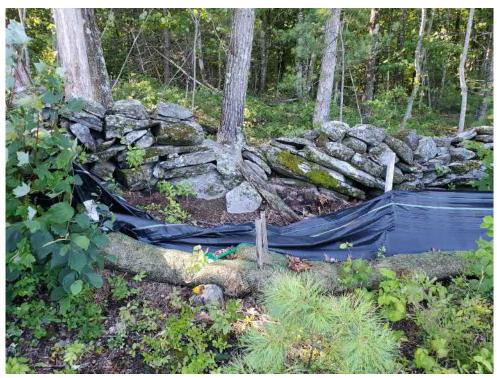
Photo 1

View of damaged silt fence in northeastern portion of the Site — facing east

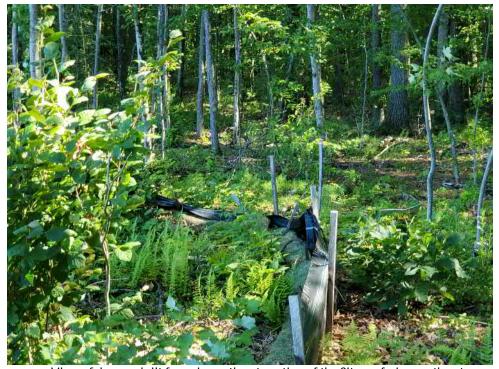
Photo 2

View of damaged silt fence in northeast portion of the Site — facing northeast

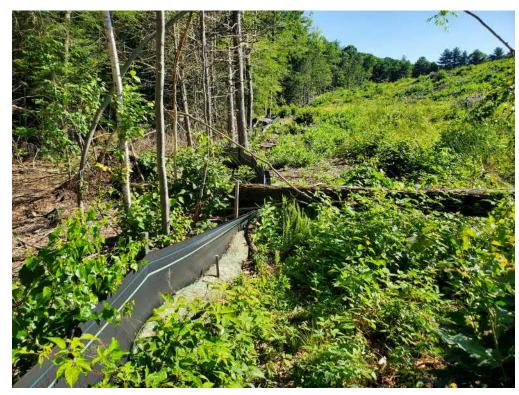
Photo 3

Condition and Effectiveness of Erosion and Sediment (E&S) Controls (CGP Part 2.2)						
Type/Location of E&S Control	Maintenance Needed?*	Corrective Action Required?*	Date on Which Maintenance or Corrective Action First Identified?	Notes		
Silt Fence and Straw Wattles	Yes	No	3/15/2022	On 7/19/2022 BETA observed fallen tree damage to the silt fence on the western perimeter of the Site, damage was first observed on 6/20/2022 On 7/19/2022 BETA observed damage to the wattles in the north-		
				east and eastern corners of the Site, damage was first observed on 3/15/2022. BETA also observed the silt fence to be partly torn in the southeastern corner of the Site, damage was first observed on 3/27/2022. General maintenance is needed for the entire silt fence. No evidence of discharge was observed.		
Stabilized Construction Entrance (Site Entrance – Access Road)	No	No

View of fallen tree damage to silt fence in southwestern portion of the Site — facing north

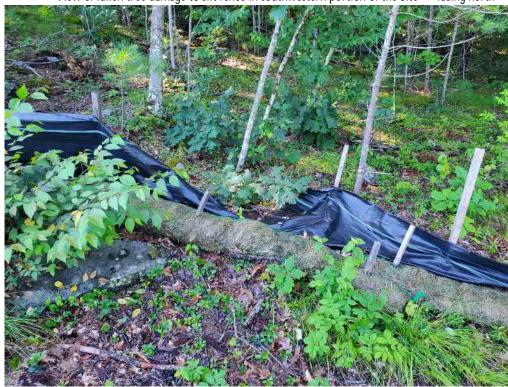
Photo 4

View of damaged silt fence in southeastern portion of the Site — facing northeast
