Inspection Report for North Sturbridge Road Solar Facility NPDES ID No.: MAR10031G

Inspection Date: 7/29/2022

PHOTOGRAPHIC DOCUMENTATION North Sturbridge Road Solar Facility Charlton, Massachusetts Photographs Documented 7.29.2022

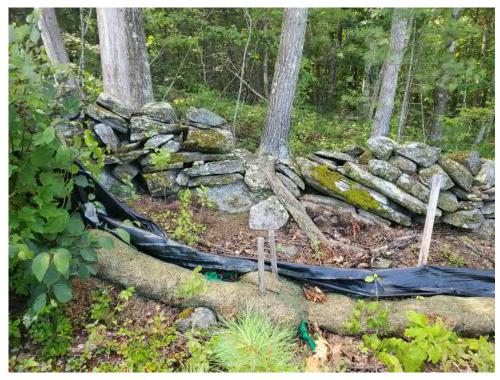
Photo 1

Condition and Effectiveness of Erosion and Sediment (E&S) Controls (CGP Part 2.2)						
Type/Location of E&S Control	Maintenance Needed?*	Corrective Action Required?*	Date on Which Maintenance or Corrective Action First Identified?	Notes			
Silt Fence and Straw Wattles	Yes	No	3/15/2022	On 7/29/2022 BETA observed fallen tree damage to the silt fence on the western perimeter of the Site, damage was first observed on 6/20/2022			
				On 7/29/2022 BETA observed damage to the wattles in the northeast and eastern corners of the Site, damage was first observed on 3/15/2022. BETA also observed the silt fence to be partly torn in the southeastern corner of the Site, damage was first observed on 3/27/2022. General maintenance is needed for the entire silt fence. No evidence of discharge was observed.			
Stabilized Construction Entrance (Site Entrance – Access Road)	No	No

View of damaged silt fence in northeastern portion of the Site — facing east

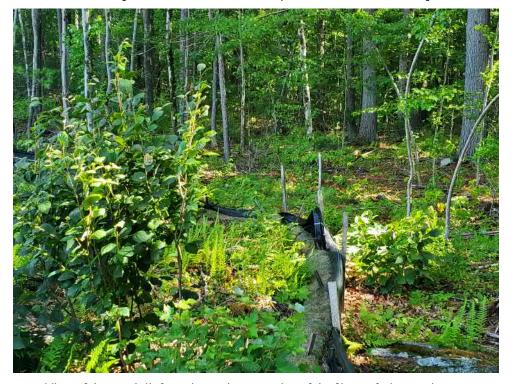
Photo 2

View of damaged silt fence in northeast portion of the Site — facing northeast

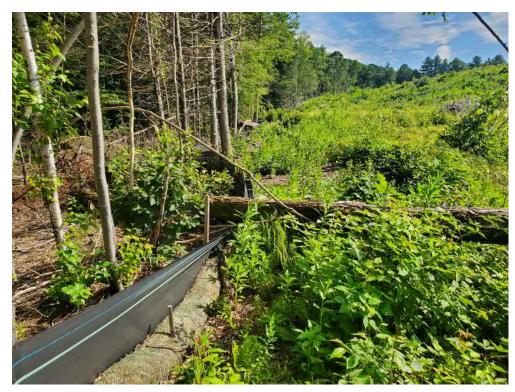
Photo 3

View of fallen tree damage to silt fence in southwestern portion of the Site — facing north

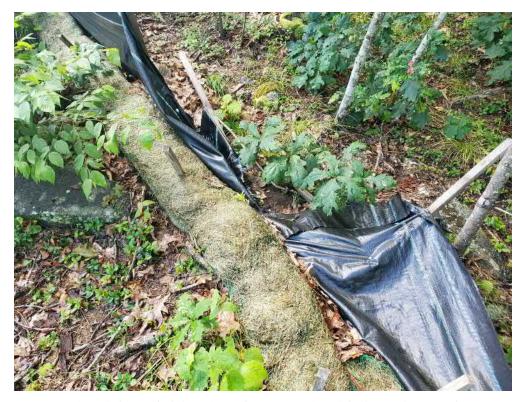
Photo 4

View of damaged silt fence in southeastern portion of the Site — facing northeast
