Inspection Report for North Sturbridge Road Solar Facility

NPDES ID No.: MAR10031G

Inspection Date: 8/19/2022

**FIGURE 1:  
SWPPP  
INSPECTION  
SKETCH  
8/19/2022**

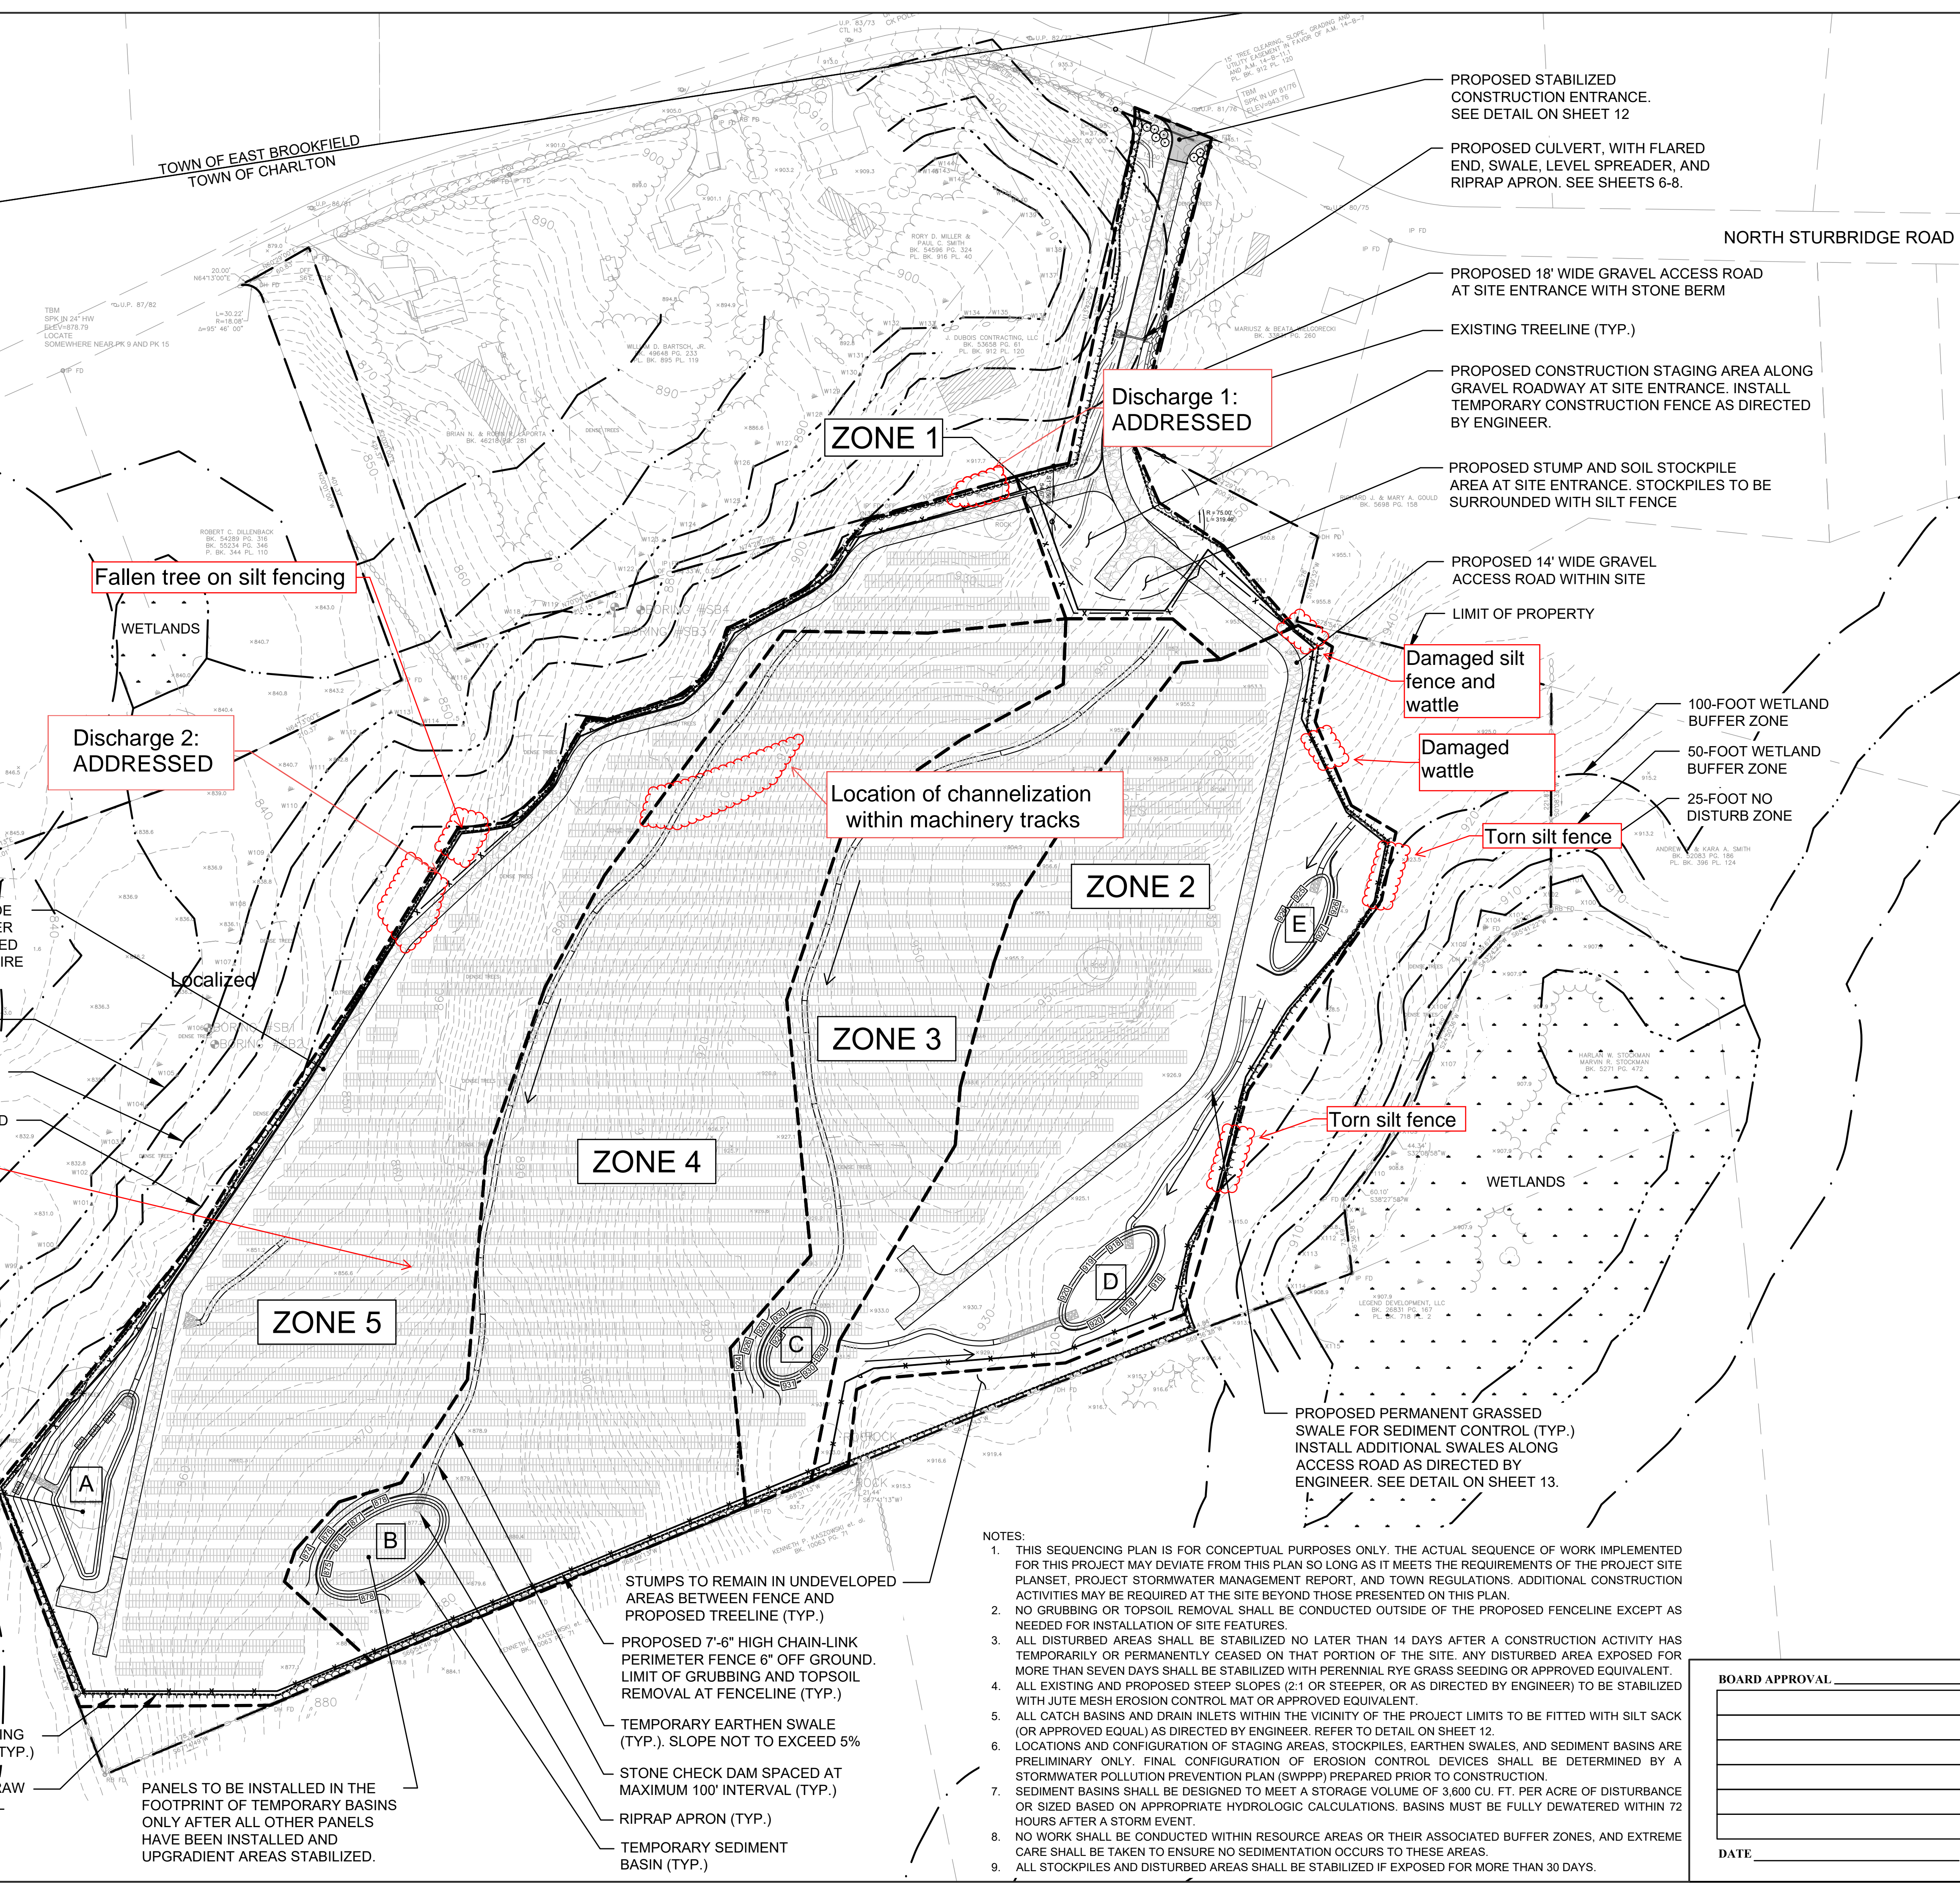
2. Informal access road along northern portion of the Site	Straw mulch or hydroseed	<input type="checkbox"/> Yes <input checked="" type="checkbox"/> No	Erosion channels are beginning to form within upgradient portions of the informal access road (Figure 1). The contractor indicated that stabilization by smoothing out soils and seeding or spreading mulch would occur on 7/30/2021. Stabilization of this area has not been initiated. After inspection of the area on 8/24/2021, it was determined that

Damaged silt fence and wattle

Damaged wattle

Torn silt fence

Fallen tree on silt fencing

Location of channelization within machinery tracks

Channelization observed throughout lower portion of Site

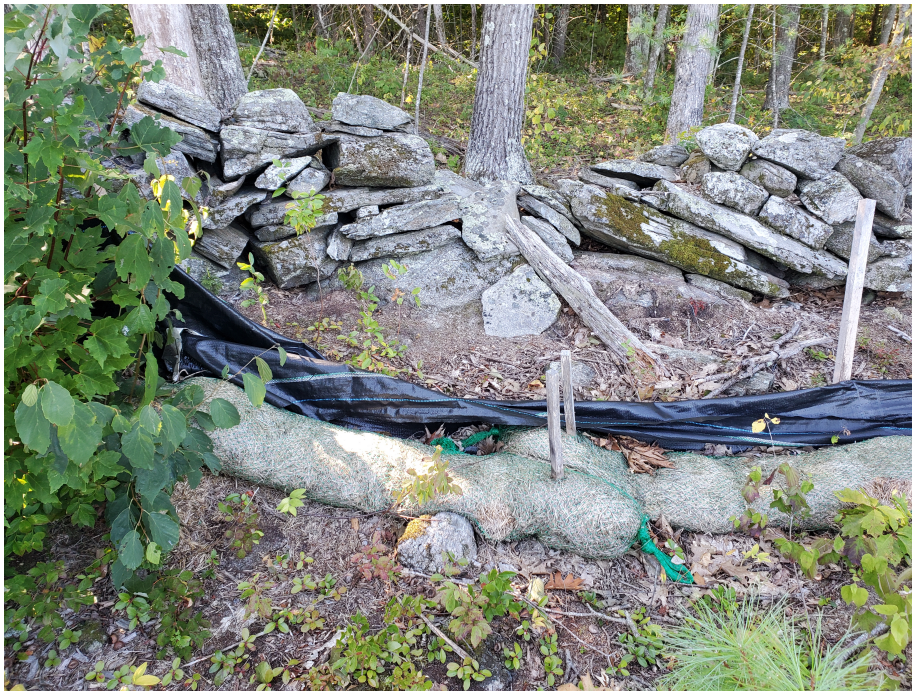
Photo 1

Type/Location of E&S Control	Maintenance Needed?*	Corrective Action Required?*	Date on Which Maintenance or Corrective Action First Identified?	Notes
1. Silt Fence and Straw Wattles	Yes	No	3/15/2022	On 8/19/2022 BETA observed fallen tree damage to the silt fence on the western perimeter of the Site, damage was first observed on 6/20/2022  On 8/19/2022 BETA observed damage to the wattles in the north-east and eastern corners of the Site, damage was first observed on 3/15/2022. BETA also observed the silt fence to be partly torn in the southeastern corner of the Site, damage was first observed on 3/27/2022. General maintenance is needed for the entire silt fence. No evidence of discharge was observed.

View of damaged silt fence in northeastern portion of the Site — facing east

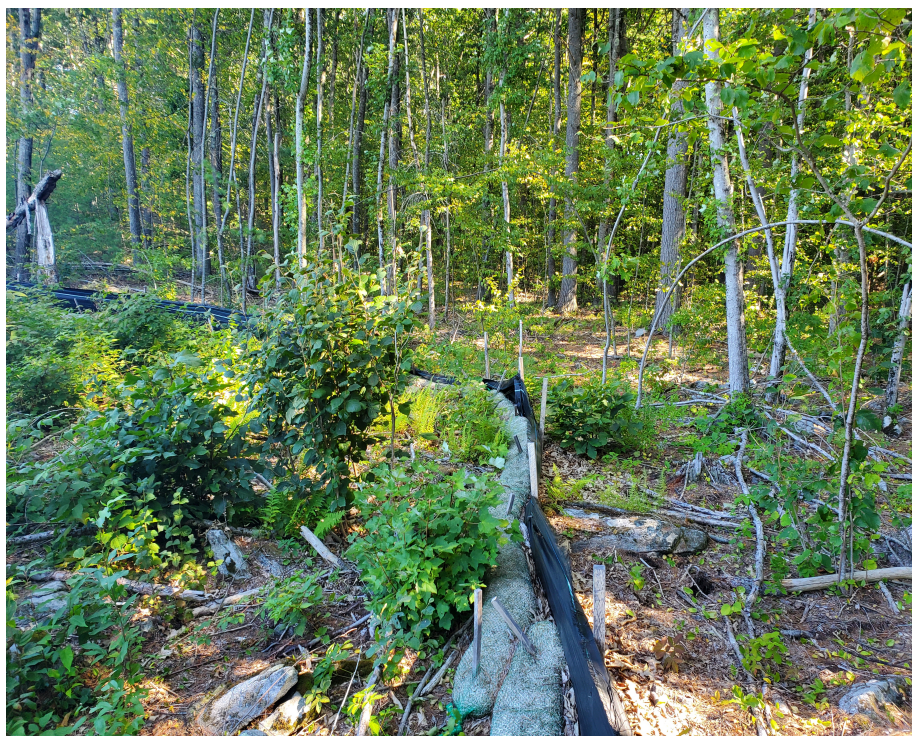
Photo 2

View of damaged silt fence in northeast portion of the Site — facing northeast

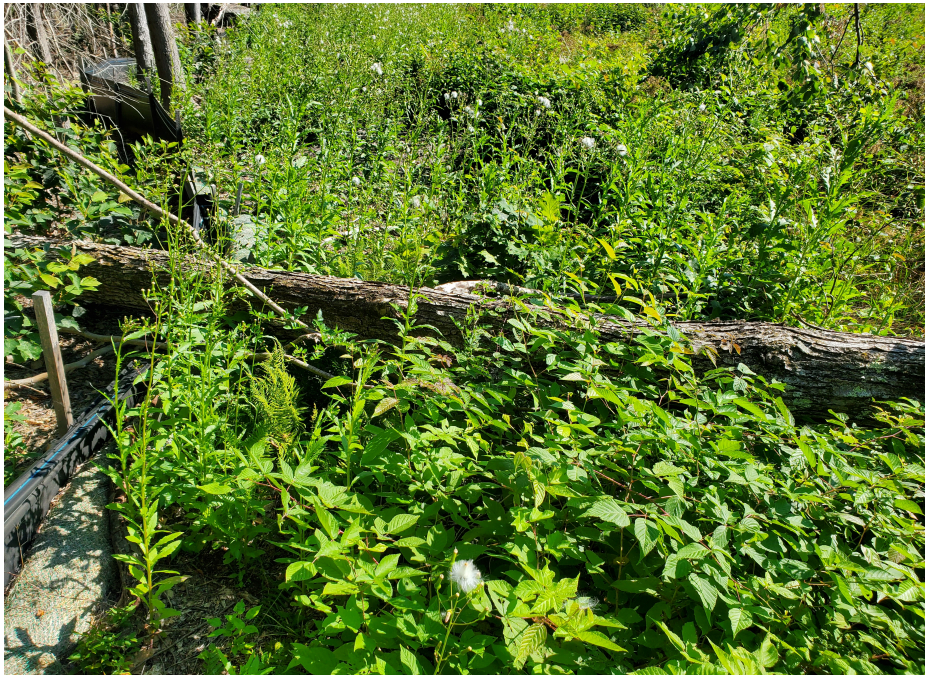
Photo 3

View of fallen tree damage to silt fence in southwestern portion of the Site — facing north

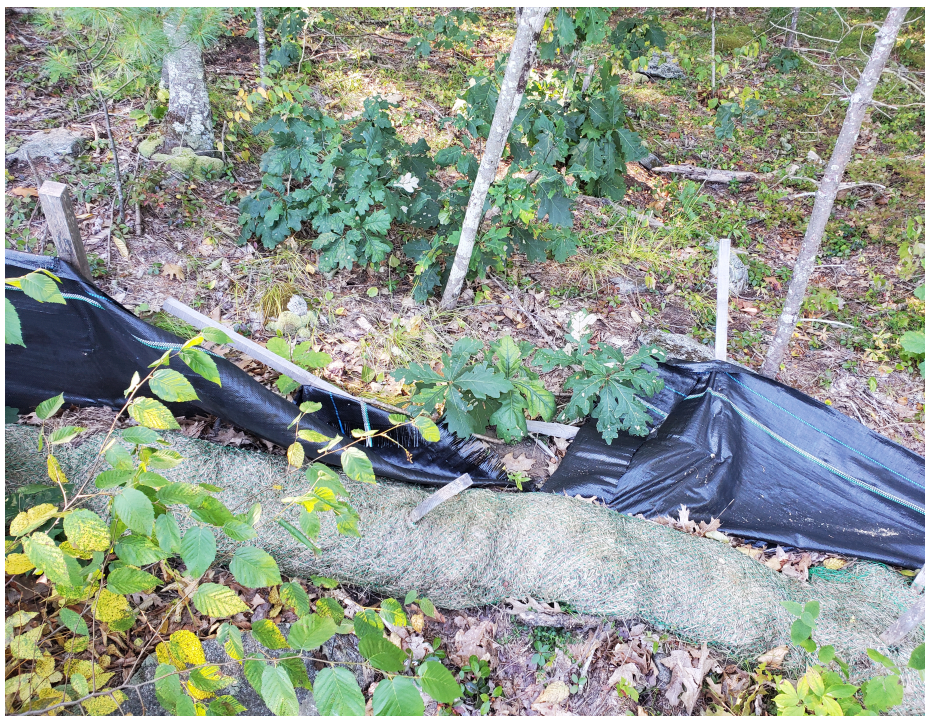
Photo 4

View of damaged silt fence in southeastern portion of the Site — facing northeast
