Inspection Report for North Sturbridge Road Solar Facility

NPDES ID No.: MAR10031G

Inspection Date: 8/19/2022

FIGURE 1:
SWPPP
INSPECTION
SKETCH
8/19/2022

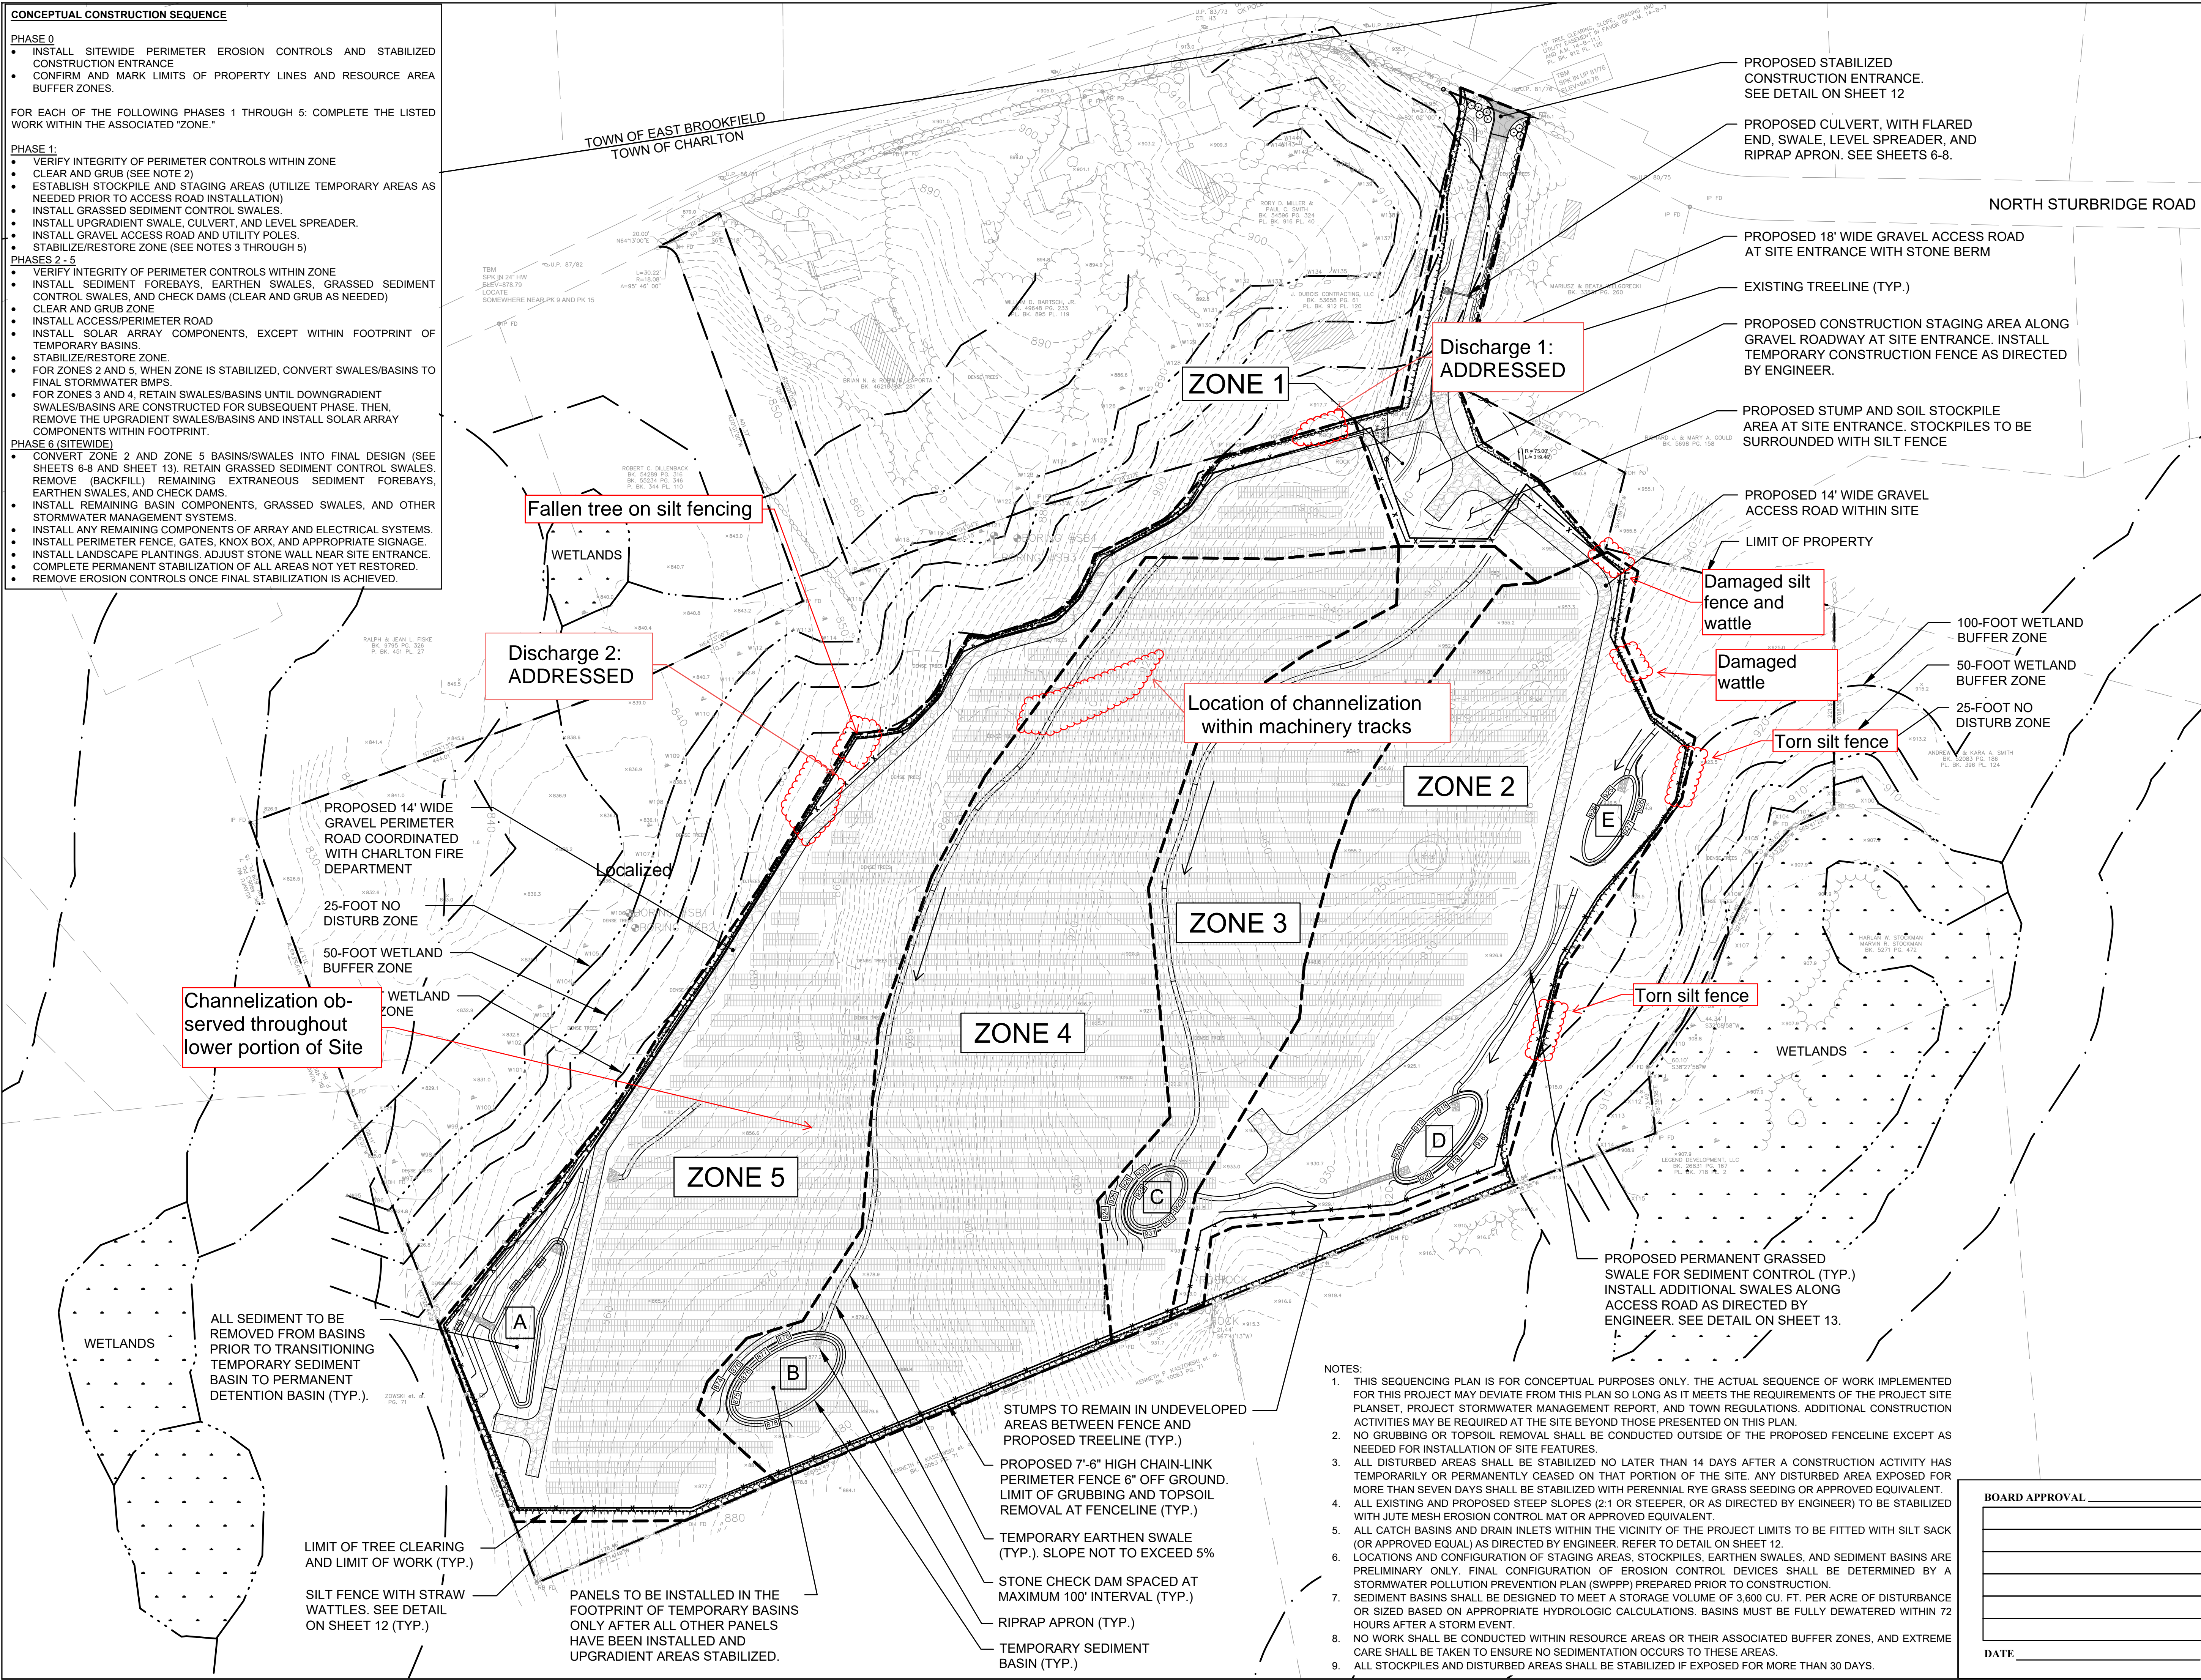
2. Informal access road along northern portion of the Site	Straw mulch or hydroseed	<input type="checkbox"/> Yes <input checked="" type="checkbox"/> No	Erosion channels are beginning to form within upgradient portions of the informal access road (Figure 1). The contractor indicated that stabilization by smoothing out soils and seeding or spreading mulch would occur on 7/30/2021. Stabilization of this area has not been initiated. After inspection of the area on 8/24/2021, it was determined that

Damaged silt fence and wattle
Damaged wattle

Torn silt fence

Fallen tree on silt fencing

Location of channelization within machinery tracks

Channelization observed throughout lower portion of Site

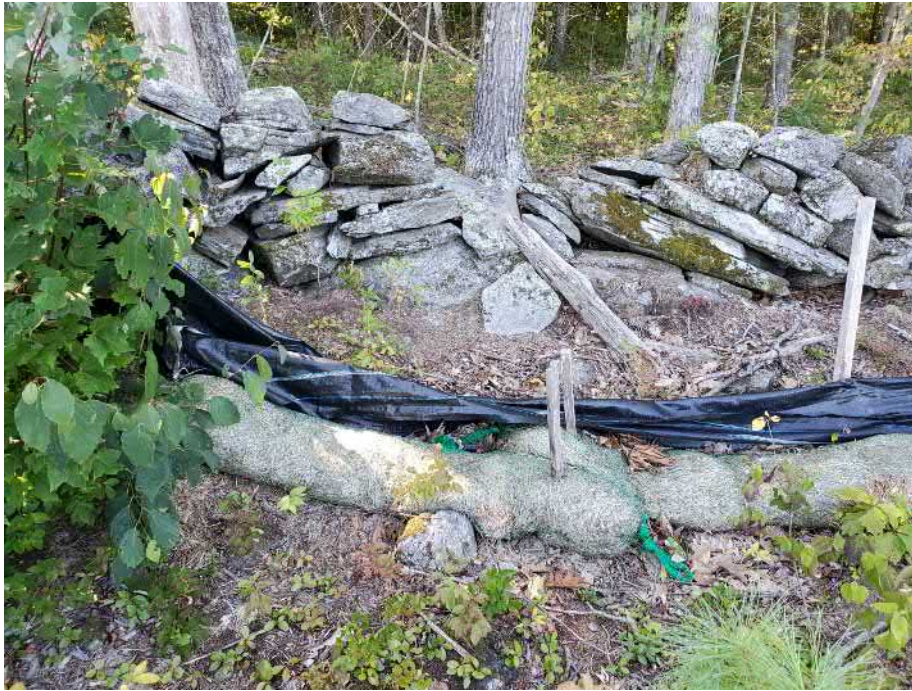
Photo 1

View of damaged silt fence in northeastern portion of the Site — facing east

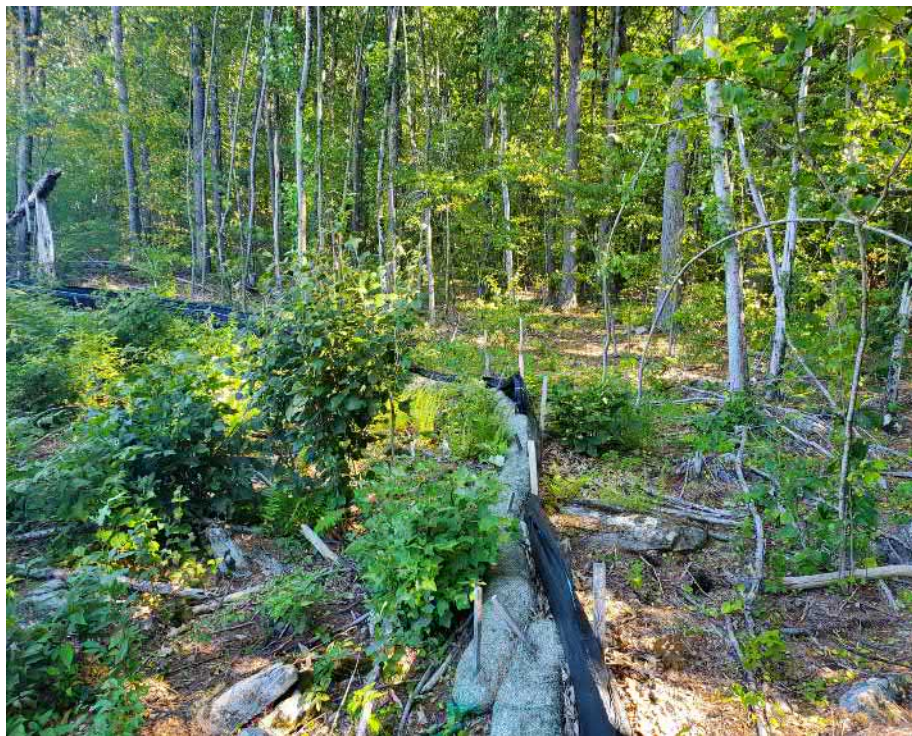
Photo 2

View of damaged silt fence in northeast portion of the Site — facing northeast

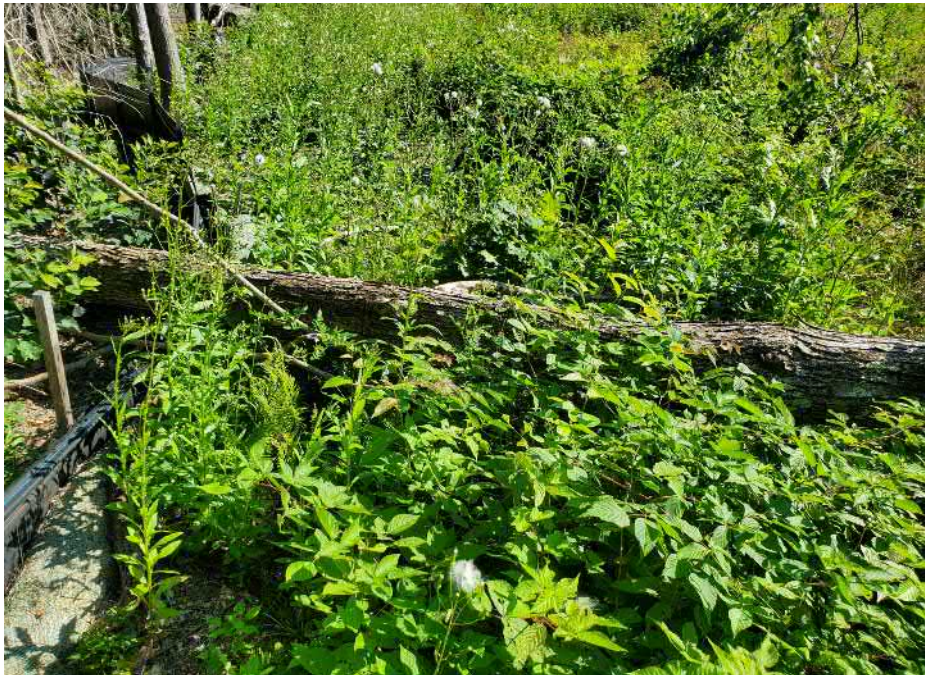
Photo 3

Type/Location of E&S Control	Maintenance Needed?*	Corrective Action Required?*	Date on Which Maintenance or Corrective Action First Identified?	Notes
1. Silt Fence and Straw Wattles	Yes	No	3/15/2022	On 8/19/2022 BETA observed fallen tree damage to the silt fence on the western perimeter of the Site, damage was first observed on 6/20/2022 On 8/19/2022 BETA observed damage to the wattles in the north-east and eastern corners of the Site, damage was first observed on 3/15/2022. BETA also observed the silt fence to be partly torn in the southeastern corner of the Site, damage was first observed on 3/27/2022. General maintenance is needed for the entire silt fence. No evidence of discharge was observed.

View of fallen tree damage to silt fence in southwestern portion of the Site — facing north

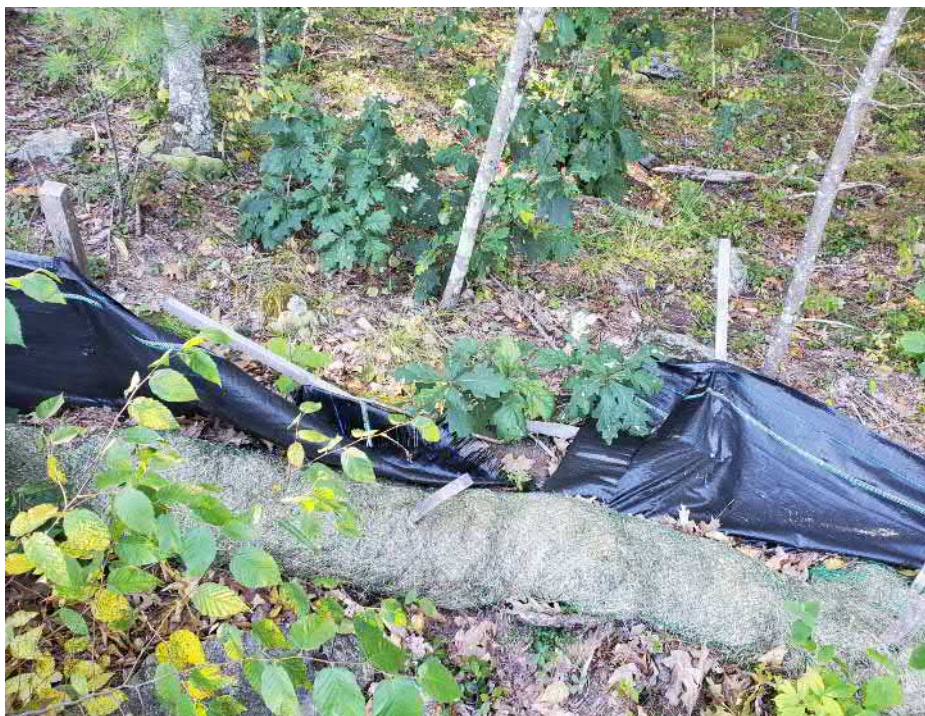
Photo 4

View of damaged silt fence in southeastern portion of the Site — facing northeast
