#### Inspection Report for North Sturbridge Road Solar Facility NPDES ID No.: MAR10031G Inspection Date: 8/23/2022

PHOTOGRAPHIC DOCUMENTATION North Sturbridge Road Solar Facility Charlton, Massachusetts Photographs Documented 8.23.2022

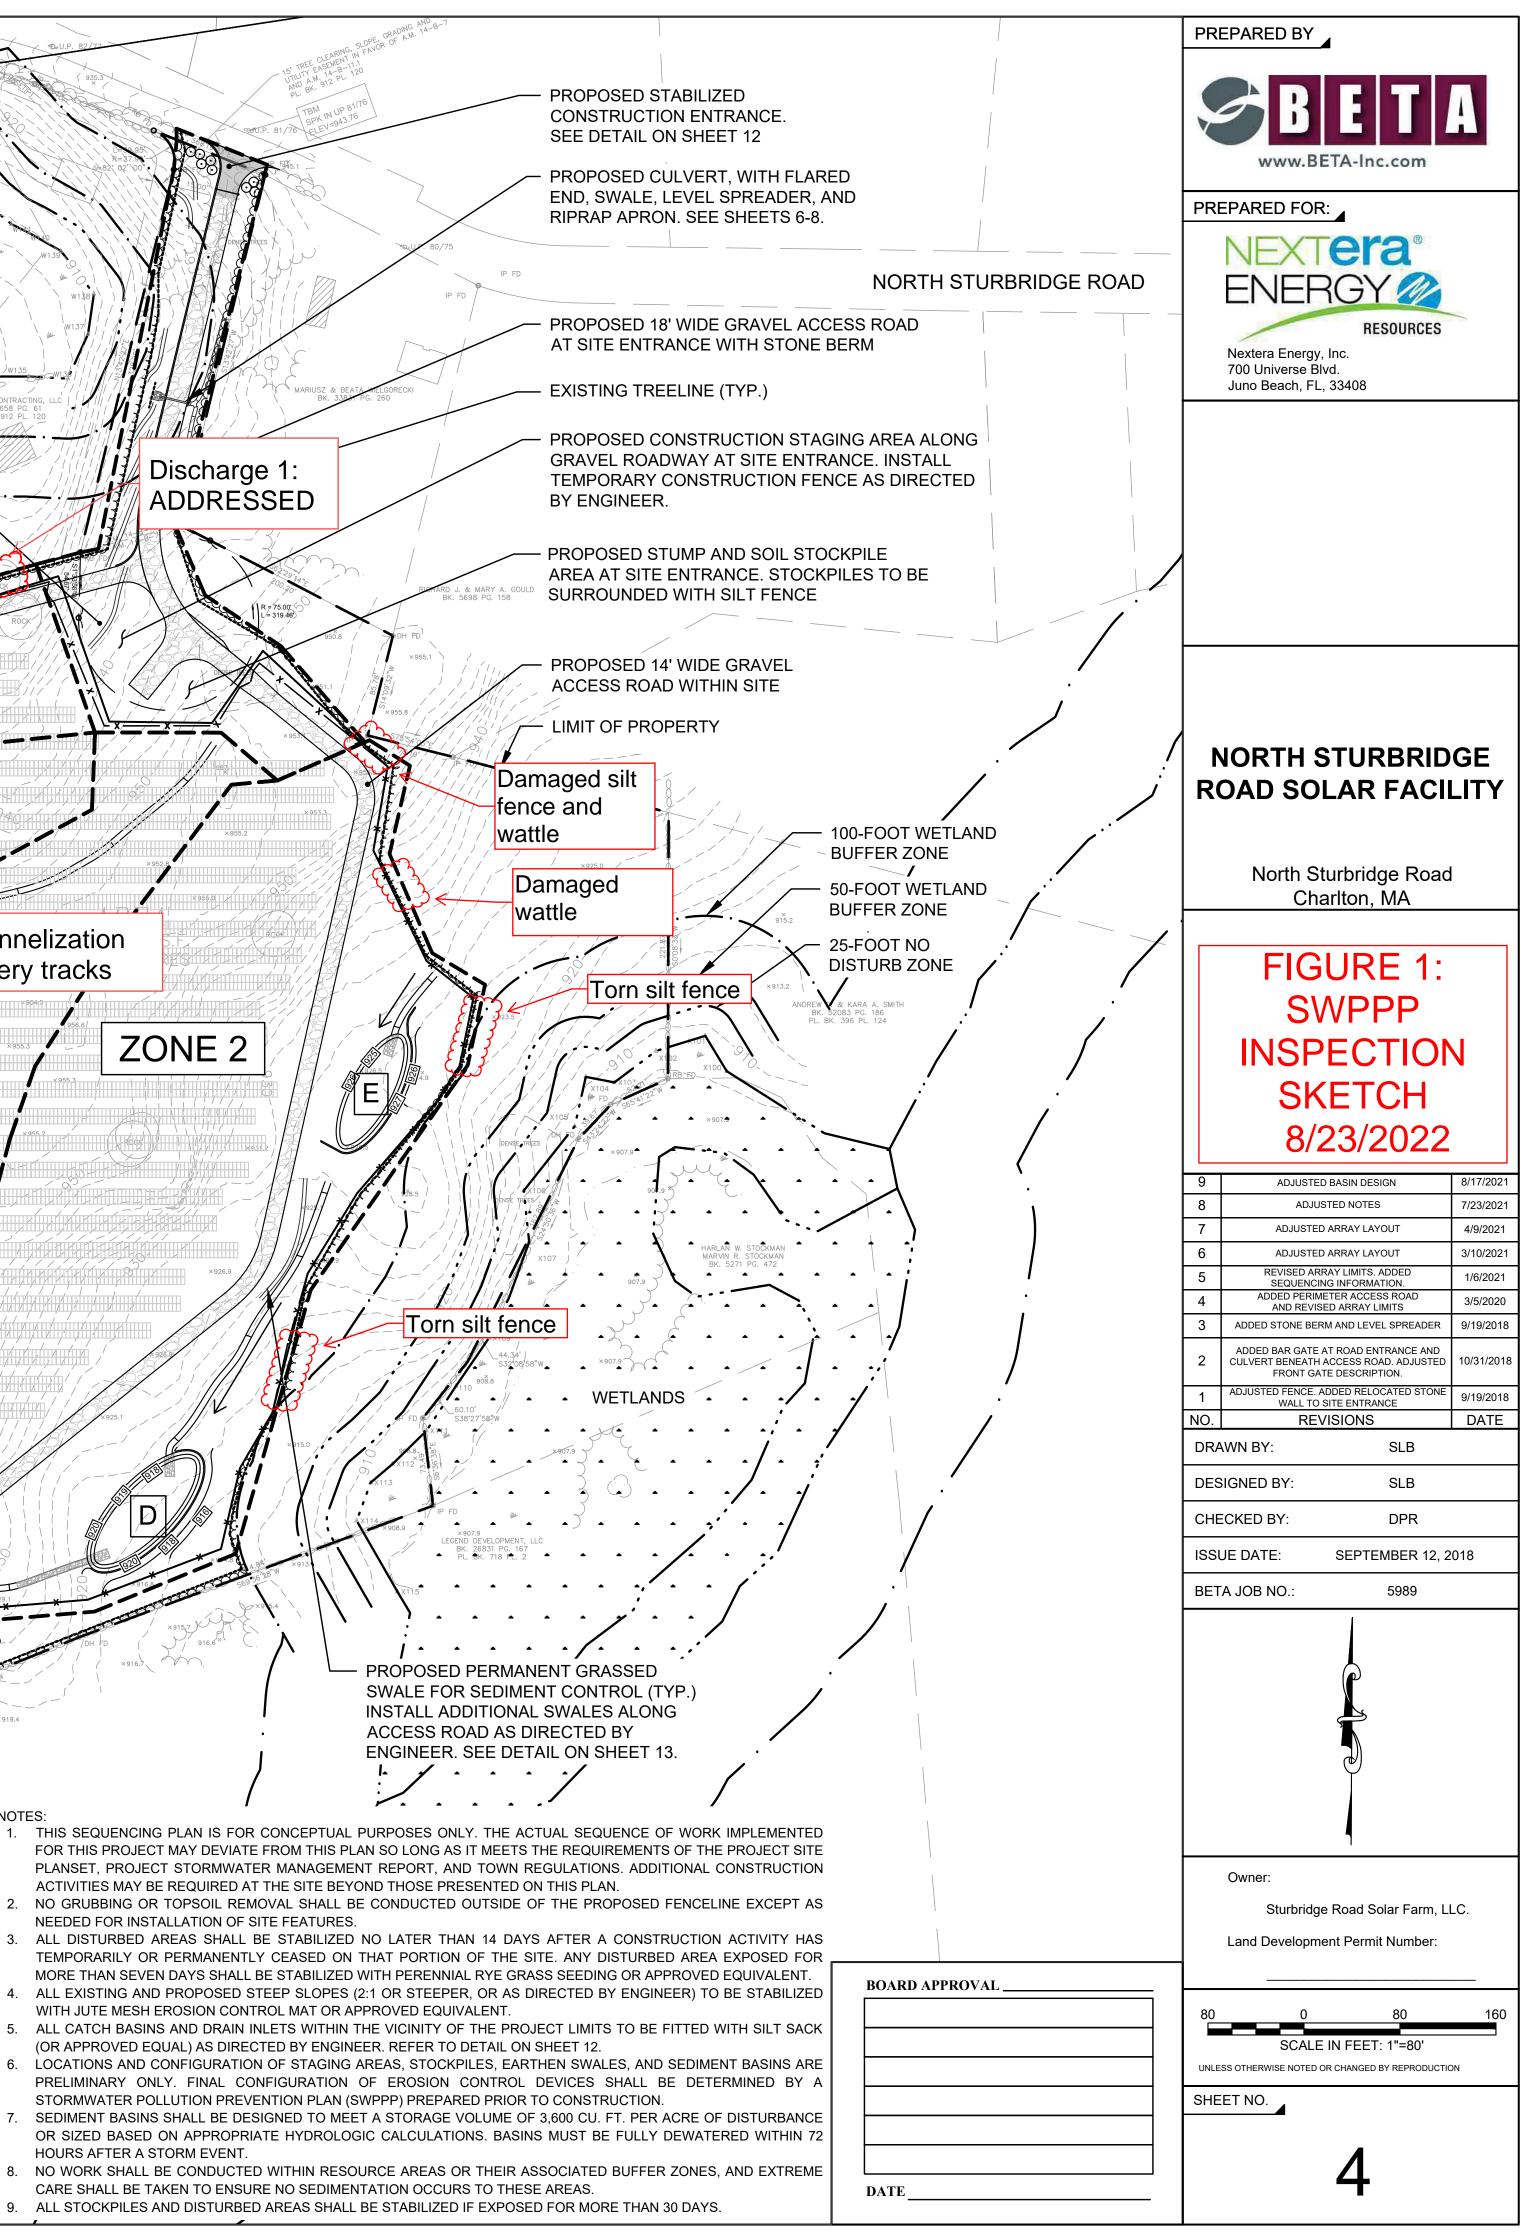
# Location of channelization within machinery tracks

Torn silt fence

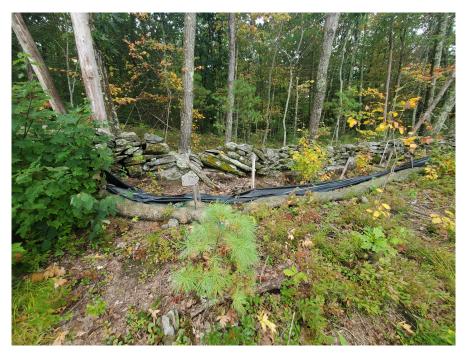
### Photo 1

View of damaged silt fence in northeastern portion of the Site — facing east

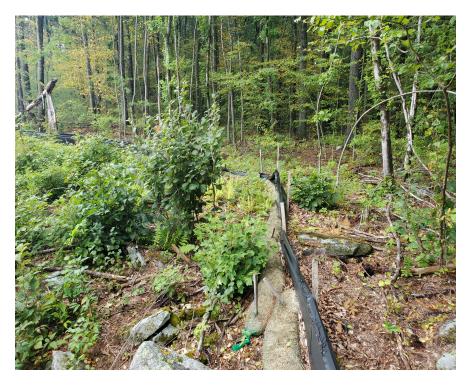
Photo 2

View of damaged silt fence in northeast portion of the Site — facing northeast

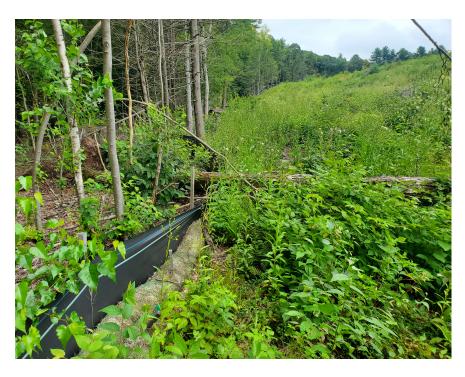
### Photo 3

1. Silt Fence and Straw Wattles	Yes	No	3/15/2022	On 8/23/2022 BETA observed fallen tree damage to the silt fence on the western perimeter of the Site, damage was first observed on 6/20/2022 On 8/23/2022 BETA observed damage to the wattles in the north- east and eastern corners of the Site, damage was first ob- served on 3/15/2022. BETA also observed the silt fence to be partly torn in the southeastern corner of the Site, damage was first observed on 3/27/2022. General maintenance is needed for the entire silt fence. No evidence of discharge was observed.

View of fallen tree damage to silt fence in southwestern portion of the Site — facing north

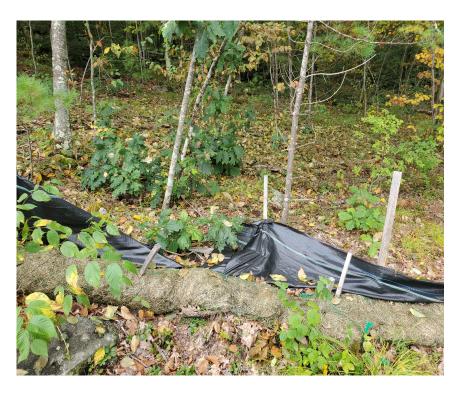
Photo 4

View of damaged silt fence in southeastern portion of the Site — facing northeast
