Inspection Report for North Sturbridge Road Solar Facility

NPDES ID No.: MAR10031G

Inspection Date: 8/23/2022

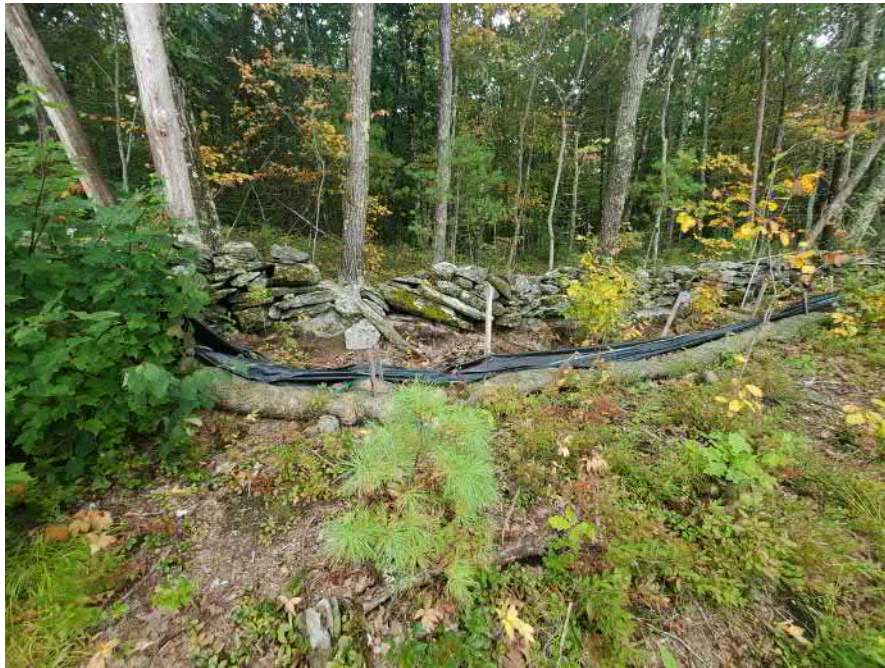
Photo 1

Type/Location of E&S Control	Maintenance Needed?*	Corrective Action Required?*	Date on Which Maintenance or Corrective Action First Identified?	Notes
1. Silt Fence and Straw Wattles	Yes	No	3/15/2022	On 8/23/2022 BETA observed fallen tree damage to the silt fence on the western perimeter of the Site, damage was first observed on 6/20/2022 On 8/23/2022 BETA observed damage to the wattles in the north-east and eastern corners of the Site, damage was first observed on 3/15/2022. BETA also observed the silt fence to be partly torn in the southeastern corner of the Site, damage was first observed on 3/27/2022. General maintenance is needed for the entire silt fence. No evidence of discharge was observed.

View of damaged silt fence in northeastern portion of the Site — facing east

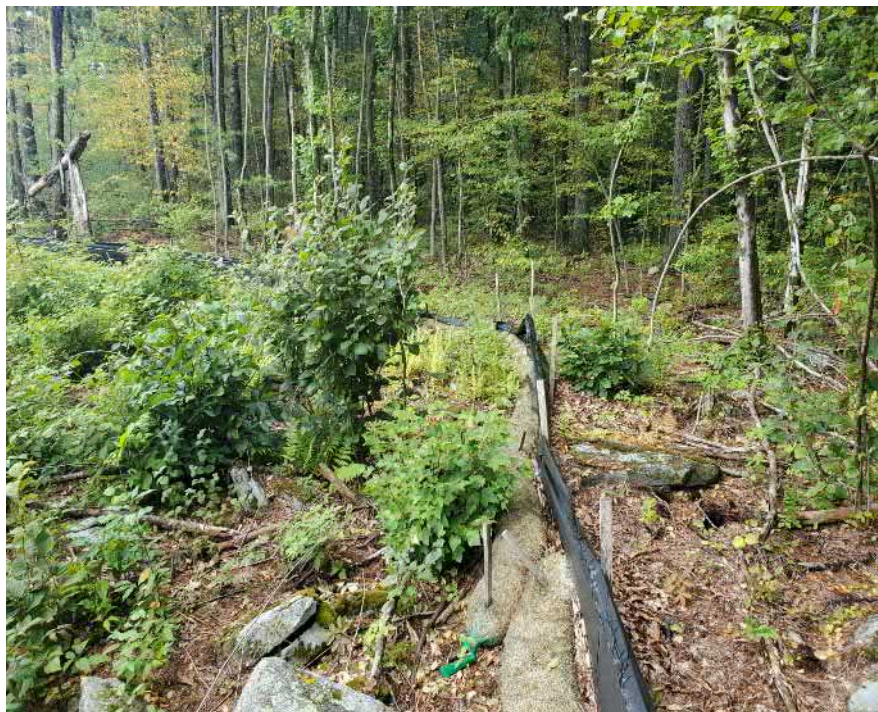
Photo 2

View of damaged silt fence in northeast portion of the Site — facing northeast

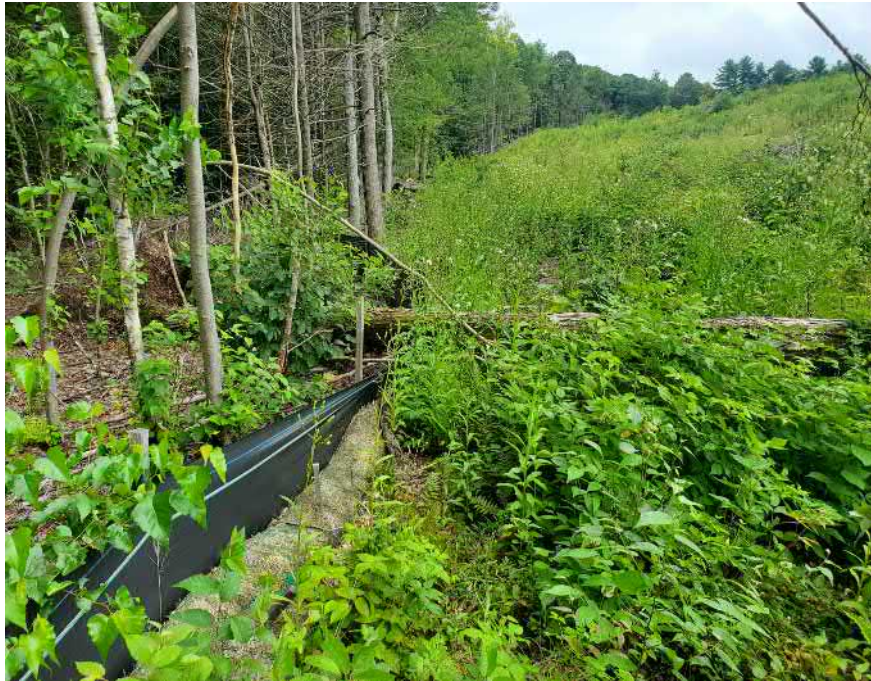
Photo 3

View of fallen tree damage to silt fence in southwestern portion of the Site — facing north

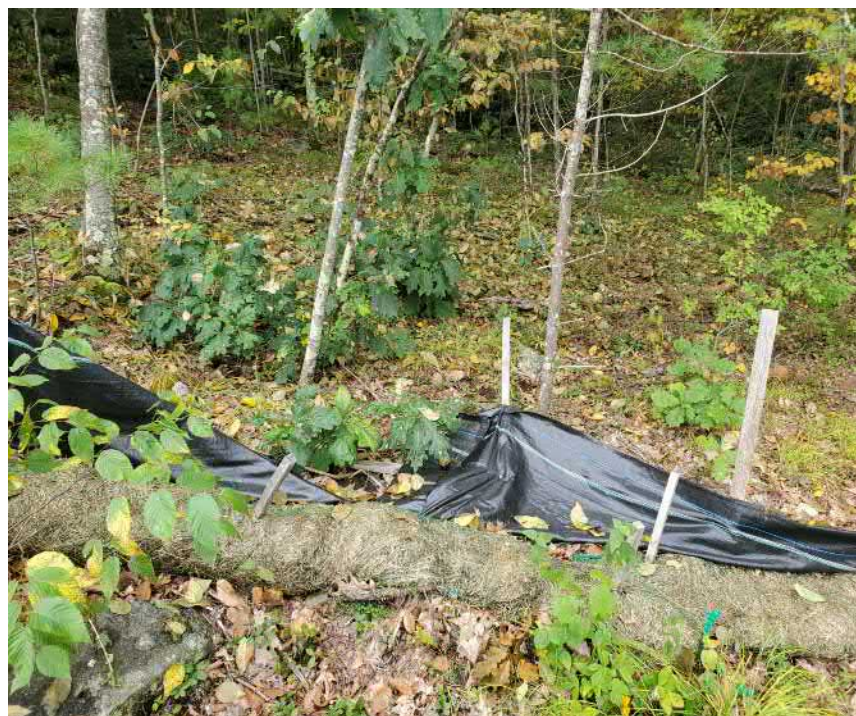
Photo 4

View of damaged silt fence in southeastern portion of the Site — facing northeast
