Inspection Report for North Sturbridge Road Solar Facility

NPDES ID No.: MAR10031G

Inspection Date: 8/24/2022

PHOTOGRAPHIC DOCUMENTATION  
North Sturbridge Road Solar Facility  
Charlton, Massachusetts  
Photographs Documented 8.24.2022

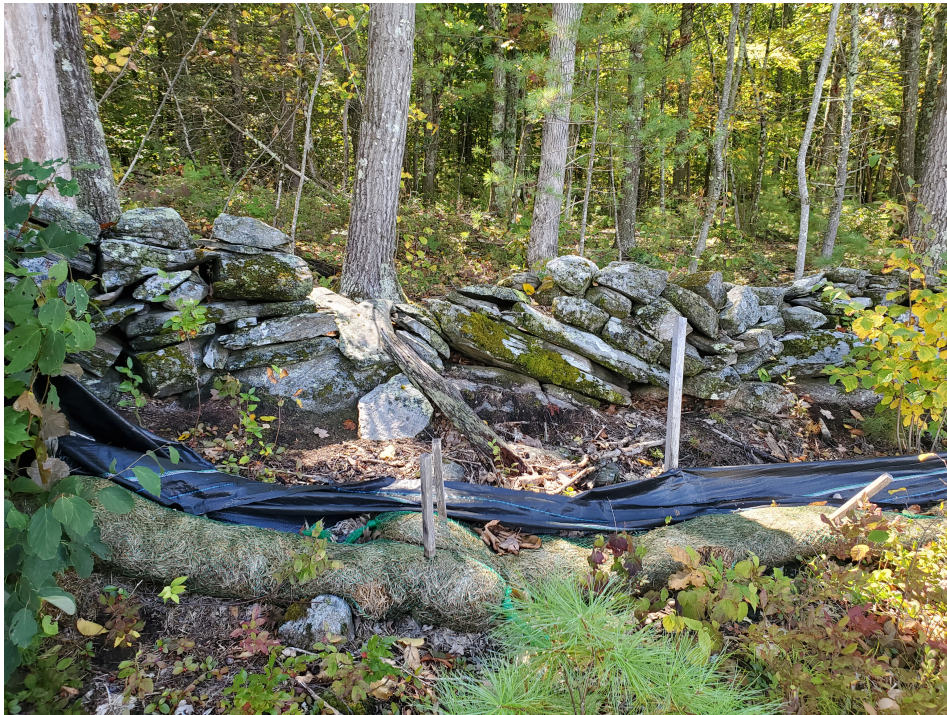
Photo 1

View of damaged silt fence in northeastern portion of the Site — facing east

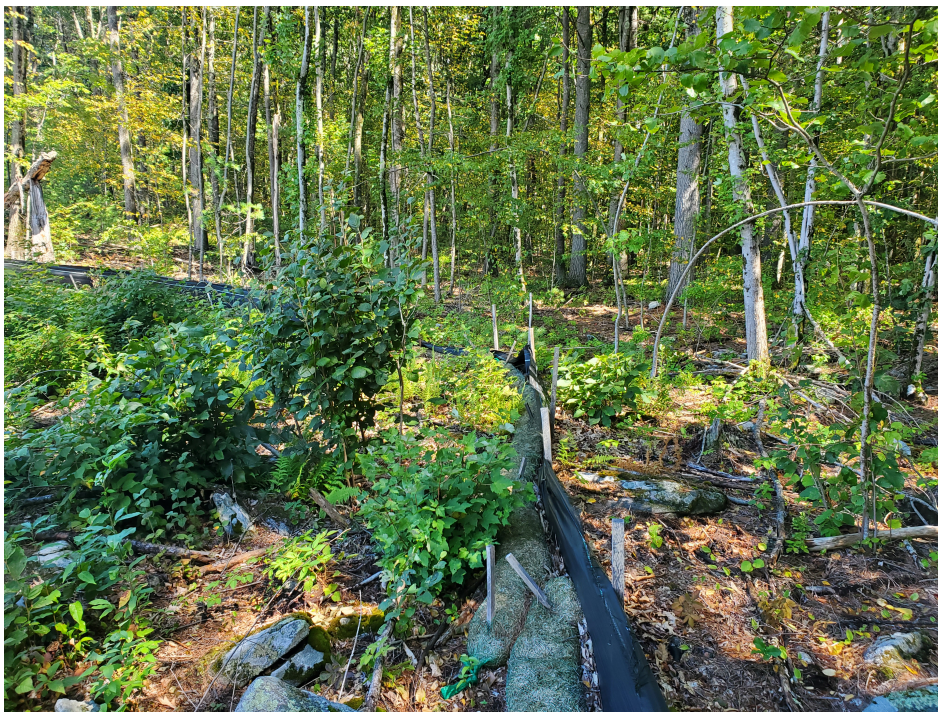
Photo 2

View of damaged silt fence in northeast portion of the Site — facing northeast

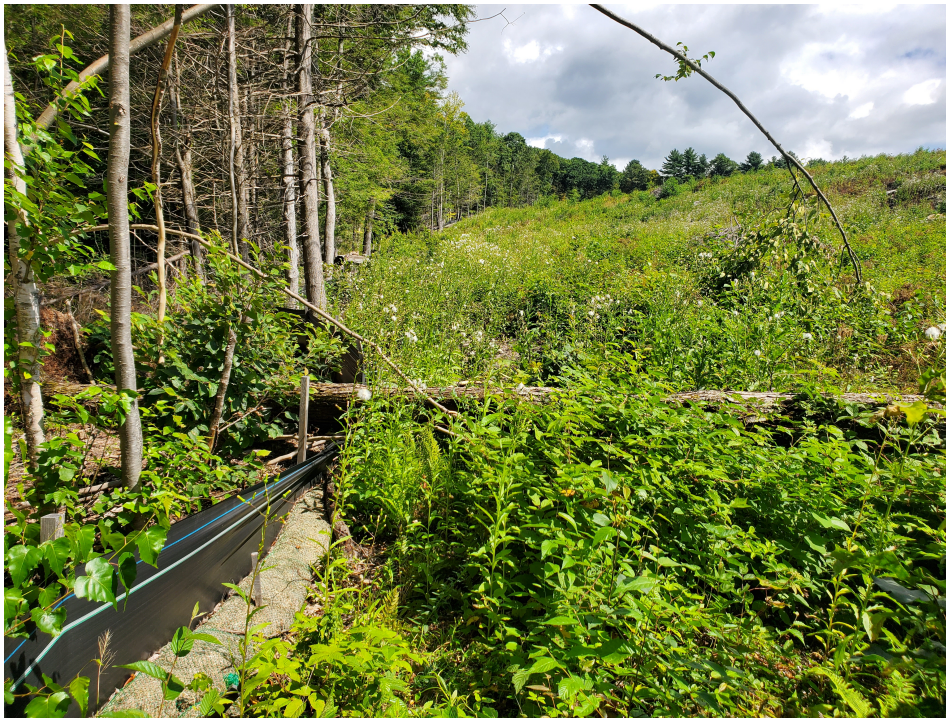
Photo 3

Type/Location of E&S Control	Maintenance Needed?*	Corrective Action Required?*	Date on Which Maintenance or Corrective Action First Identified?	Notes
1. Silt Fence and Straw Wattles	Yes	No	3/15/2022	On 8/24/2022 BETA observed fallen tree damage to the silt fence on the western perimeter of the Site, damage was first observed on 6/20/2022  On 8/24/2022 BETA observed damage to the wattles in the north-east and eastern corners of the Site, damage was first observed on 3/15/2022. BETA also observed the silt fence to be partly torn in the southeastern corner of the Site, damage was first observed on 3/27/2022. General maintenance is needed for the entire silt fence. No evidence of discharge was observed.

View of fallen tree damage to silt fence in southwestern portion of the Site — facing north

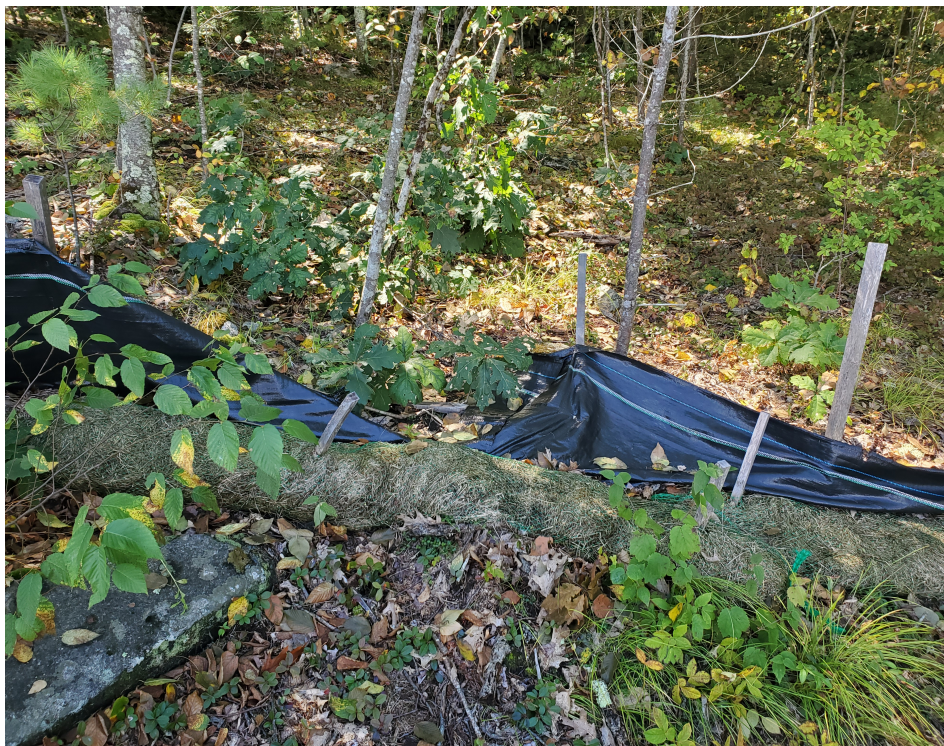
Photo 4

View of damaged silt fence in southeastern portion of the Site — facing northeast
