Inspection Report for North Sturbridge Road Solar Facility NPDES ID No.: MAR10031G

Inspection Date: 8/24/2022

PHOTOGRAPHIC DOCUMENTATION
North Sturbridge Road Solar Facility
Charlton, Massachusetts
Photographs Documented 8.24.2022

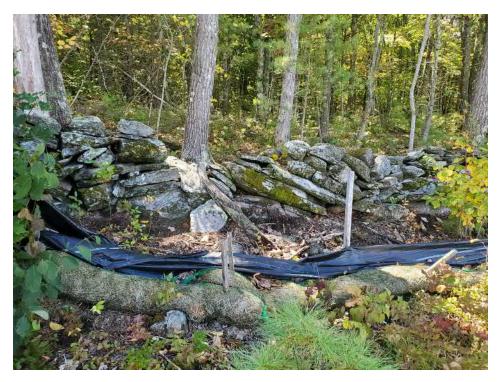
Photo 1

View of damaged silt fence in northeastern portion of the Site — facing east

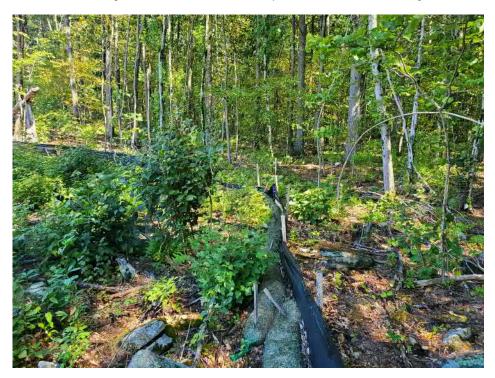
Photo 2

View of damaged silt fence in northeast portion of the Site — facing northeast

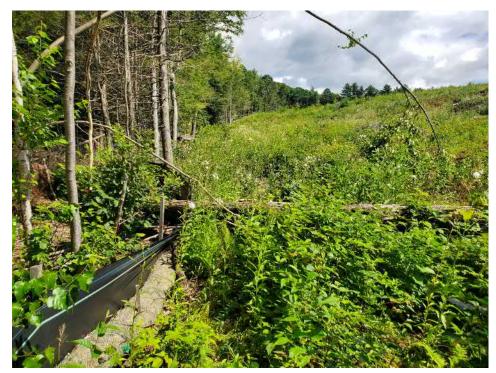
Photo 3

1. Silt Fence and Straw Wattles	Yes	No	3/15/2022	On 8/24/2022 BETA observed fallen tree damage to the silt fence on the western perimeter of the Site, damage was first observed on 6/20/2022 On 8/24/2022 BETA observed damage to the wattles in the northeast and eastern corners of the Site, damage was first observed on 3/15/2022. BETA also observed the silt fence to be partly torn in the southeastern corner of the Site, damage was first observed on 3/27/2022. General maintenance is needed for the entire silt fence. No evidence of discharge was observed.		
Stabilized Construction Entrance (Site Entrance – Access Road)	No	No

View of fallen tree damage to silt fence in southwestern portion of the Site — facing north

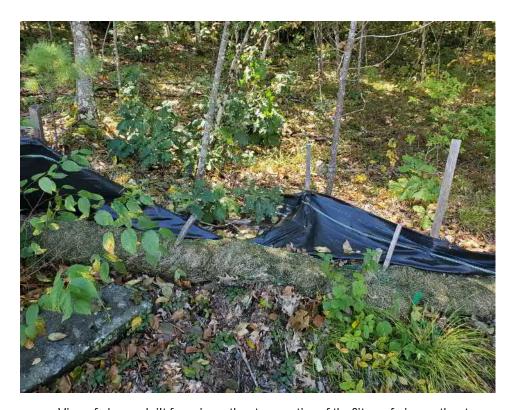
Photo 4

View of damaged silt fence in southeastern portion of the Site — facing northeast
