Inspection Report for North Sturbridge Road Solar Facility NPDES ID No.: MAR10031G

Inspection Date: 8/26/2022

PHOTOGRAPHIC DOCUMENTATION
North Sturbridge Road Solar Facility
Charlton, Massachusetts
Photographs Documented 8.26.2022

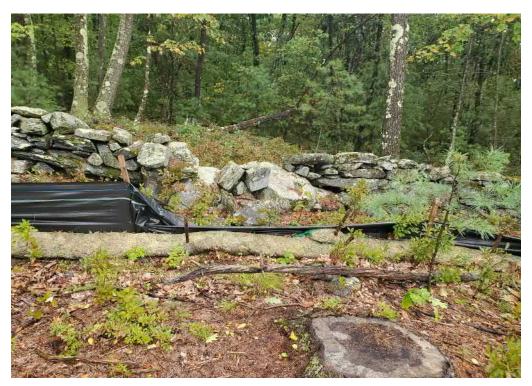
Photo 1

| | Condition and | Effectiveness o | f Erosion and Sedim | ent (E&S) Controls (CGP Part 2.2) |
|--|---|---|---|--|
| | | | | On 8/26/2022 BETA observed damage to the wattles in the northeast and eastern corners of the Site, damage was first observed on 3/15/2022. BETA also observed the silt fence to be partly torn in the southeastern corner of the Site, damage was first observed on 3/27/2022. General maintenance is needed for the entire silt fence. No evidence of discharge was observed. |

View of damaged silt fence in northeastern portion of the Site — facing east

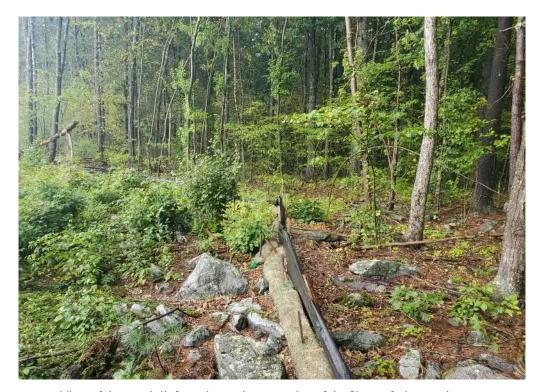
Photo 2

View of damaged silt fence in northeast portion of the Site — facing northeast

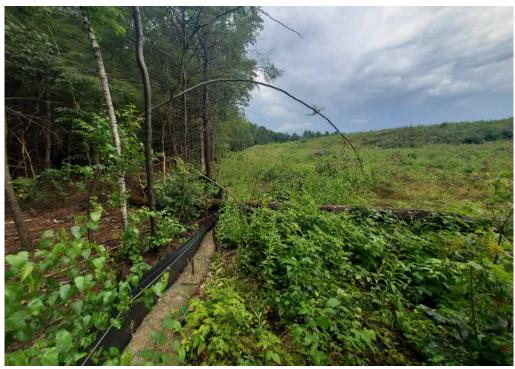
Photo 3

| | Condition and | Effectiveness o | f Erosion and Sedim | ent (E&S) Controls (CGP Part 2.2) |
|--|---|---|---|--|
| Silt Fence and Straw Wattles | Yes | No | 3/15/2022 | On 8/26/2022 BETA observed fallen tree damage to the silt fence on the western perimeter of the Site, damage was first observed on 6/20/2022 |

View of fallen tree damage to silt fence in southwestern portion of the Site — facing north

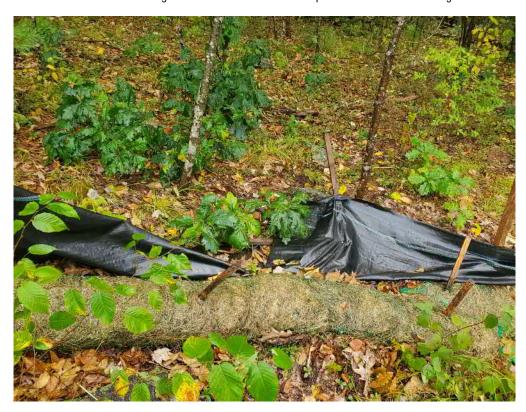
Photo 4

View of damaged silt fence in southeastern portion of the Site — facing northeast
