Inspection Report for North Sturbridge Road Solar Facility

NPDES ID No.: MAR10031G

Inspection Date: 8/31/2022

**FIGURE 1:  
SWPPP  
INSPECTION  
SKETCH  
8/31/2022**

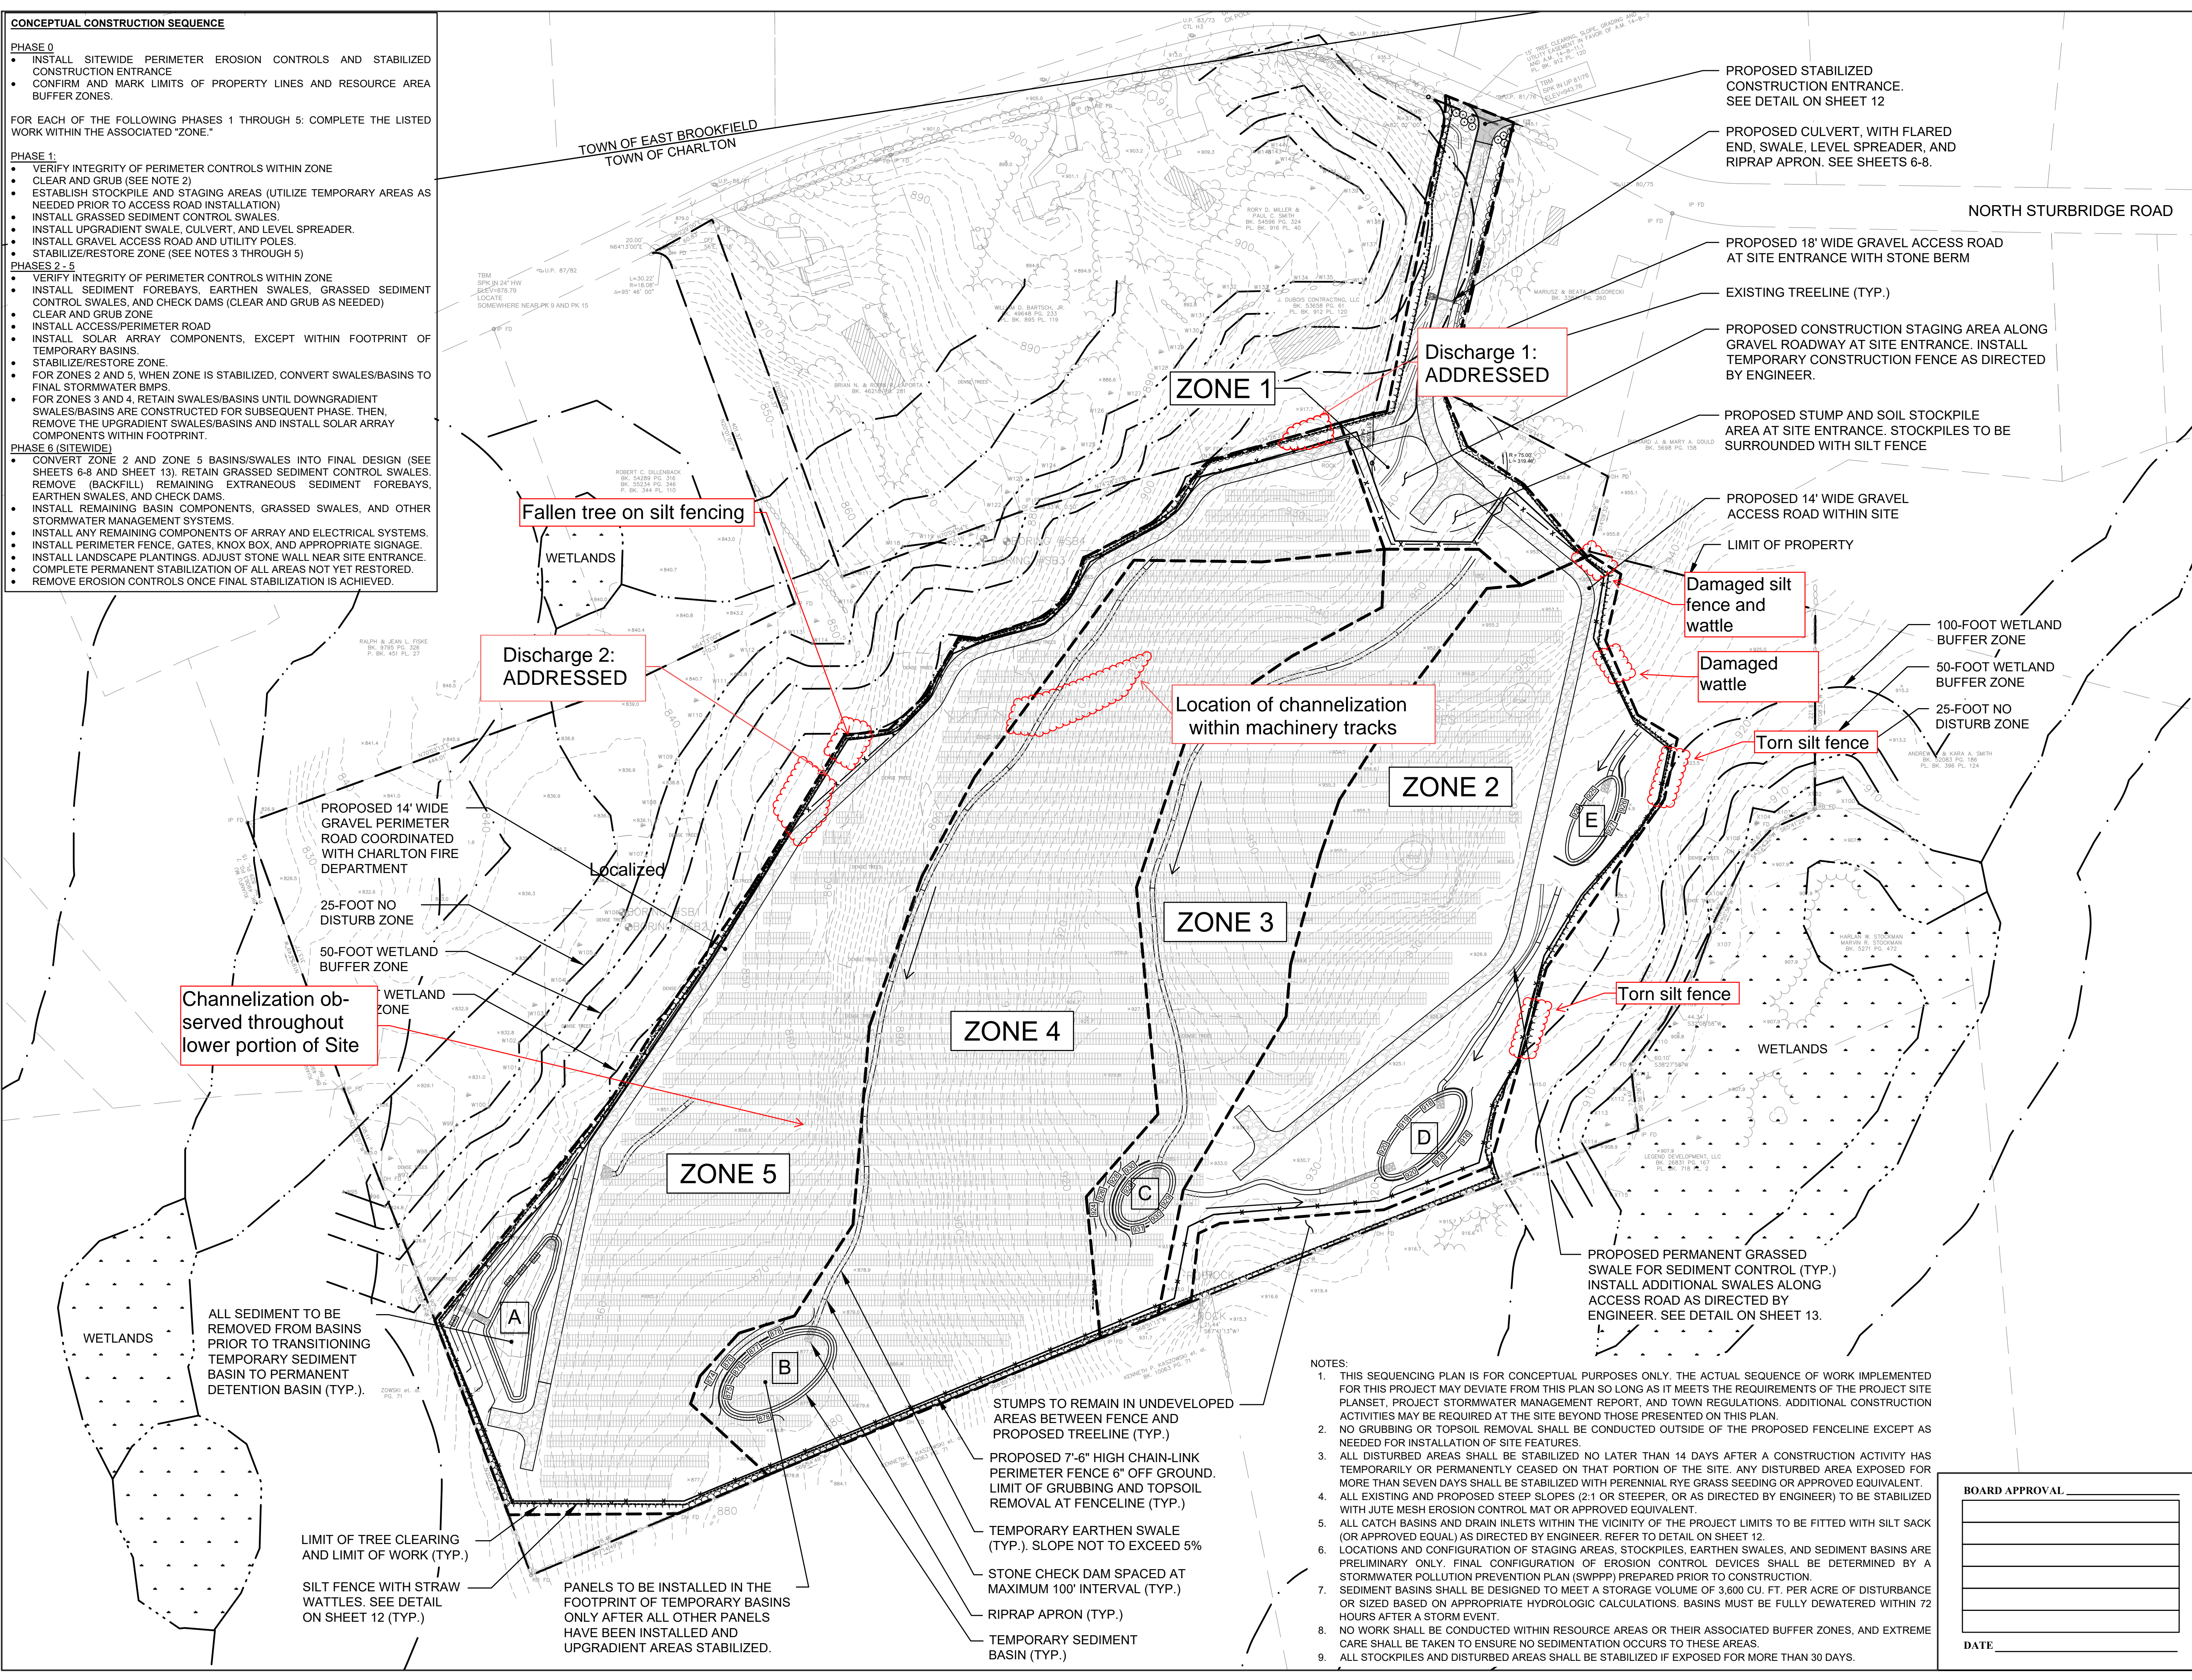
| Stabilization of Exposed Soil (CGP Part 2.2.14) | | | |
|--|---|---|--|
| 2. Informal access road along northern portion of the Site | Straw mulch or hydroseed | <input type="checkbox"/> Yes <input checked="" type="checkbox"/> No | Erosion channels are beginning to form within upgradient portions of the informal access road (Figure 1). The contractor indicated that stabilization by smoothing out soils and seeding or spreading mulch would occur on 7/30/2021. Stabilization of this area has not been initiated. After inspection of the area on 8/24/2021, it was determined that |

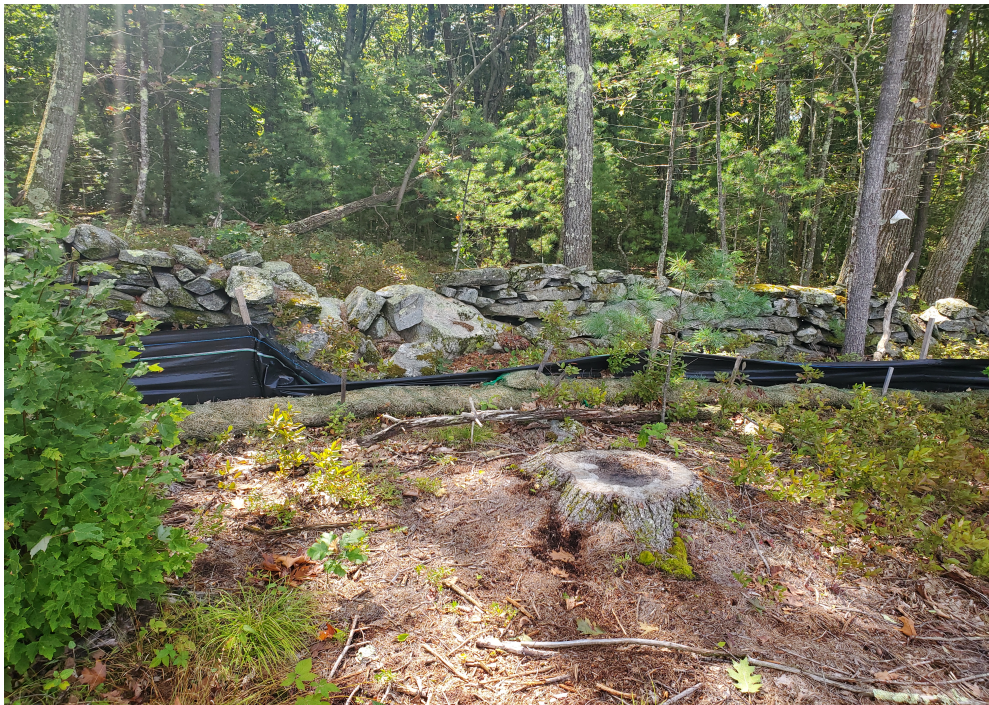
Photo 1

| Type/Location of E&S Control | Maintenance Needed?* | Corrective Action Required?* | Date on Which Maintenance or Corrective Action First Identified? | Notes |
|---|---|---|--|---|
| 1. Silt Fence and Straw Wattles | Yes | No | 3/15/2022 | On 8/31/2022 BETA observed fallen tree damage to the silt fence on the western perimeter of the Site, damage was first observed on 6/20/2022<br><br>On 8/31/2022 BETA observed damage to the wattles in the north-east and eastern corners of the Site, damage was first observed on 3/15/2022. BETA also observed the silt fence to be partly torn in the southeastern corner of the Site, damage was first observed on 3/27/2022. General maintenance is needed for the entire silt fence. No evidence of discharge was observed. |

View of damaged silt fence in northeastern portion of the Site — facing east

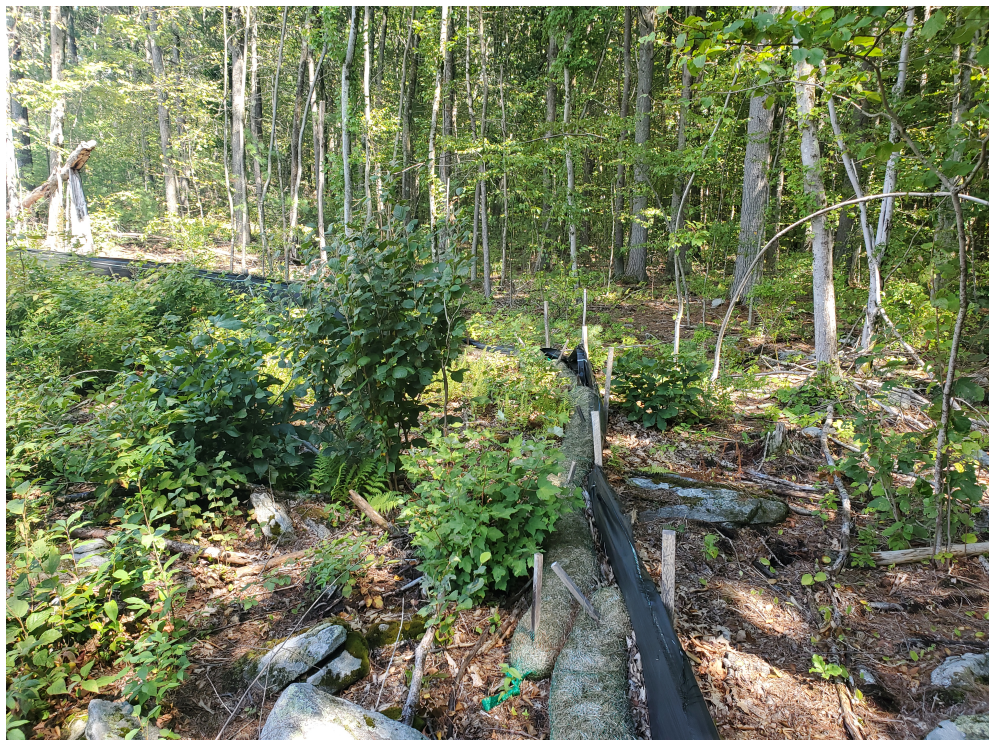
Photo 2

View of damaged silt fence in northeast portion of the Site — facing northeast

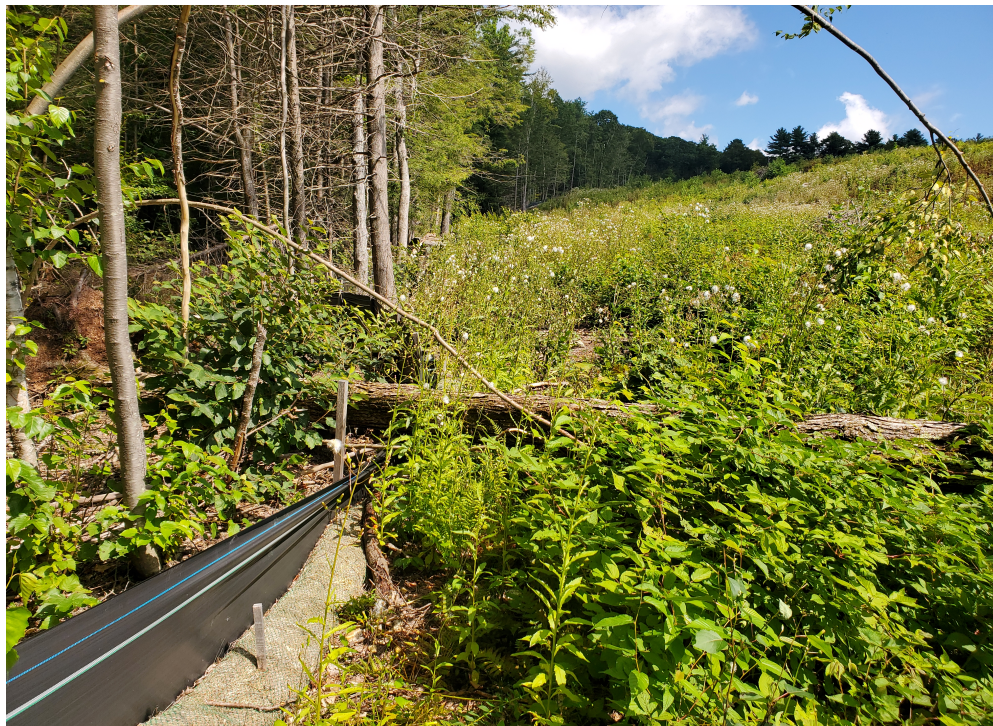
Photo 3

View of fallen tree damage to silt fence in southwestern portion of the Site — facing north

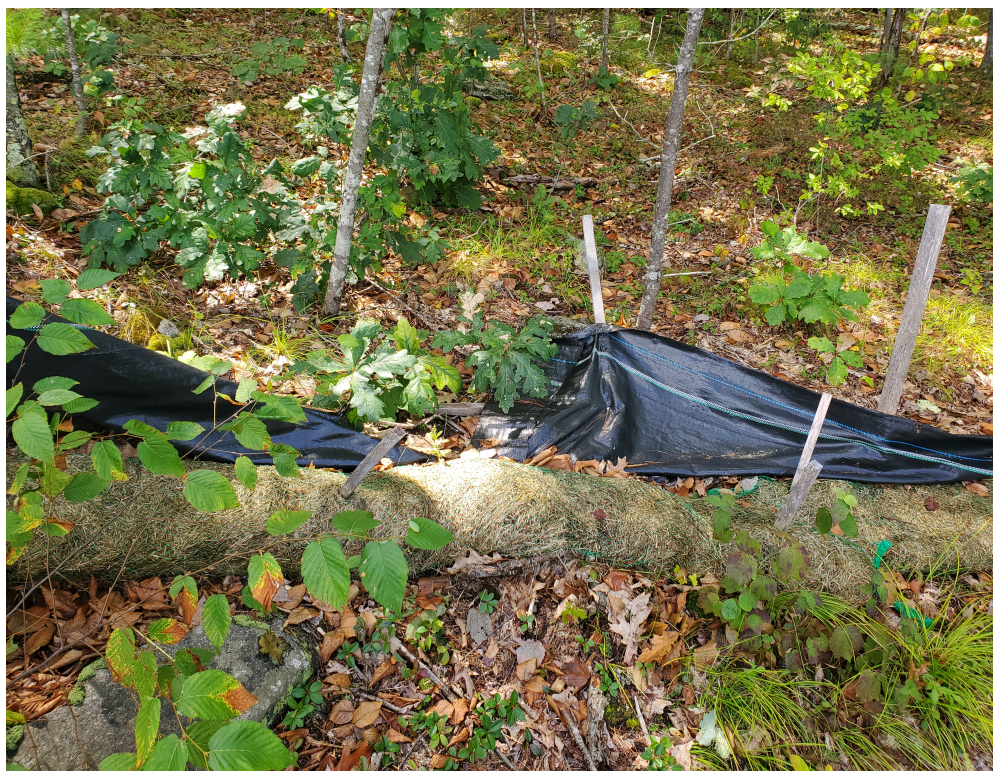
Photo 4

View of damaged silt fence in southeastern portion of the Site — facing northeast
