Inspection Report for North Sturbridge Road Solar Facility NPDES ID No.: MAR10031G

Inspection Date: 8/31/2022

PHOTOGRAPHIC DOCUMENTATION
North Sturbridge Road Solar Facility
Charlton, Massachusetts
Photographs Documented 8.31.2022

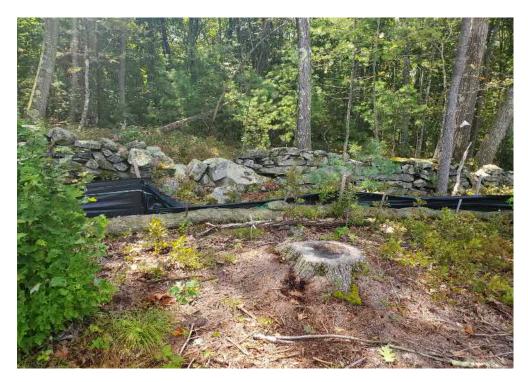
Photo 1

1. Silt Fence and Straw Wattles	Yes	No	3/15/2022	On 8/31/2022 BETA observed fallen tree damage to the silt fence on the western perimeter of the Site, damage was first observed on 6/20/2022 On 8/31/2022 BETA observed damage to the wattles in the northeast and eastern corners of the Site, damage was first observed on 3/15/2022. BETA also observed the silt fence to be partly torn in the southeastern corner of the Site, damage was		
				first observed on 3/27/2022. General maintenance is needed for the entire silt fence. No evidence of discharge was observed.

View of damaged silt fence in northeastern portion of the Site — facing east

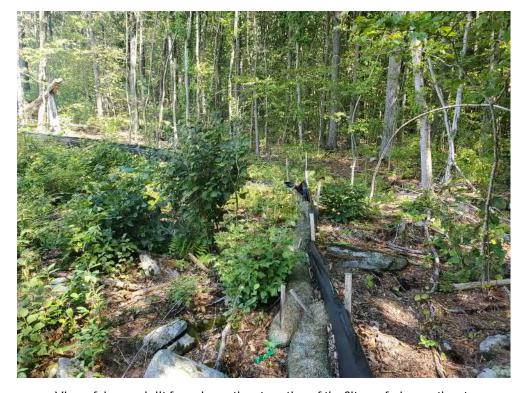
Photo 2

View of damaged silt fence in northeast portion of the Site — facing northeast

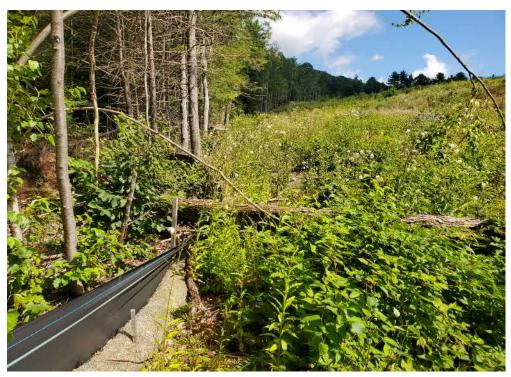
Photo 3

View of fallen tree damage to silt fence in southwestern portion of the Site — facing north

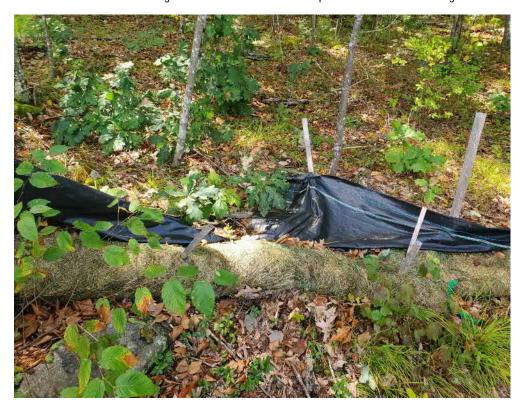
Photo 4

View of damaged silt fence in southeastern portion of the Site — facing northeast
