Inspection Report for North Sturbridge Road Solar Facility

NPDES ID No.: MAR10031G

Inspection Date: 9/6/2022

PHOTOGRAPHIC DOCUMENTATION
North Sturbridge Road Solar Facility
Charlton, Massachusetts
Photographs Documented 9.6.2022

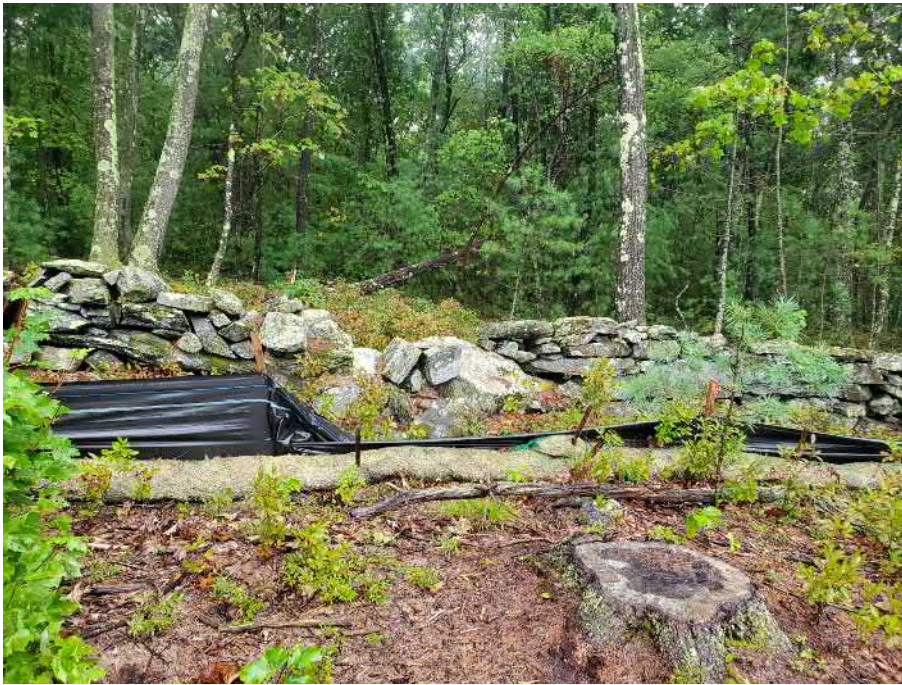
Photo 1

View of damaged silt fence in northeastern portion of the Site — facing east

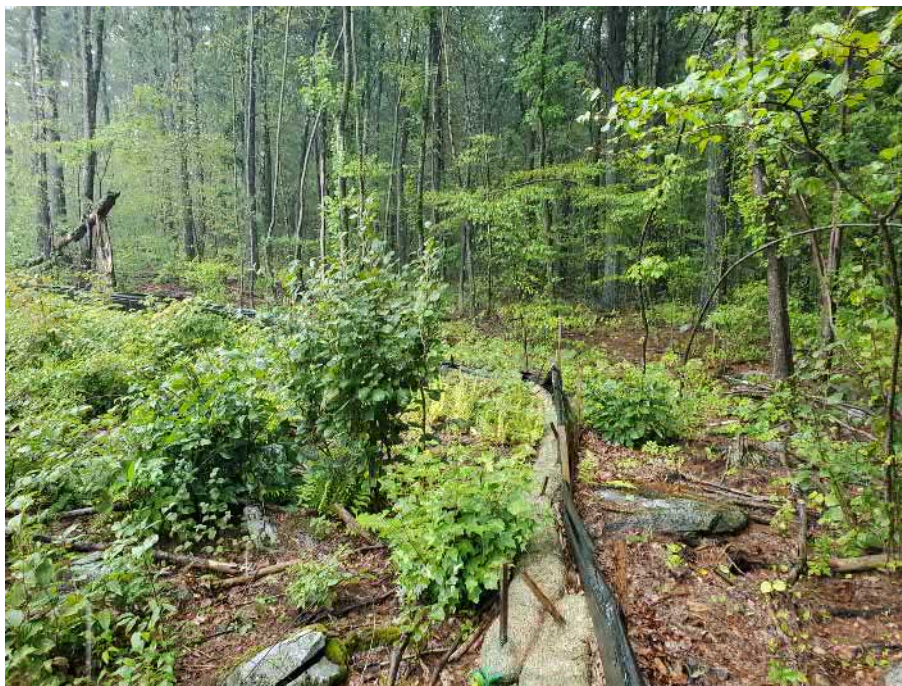
Photo 2

View of damaged silt fence in northeast portion of the Site — facing northeast

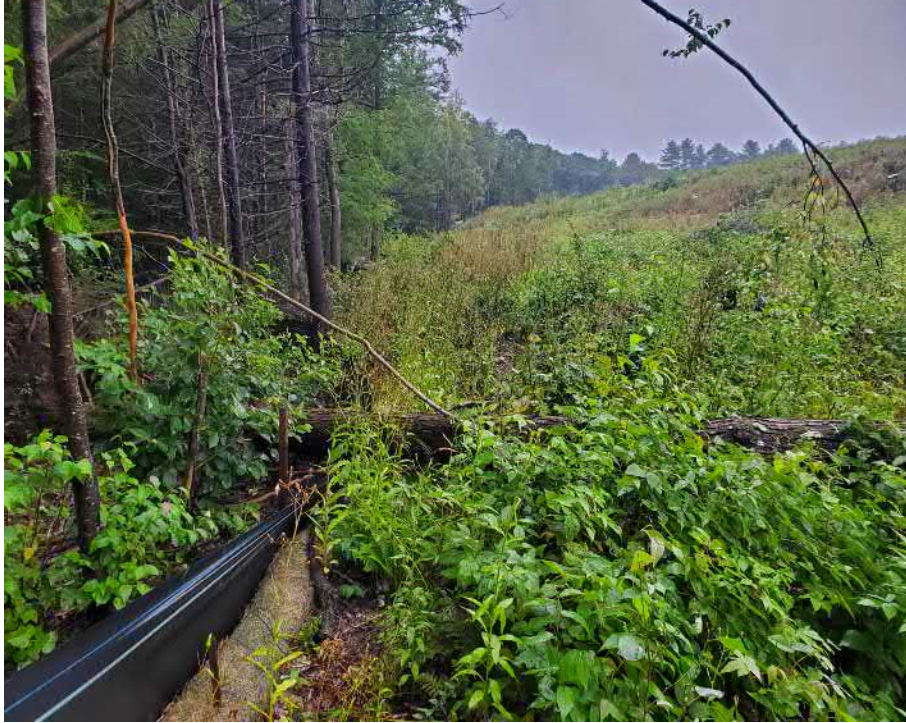
Photo 3

Type/Location of E&S Control	Maintenance Needed?*	Corrective Action Required?*	Date on Which Maintenance or Corrective Action First Identified?	Notes
1. Silt Fence and Straw Wattles	Yes	No	3/15/2022	On 9/6/2022 BETA observed fallen tree damage to the silt fence on the western perimeter of the Site, damage was first observed on 6/20/2022 On 9/6/2022 BETA observed damage to the wattles in the north-east and eastern corners of the Site, damage was first observed on 3/15/2022. BETA also observed the silt fence to be partly torn in the southeastern corner of the Site, damage was first observed on 3/27/2022. General maintenance is needed for the entire silt fence. No evidence of discharge was observed.

View of fallen tree damage to silt fence in southwestern portion of the Site — facing north

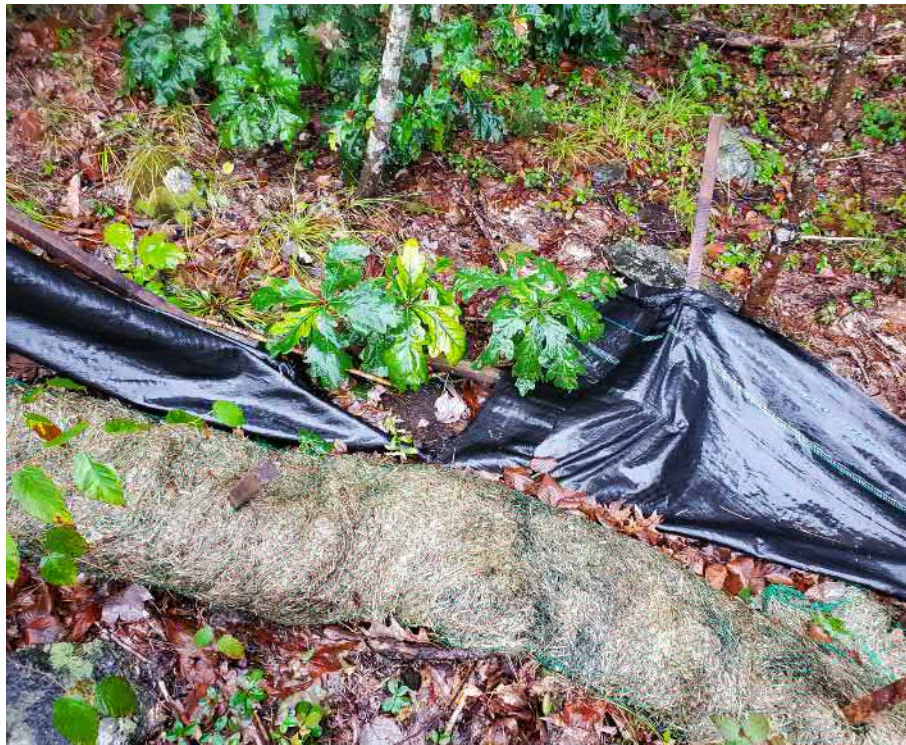
Photo 4

View of damaged silt fence in southeastern portion of the Site — facing northeast
